Malibu Lagoon Restoration and Enhancement Project Comprehensive Monitoring Report (Year 4)

August 2017

Prepared by: The Bay Foundation (TBF)

Prepared for: State of California, Department of Parks and Recreation

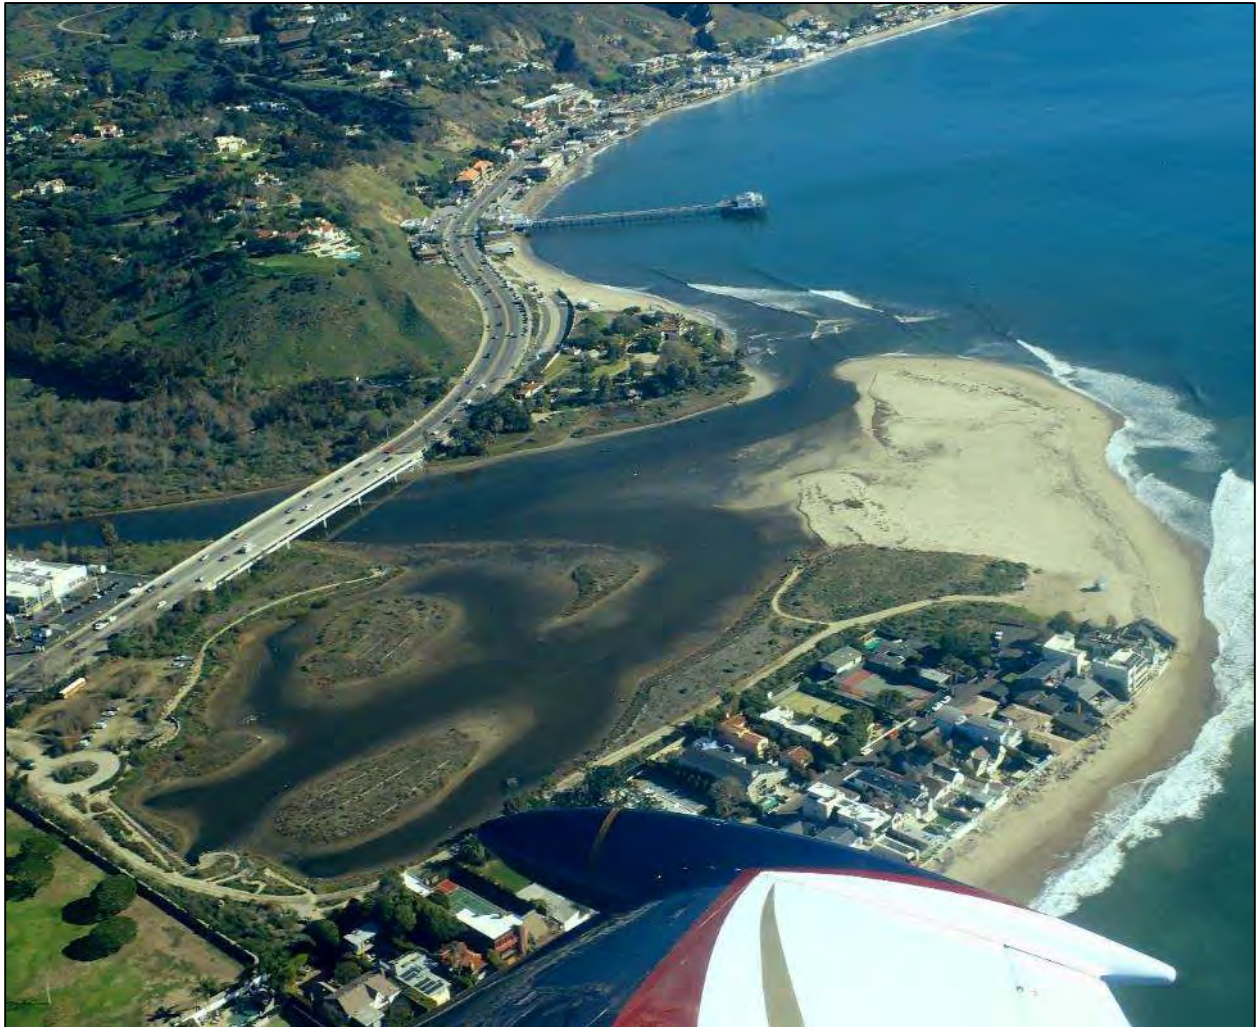
Figure 1. Aerial view of Malibu Lagoon from Lighthawk flight on 26 January 2017 with an open berm condition (credit: P. House, The Bay Foundation).

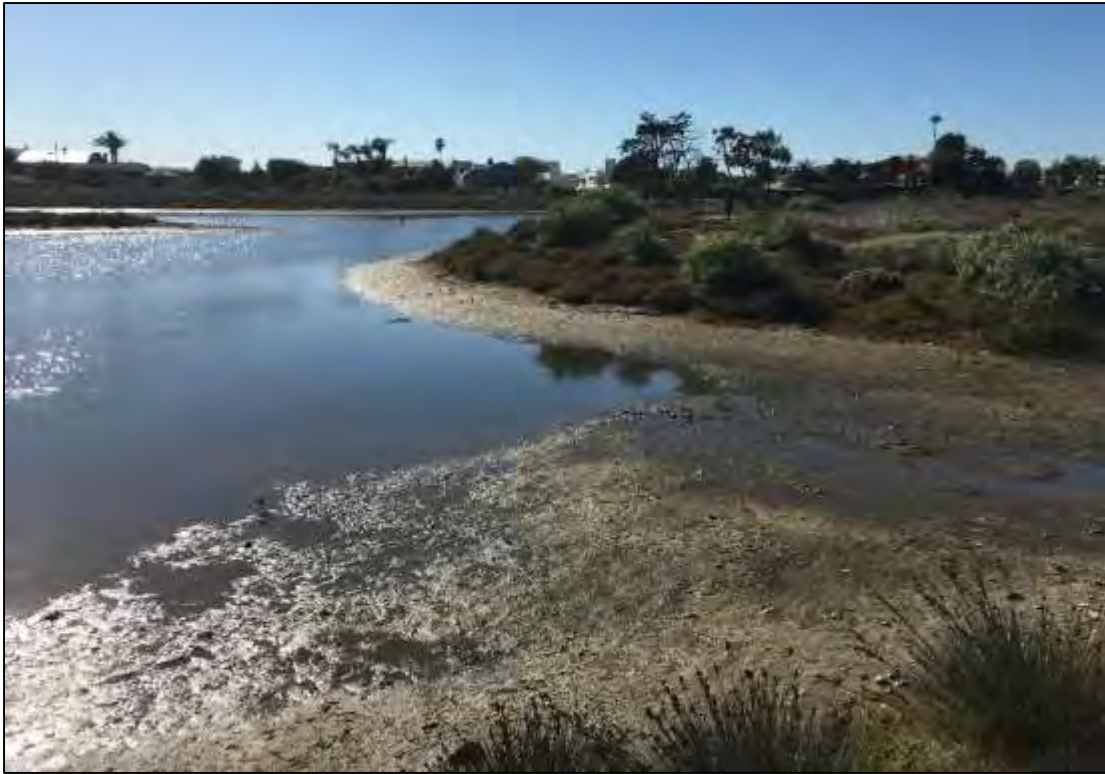
Figure 4 displays the Assessment Area (AA) and buffer lines for the post-restoration CRAM survey. The AA is approximately one hectare, or two and a half acres of wetland habitats, following guidelines described in the User Manual. The AA location is approximately the same as the pre-restoration survey.

Figure 3. Landscape photo of a portion of the CRAM AA at Malibu on the most recent survey, 27 December 2016.

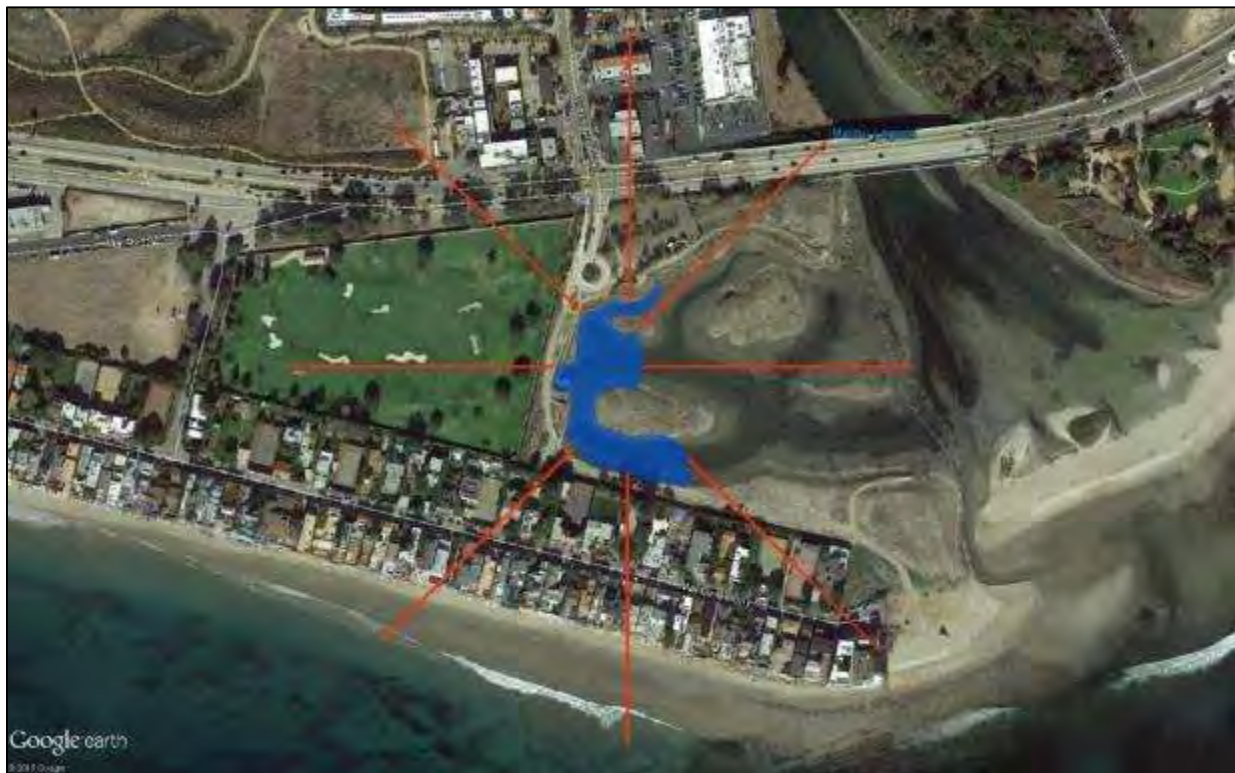
Figure 4. Post-restoration CRAM Assessment Area (blue polygon) at Malibu Lagoon. Red lines indicate radiating (potential) buffer lines.

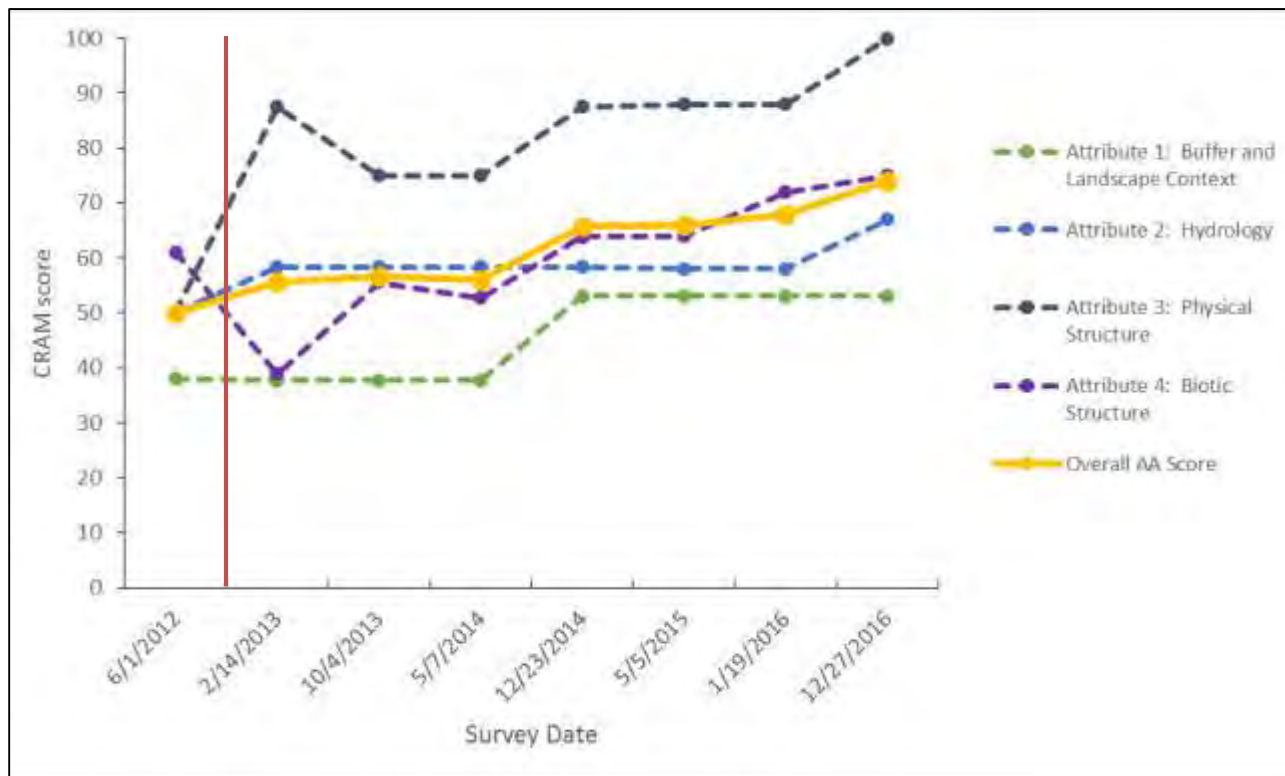
The results of all post-restoration CRAM assessment surveys are shown in Table 2 and Figure 5, with the pre-restoration data (2012) also included for comparison. The overall CRAM score increased from 50 pre-restoration to 74 based on the latest survey, with an additional increase in the hydrology, physical, and biotic attributes since the January 2016 survey. The hydroperiod metric improved largely due to a lack of artificial breaching occurring during the survey time period. The lagoon breached from a closed to open condition naturally in the appropriate location on 28 November 2016. The scores for topographic complexity and overall complexity of the Assessment Area also improved, with the addition of several new microtopographic patch types. The vegetation community was similar to last year, with additional establishment of a large plant layer, predominantly in the form of *Schoenoplectus californicus* (California bulrush).

Figure 5. Graph of CRAM attribute and overall scores over time. Note: the 2012 survey date is pre-restoration.

Post-restoration surveys show a consistent increase in final CRAM scores over time, with the most recent scores indicating that the wetlands are in good condition, overall. As predicted, the biotic structure attribute continued to increase slightly as the vegetation community increased in overall cover and complexity over time. The hydrology score increased for the first time in several years due to a significant reduction in irrigation and a lack of artificial breaching occurring this year. The overall CRAM final score is also likely to remain consistently above the pre-restoration assessment final score. CRAM surveys will continue annually (at minimum) throughout the duration of the monitoring program.

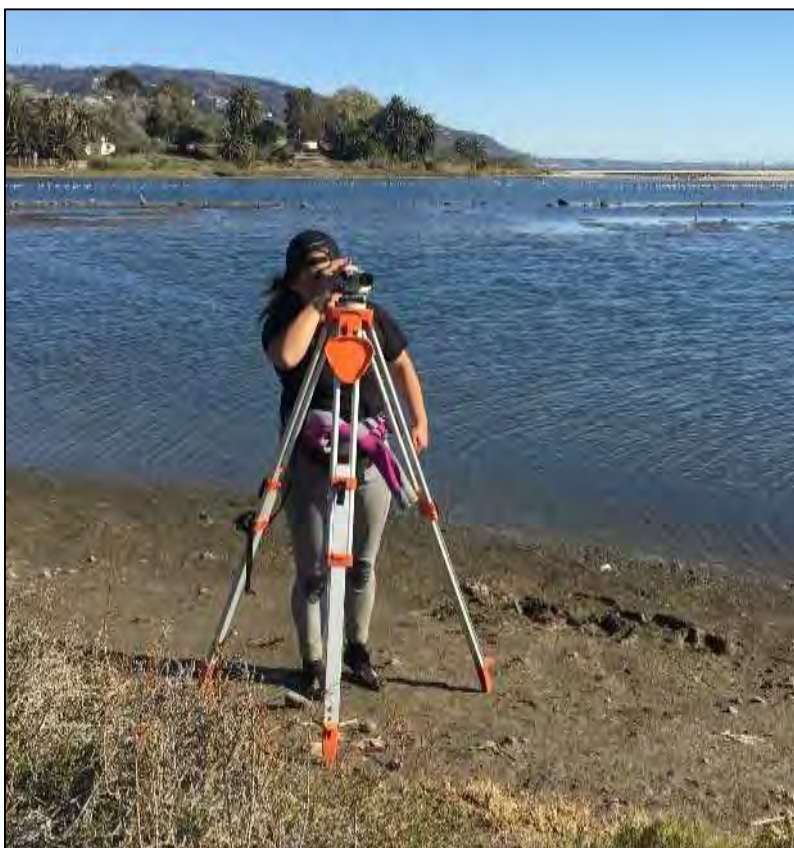
Five permanent and repeatable cross-section locations were monitored for four consecutive post-restoration years on 14 February 2013, 18 December 2014, 19 January 2016, and in December 2016 (21 and 27 December 2016) (Figures 6 and 7). Two survey days were needed in Year 4 to complete the monitoring. Horizontal and vertical locations of cross-section end-points were fixed by monuments. Sediment scour or deposition depths were calculated from the data.

Figure 6. Cross-channel elevation surveys at Malibu Lagoon, 27 December 2016.

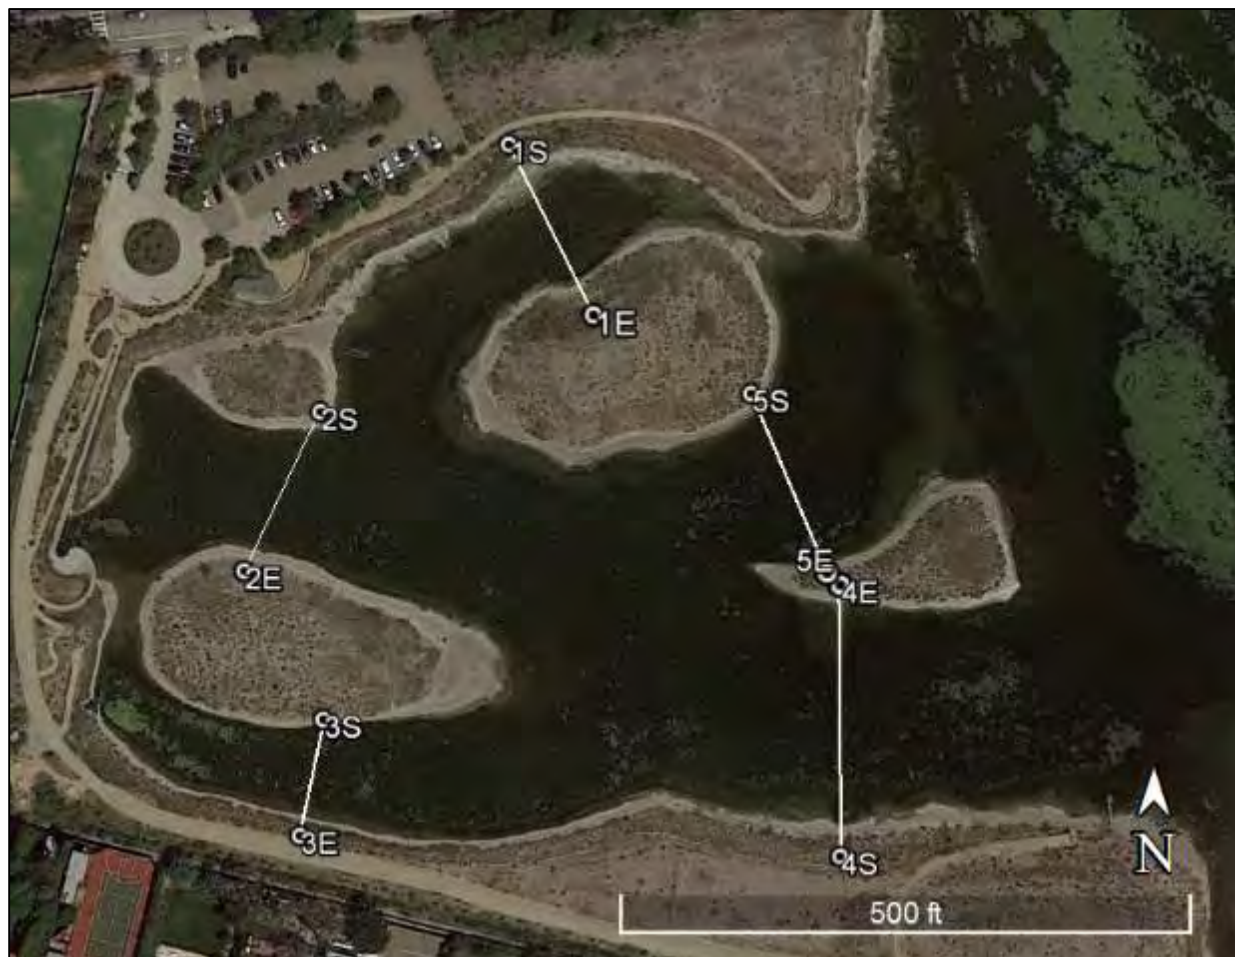
Figure 7. Map of cross-channel elevation transect locations.

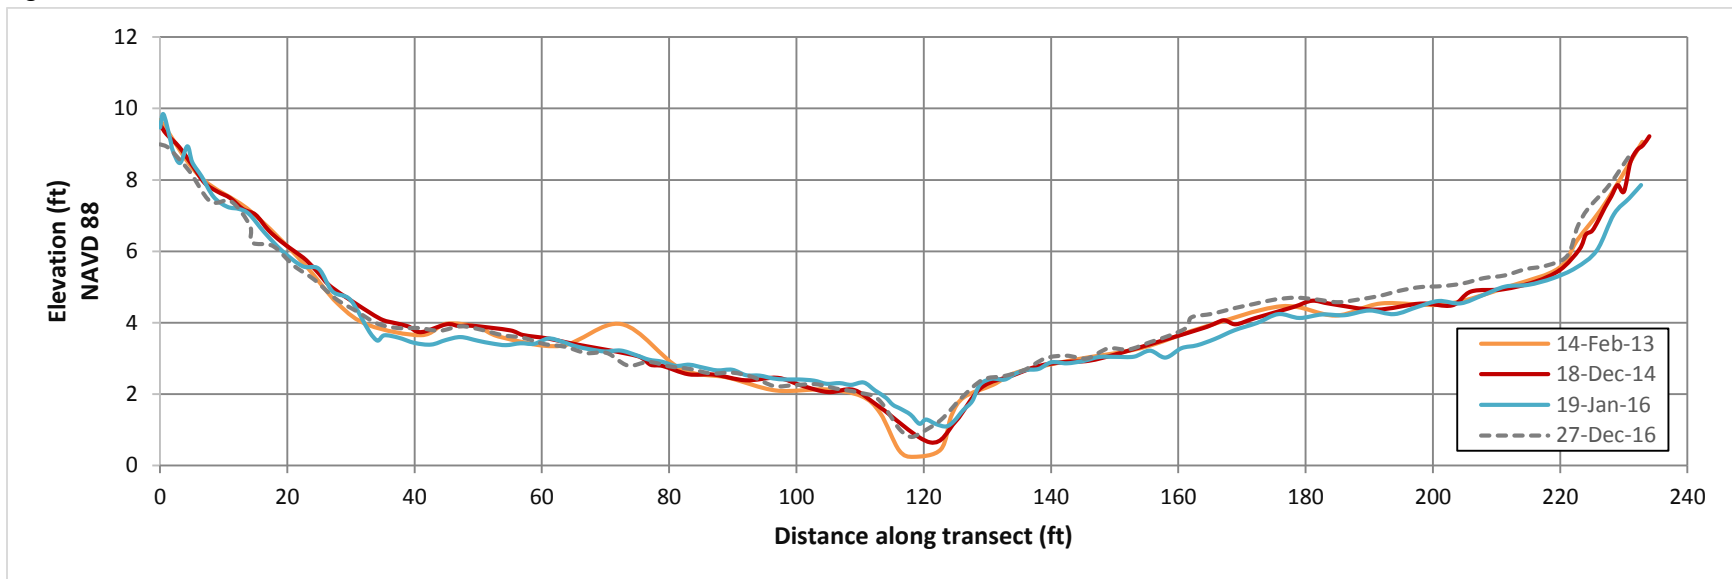
Figure 11. Channel Cross-section Transect 4.

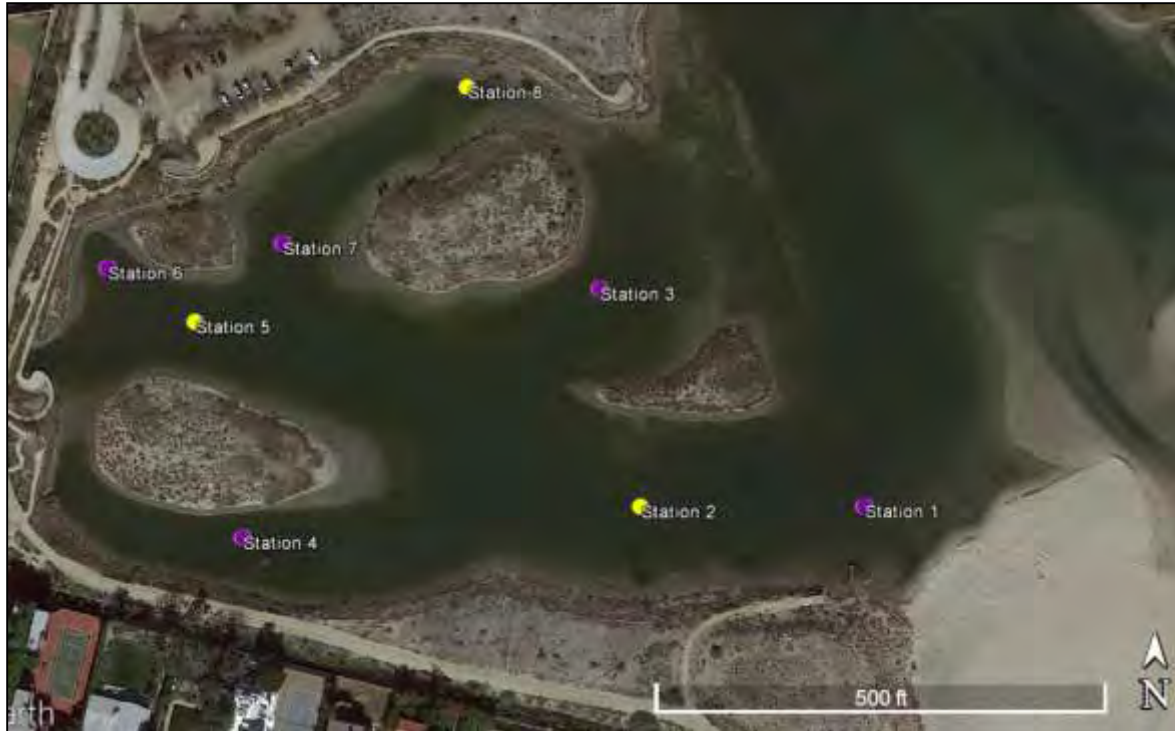
Figure 14. Map of post-restoration vertical profile, SAV/algae, surface and bottom water nutrient, and sediment survey stations. Stations 2, 5, and 8 are the locations of the three permanently-deployed Hydrolab data sondes (in yellow).

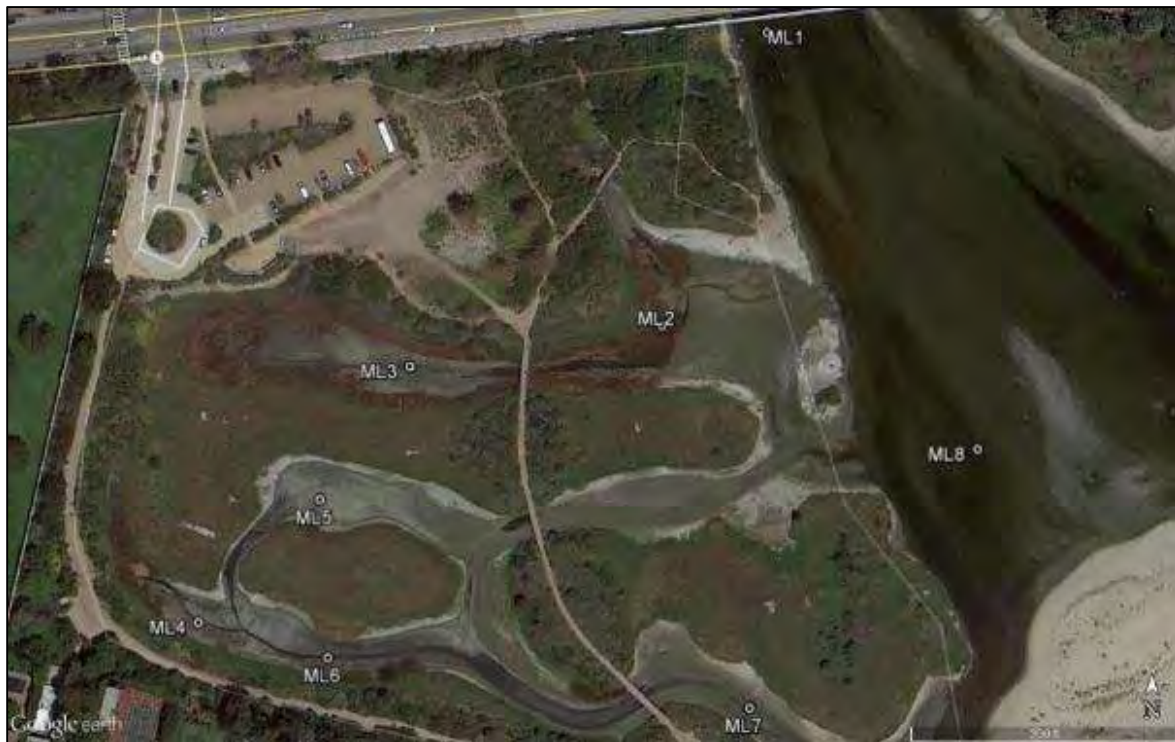
Data were collected between May 2013 and December 2016 at three permanent post-restoration stations. Dates of deployment varied by station due to probe malfunctions, servicing, or calibration glitches (Table 3). Post-restoration monitoring stations were located within the western Lagoon's main channel (Station 2) and within the western Lagoon's back channels (Stations 5 and 8) (Figure 14). When possible, data were compared to pre-restoration data collected from hydrologically similar back channels (ML2 and ML6) (Figure 15). Pre-restoration data were collected between October 2006 and June 2012.

Figure 15. Map of pre-restoration water quality monitoring stations. ML2 and ML6 are the locations of the pre-restoration permanently-deployed YSI data sondes.

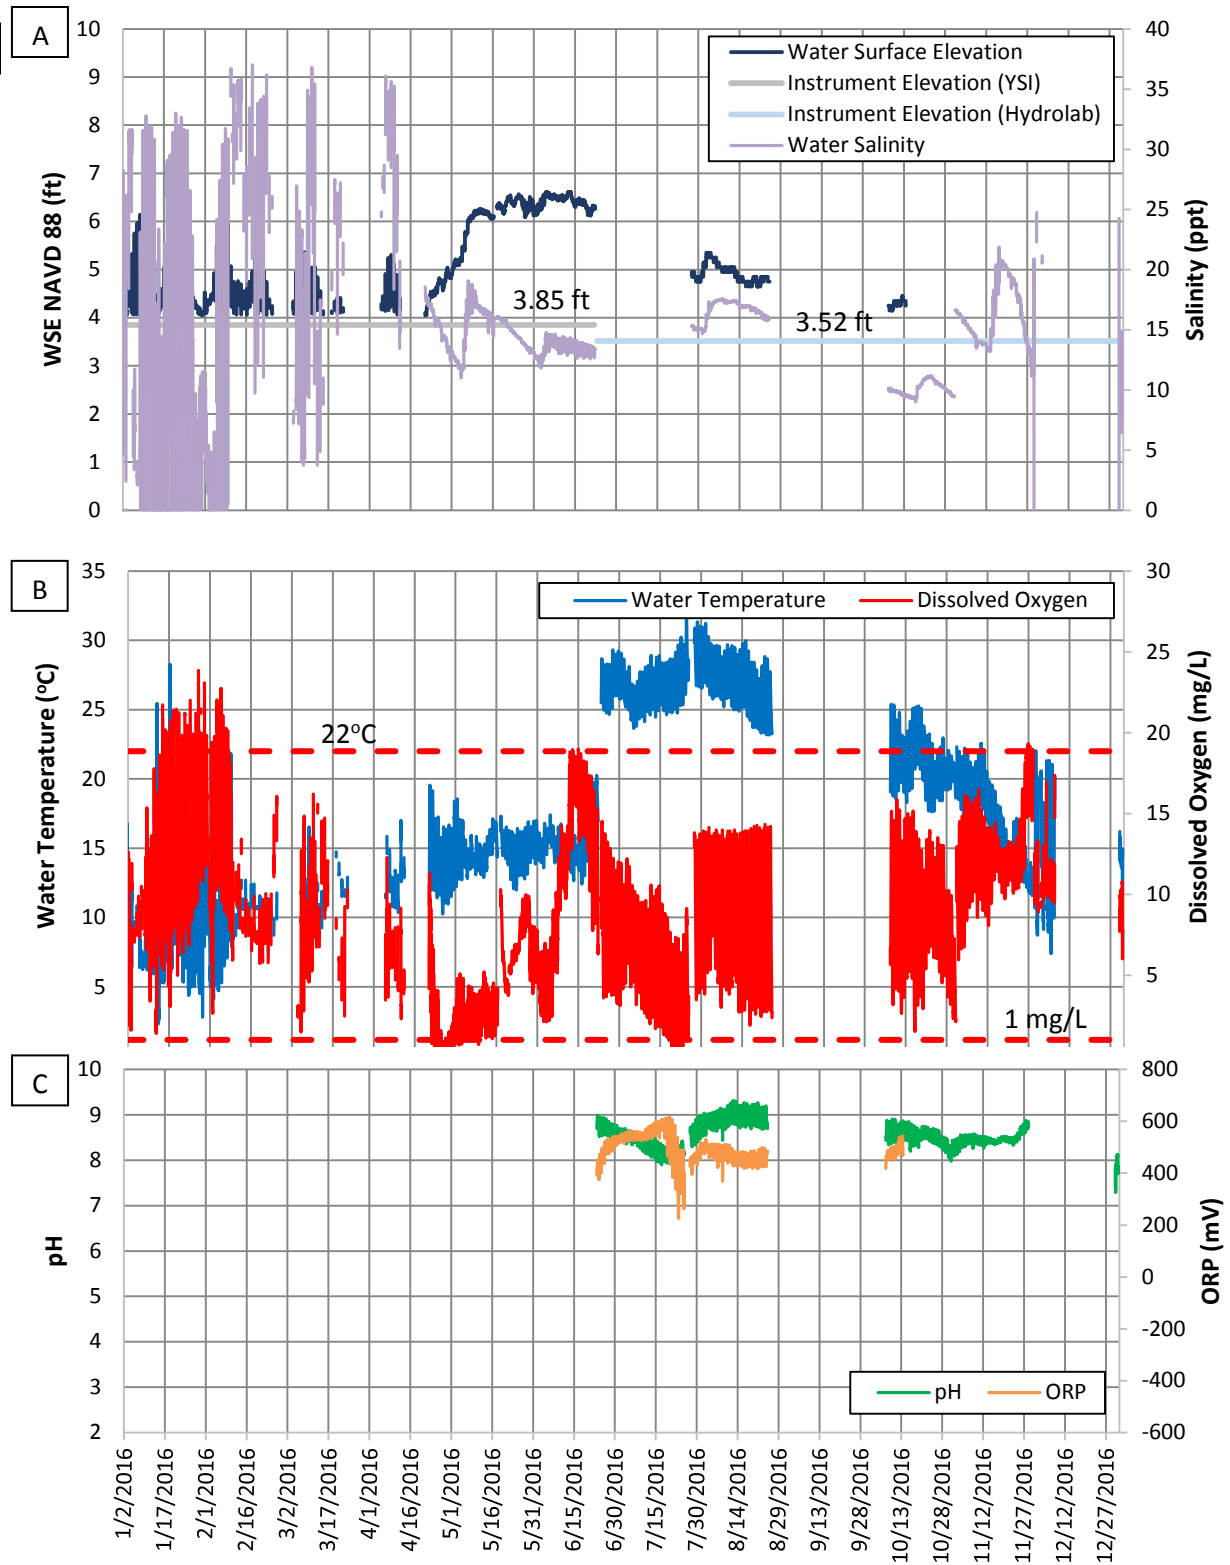
Figure 17. Graphs illustrating continuous water quality parameters from Station 8 (2016).

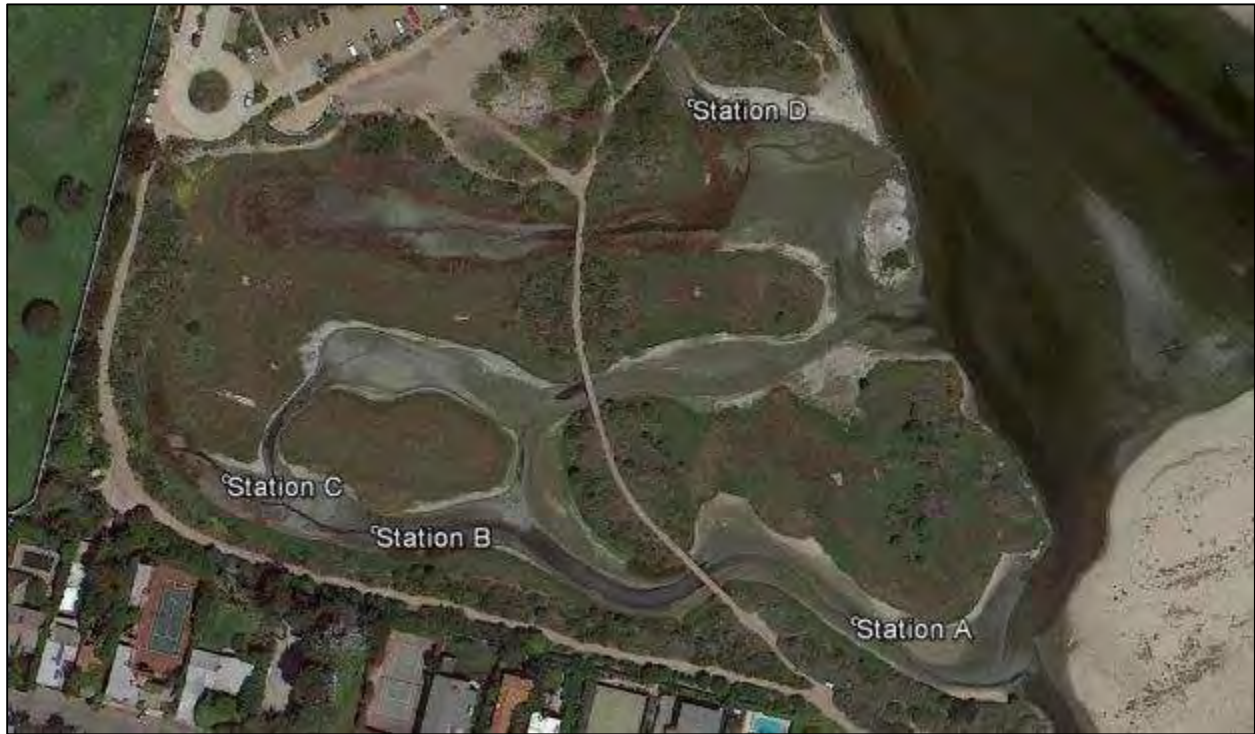
Sediment data were collected during pre-restoration conditions at four sampling locations (Figure 26) during four sampling events in September 2006, April 2007, September 2007, and April 2008. Pre-restoration sediment samples were processed for nitrates, total phosphorus, Total Kjeldahl nitrogen, and total nitrogen. Whenever possible, site-wide data trends are compared for pre- and post-restoration sediment nutrient data.

Figure 26. Map showing the location of pre-restoration sediment monitoring stations.

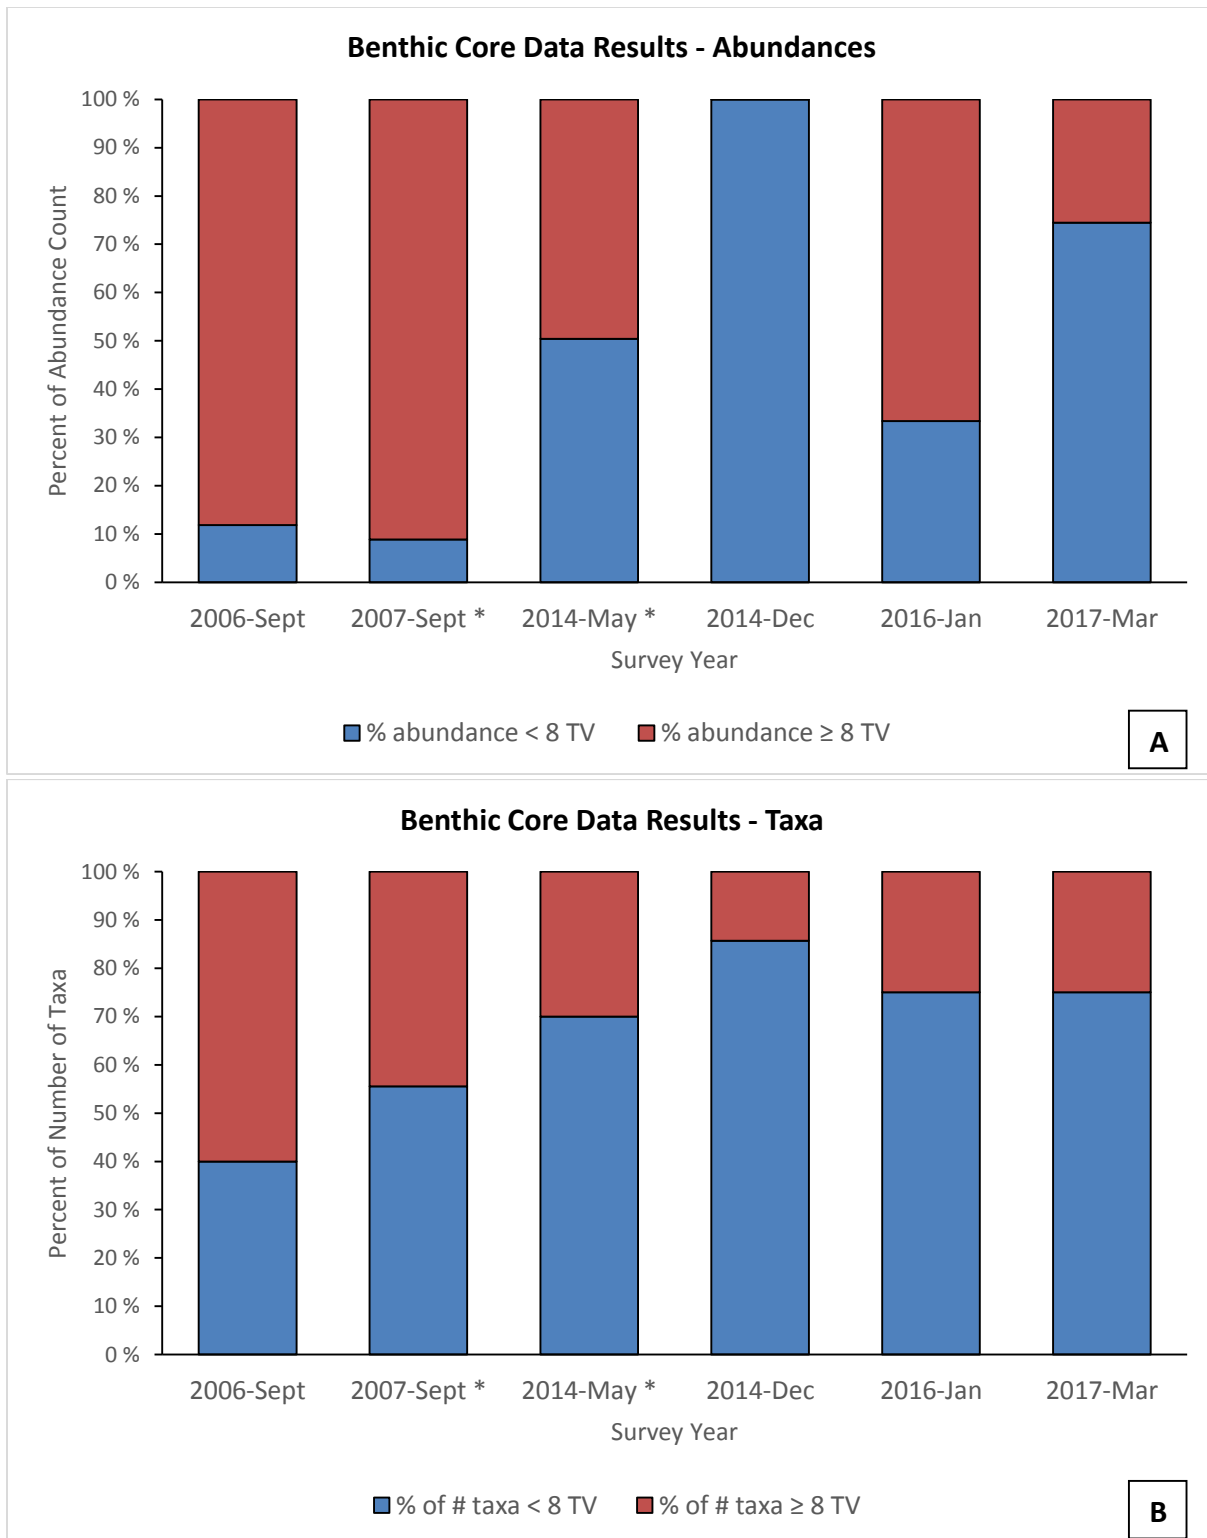
Figure 27. Benthic invertebrate core data results organized by (A) percent of abundance count data with pollution tolerance values (TV) below 8, and (B) percent of number of taxa with TV below 8. Asterisks indicate a closed berm condition.

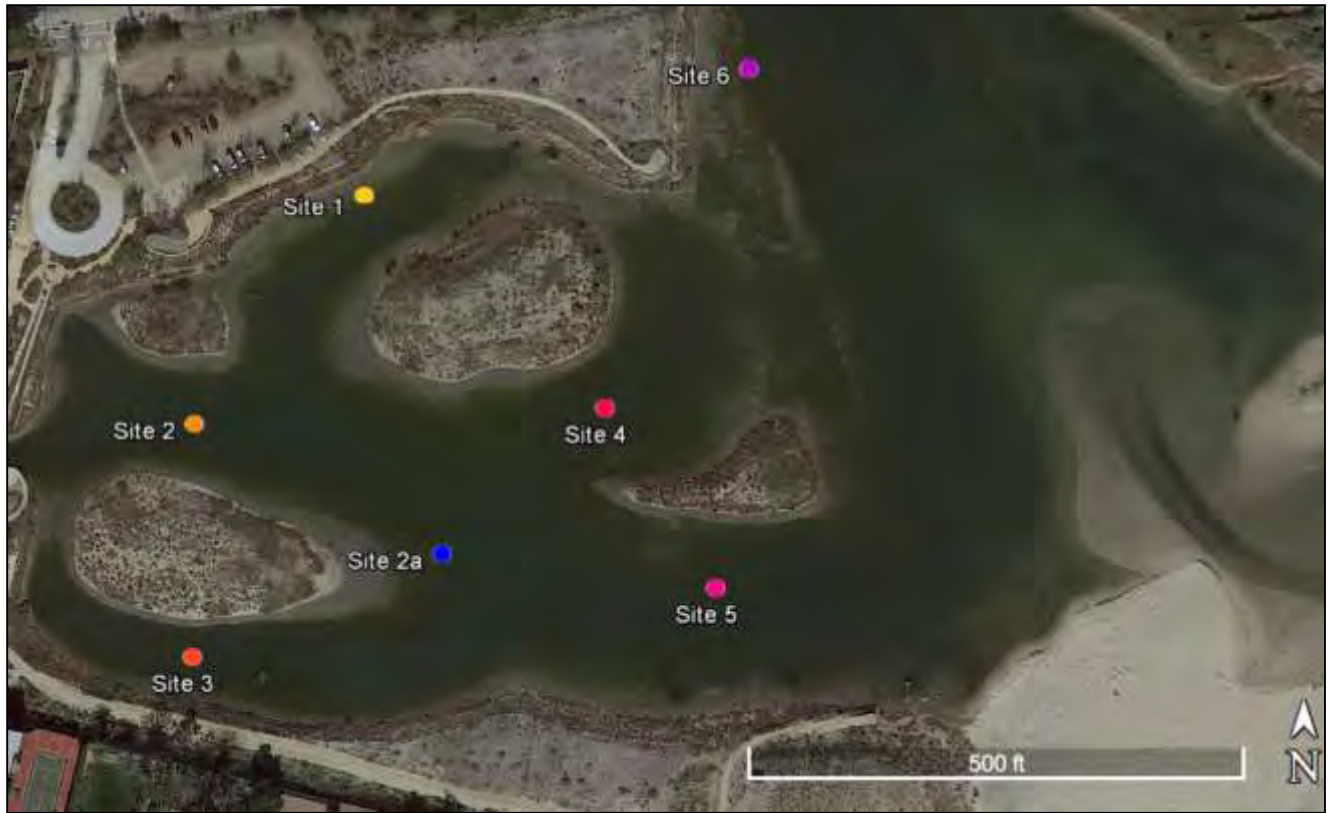
Figure 29. Map of the six permanent fish monitoring Sites.

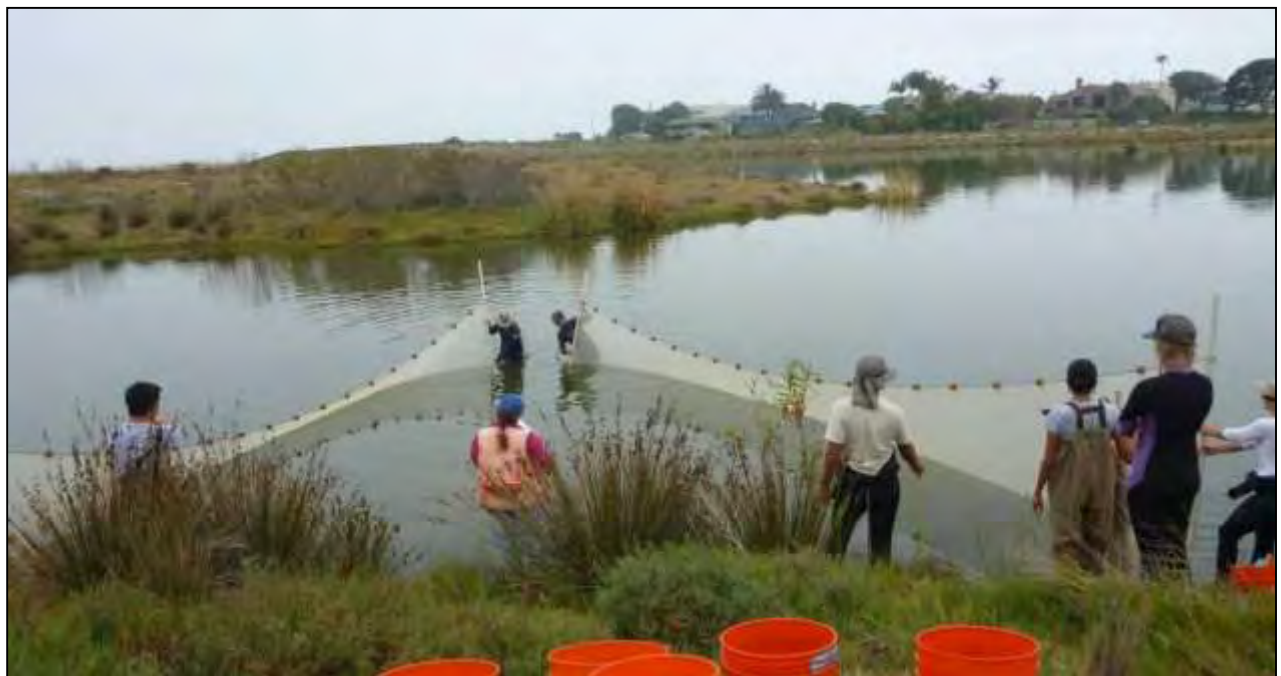
Figure 30. Representative photograph of fish surveys being conducted at Site 1 on 1 June 2016 (photo: RCDSMM).

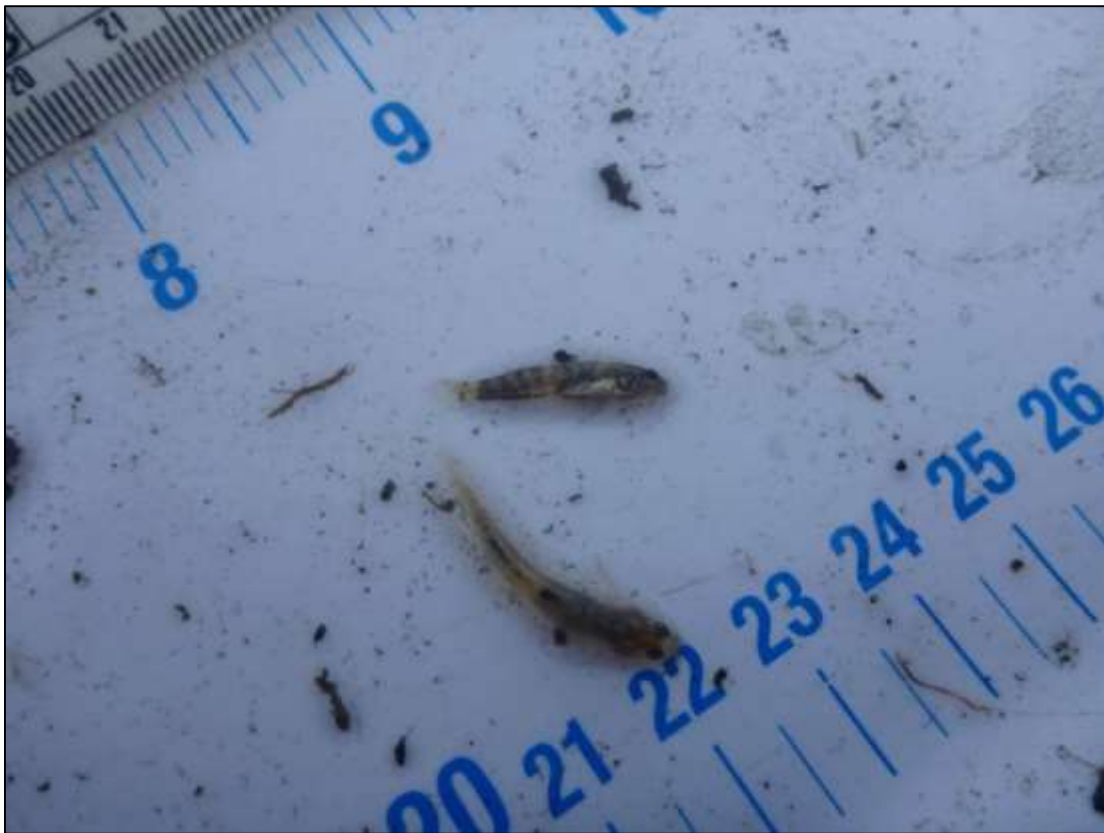
A total of 12 tidewater gobies were captured in several sites (Figure 31). Due to time constraints, we did not conduct spot surveys along the beach, where they have also been identified in past surveys. Striped mullet were observed jumping throughout the lagoon. The dominant species surveyed and identified was staghorn sculpin (juveniles =132), followed by topsmelt (adult n=49, juvenile n= 35). Notably, only one non-native mosquitofish was captured across all sites.

Figure 31. Photograph of two tidewater gobies from the March 2017 survey (credit: R. Dagit, RCDSMM).

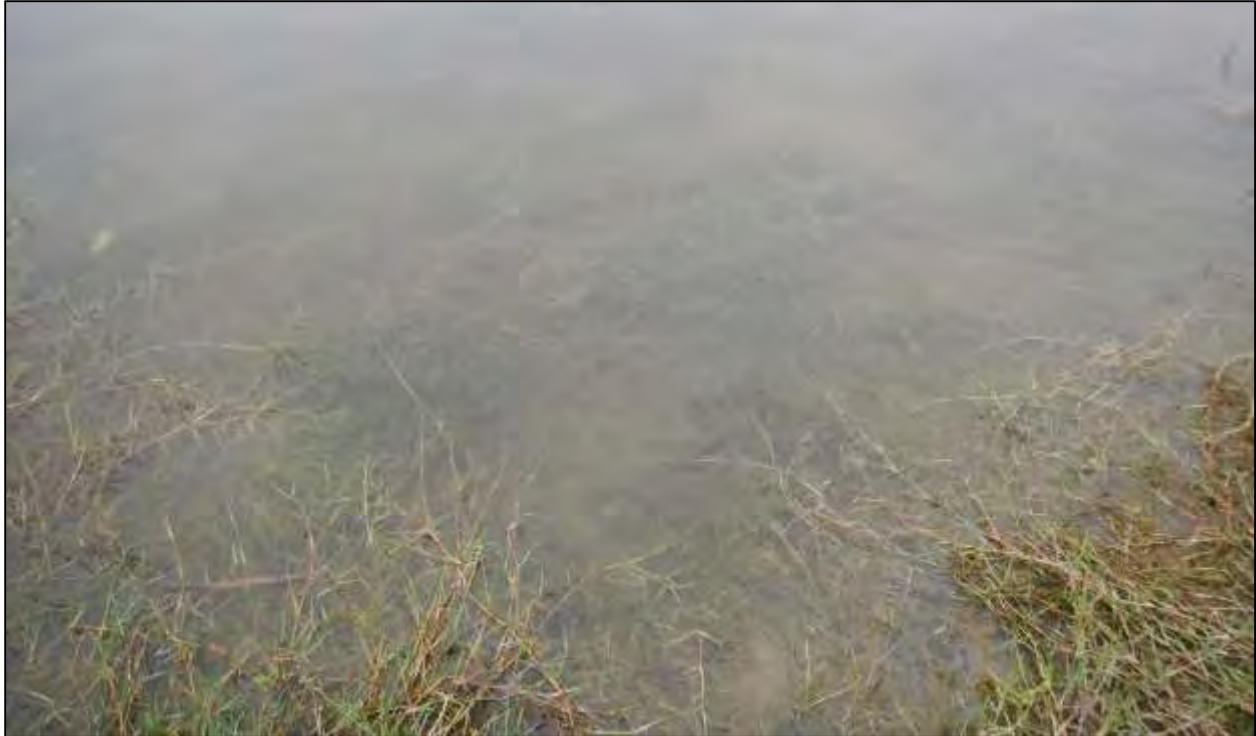
At several stations, the most recent survey also identified *Ruppia sp.*, or ditchgrass, which is an attached submerged aquatic vegetation (SAV) species (Table 18, Figure 34). Percent of total cover averaged for all stations for *Ruppia* equaled approximately 55% of the total cover, with a range from 0-100% of the total cover; it varied by station, but was found to be 0% at Station 6 and 100% at Station 8. SAV in the form of seagrasses sequester nutrients and carbon and provide oxygen to the water column. They also provide important estuarine habitat for invertebrates and fish.

Figure 34. Photograph of *Ruppia sp.* at the Malibu Lagoon on 26 August 2016.

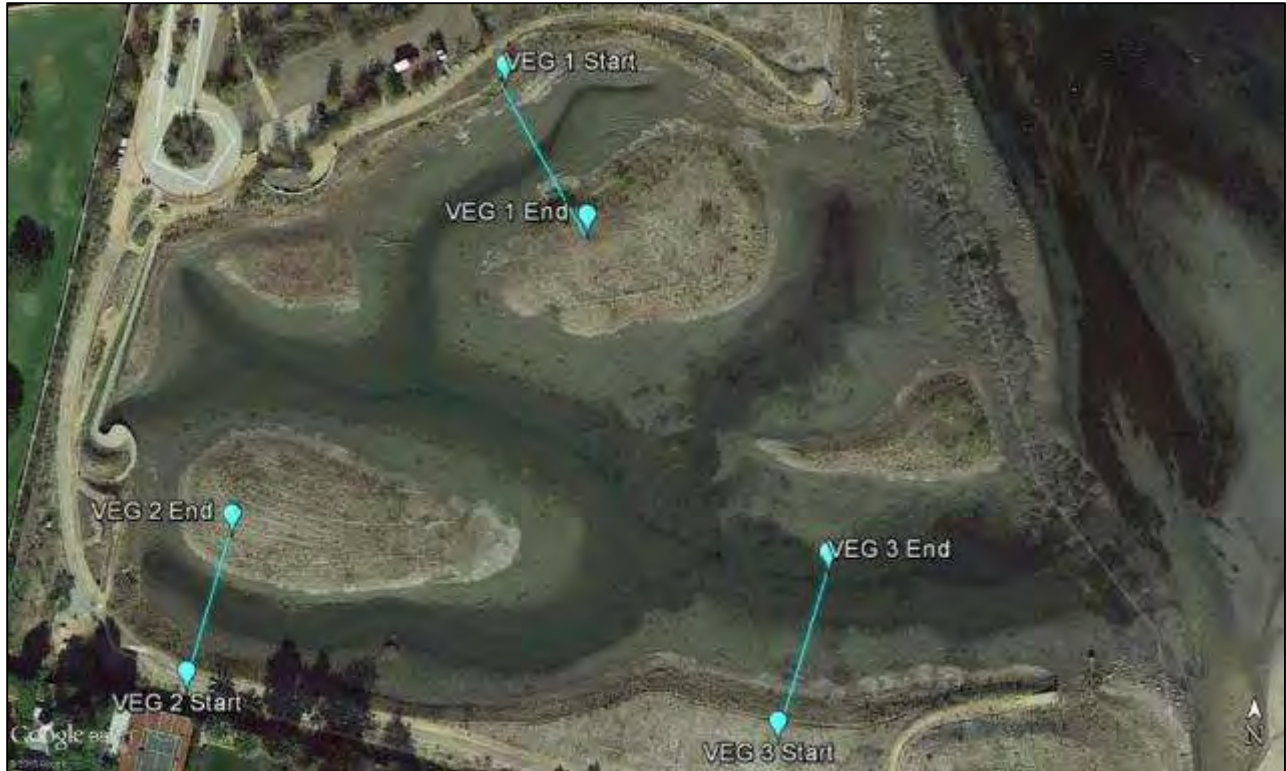
Data for absolute percent cover of native/nonnative vegetation species were collected along three, 50-meter transects (Figure 35) using the line-intercept method on 15 March 2013, 7 May 2014, 18 December 2014, 5 May 2015, 22 December 2015, 20 May 2016, and 21 December 2016. These data were combined to provide a comprehensive set of post-restoration vegetation surveys to evaluate native and non-native relative vegetation cover over time.

Figure 35. Map of vegetation transect locations and start/end points.

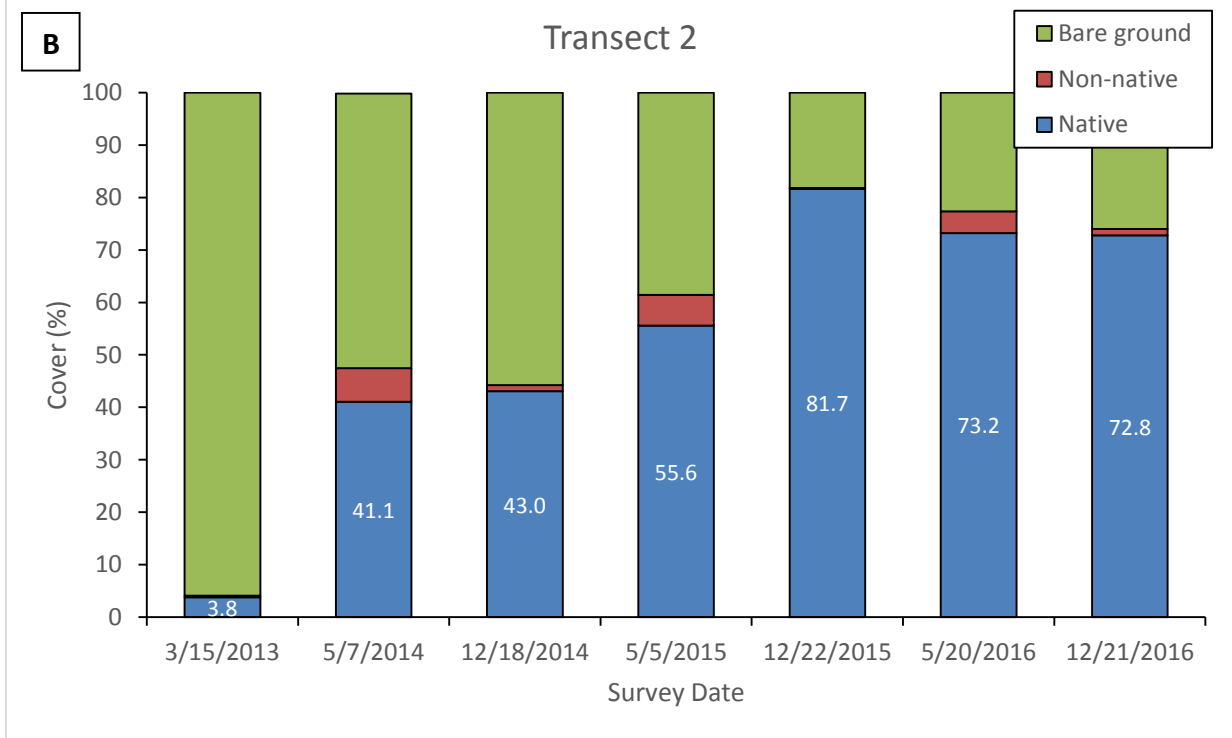
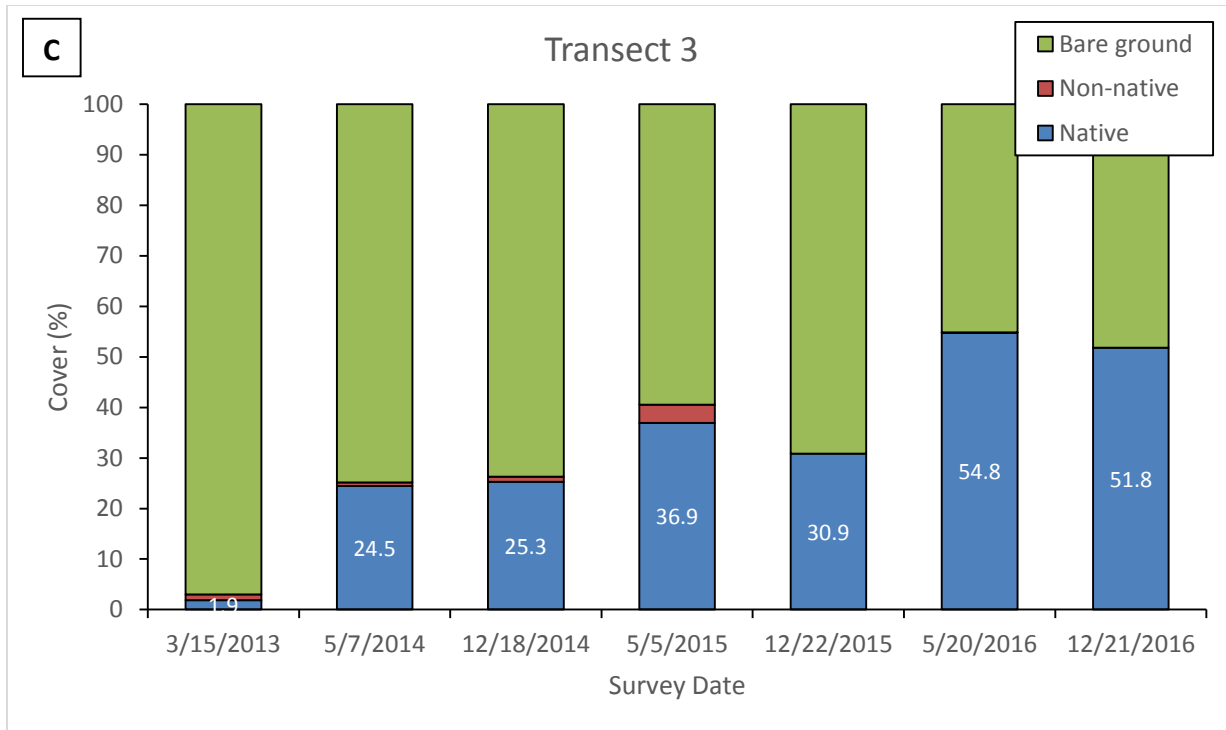
Figure 36. Graphs displaying absolute cover of vegetation across each Transect: (A) 1, (B) 2, and (C) 3.

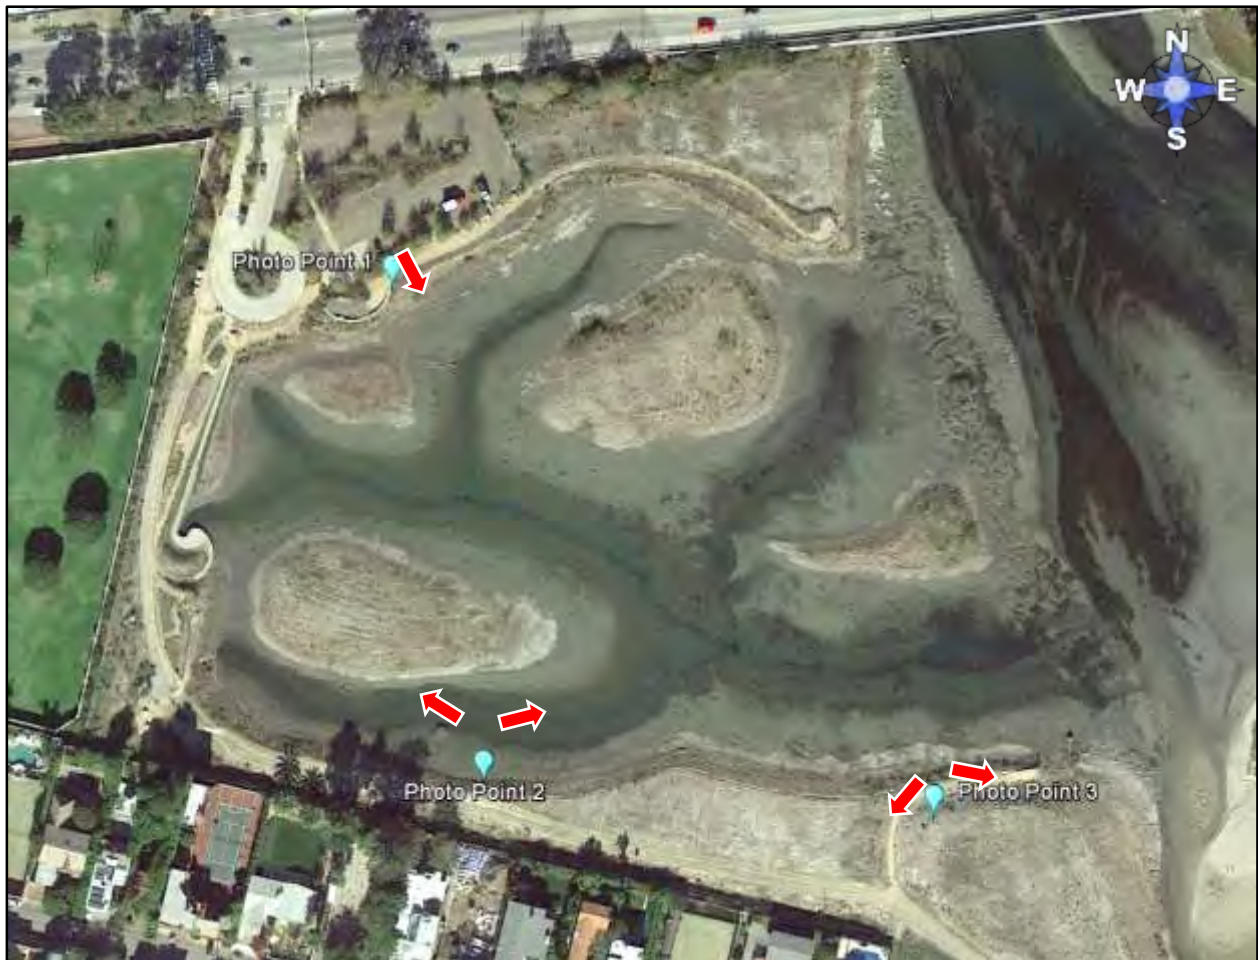
Figure 37. Map of photo-point locations and bearings for the surveys.
