Malibu Lagoon Restoration and Enhancement Project Comprehensive Monitoring Report (Year 4)

August 2017

Prepared by: The Bay Foundation (TBF)

Prepared for: State of California, Department of Parks and Recreation

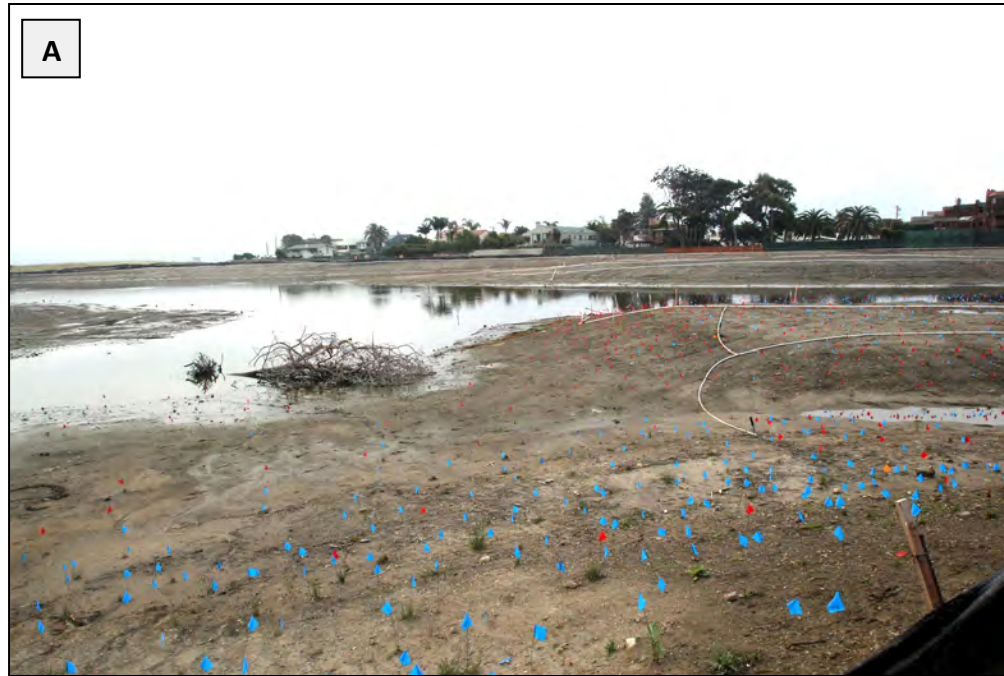
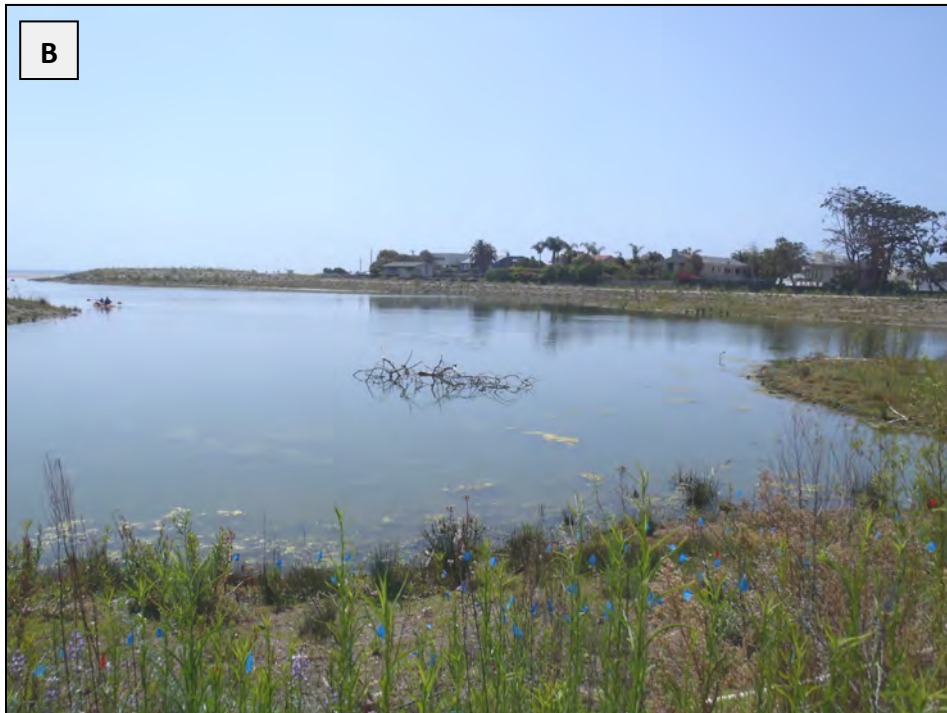
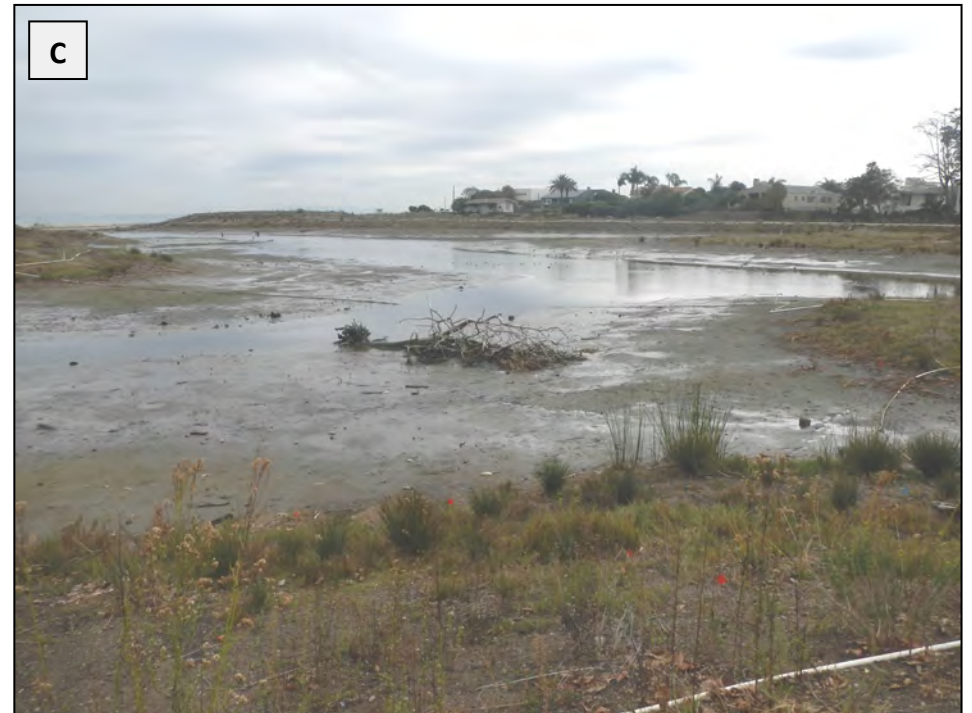
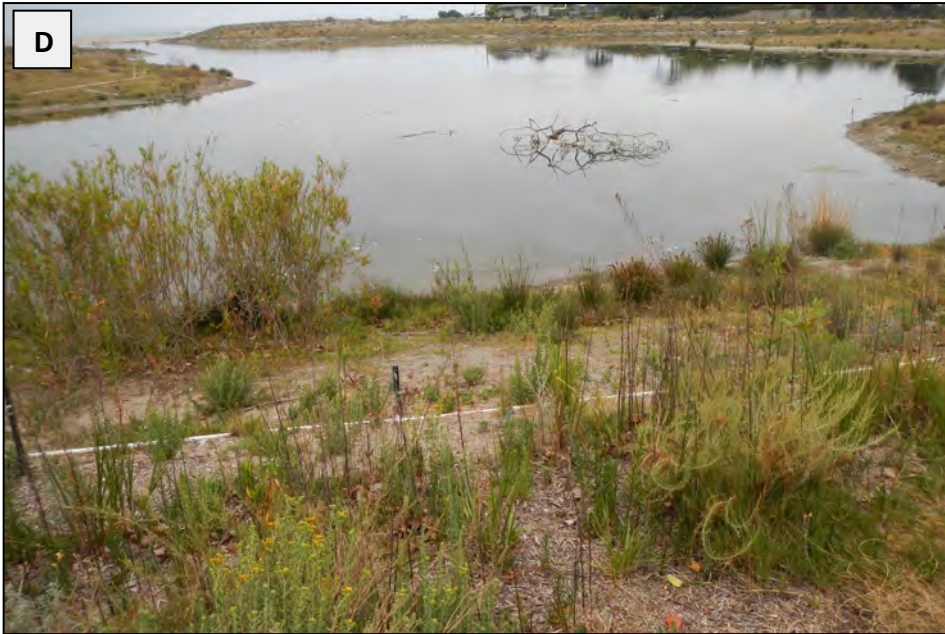
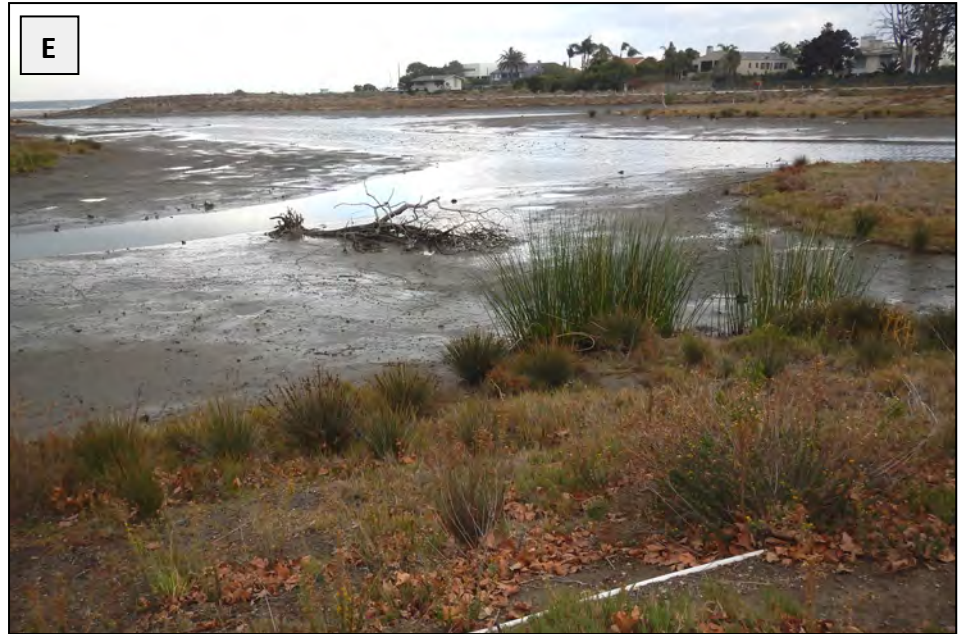
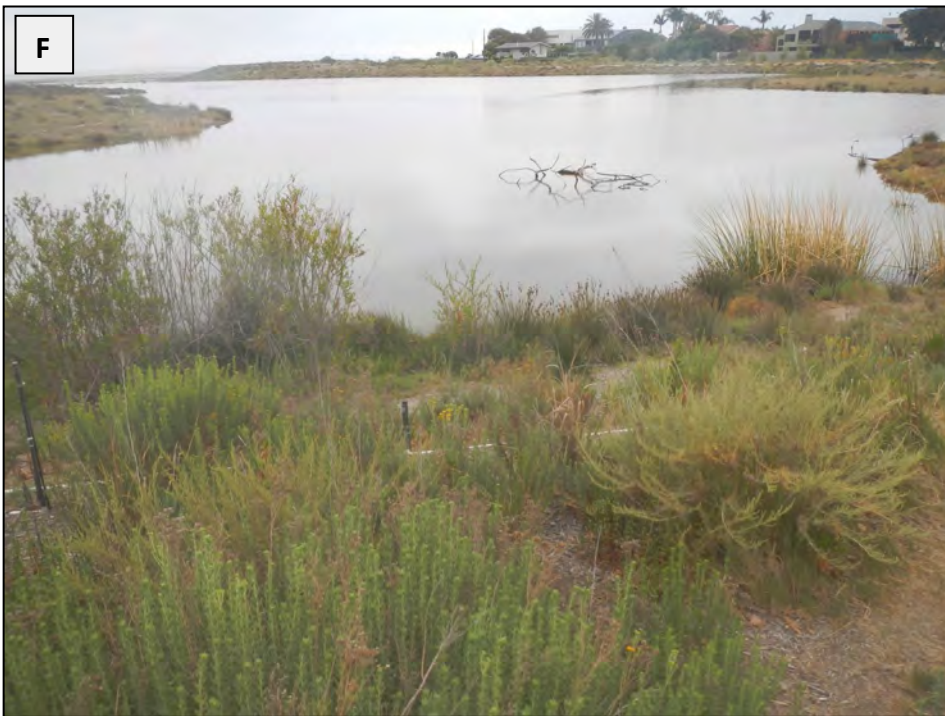
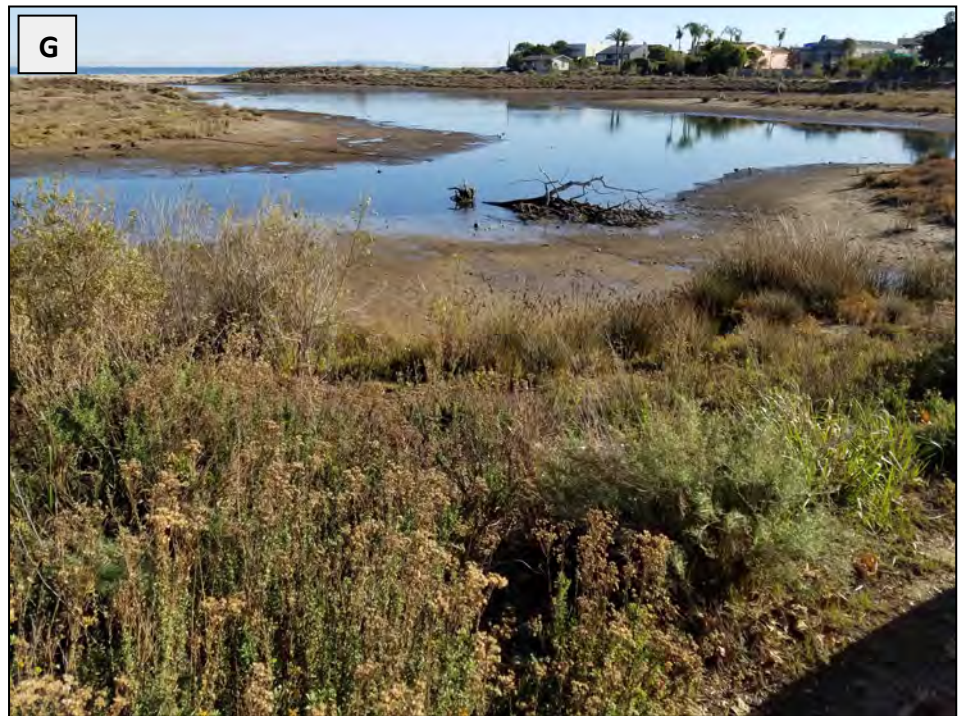
Consistent with the evaluation for plant cover transect monitoring and CRAM scores, the post-restoration georeferenced photos show a consistent increase in vegetation over time, with a large increase after the initial post-restoration Photo Point survey. Unlike the prolific growth seen in the second and third photo point surveys (March 2014 and December 2014), the third and fourth year surveys (May 2015, December 2015, May 2016, and December 2016) showed more subtle variations.

Figure 38. Photograph of Photo Point 1, bearing 155° on (A) 15 March 2013; (B) 7 May 2014; (C) 18 December 2014.

Figure 38 (continued). Photograph of Photo Point 1, bearing 155° on (D) 5 May 2015; (E) 22 December 2015; (F) 16 May 2016; (G) 27 December 2016.

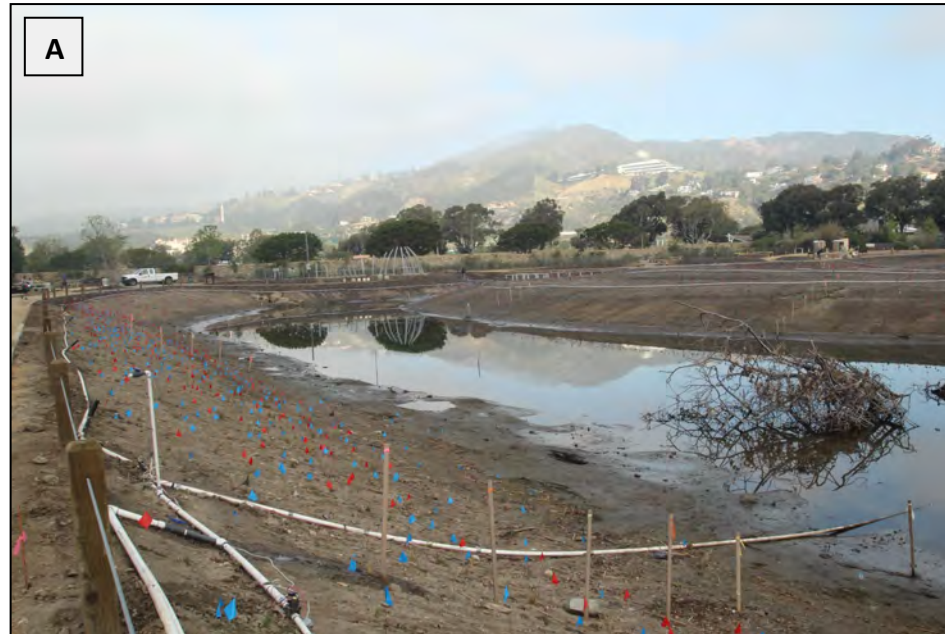
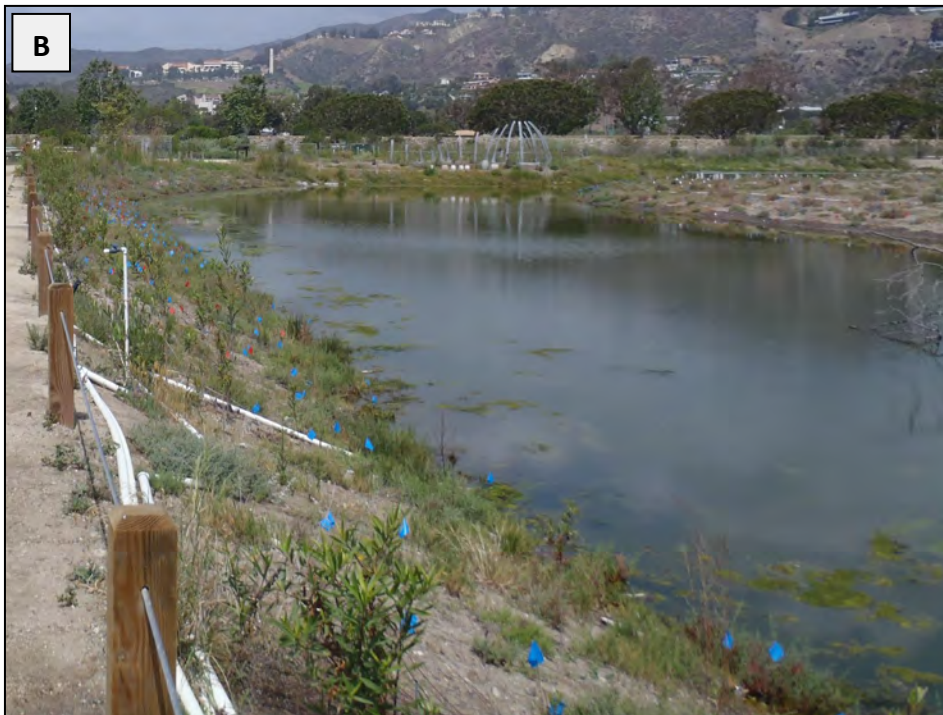
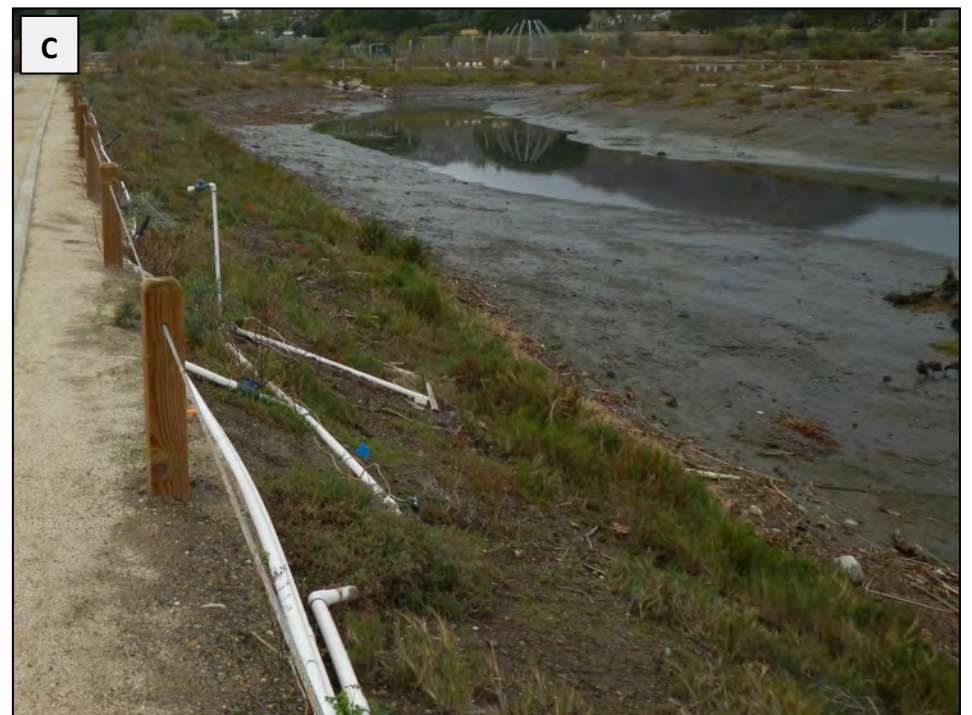
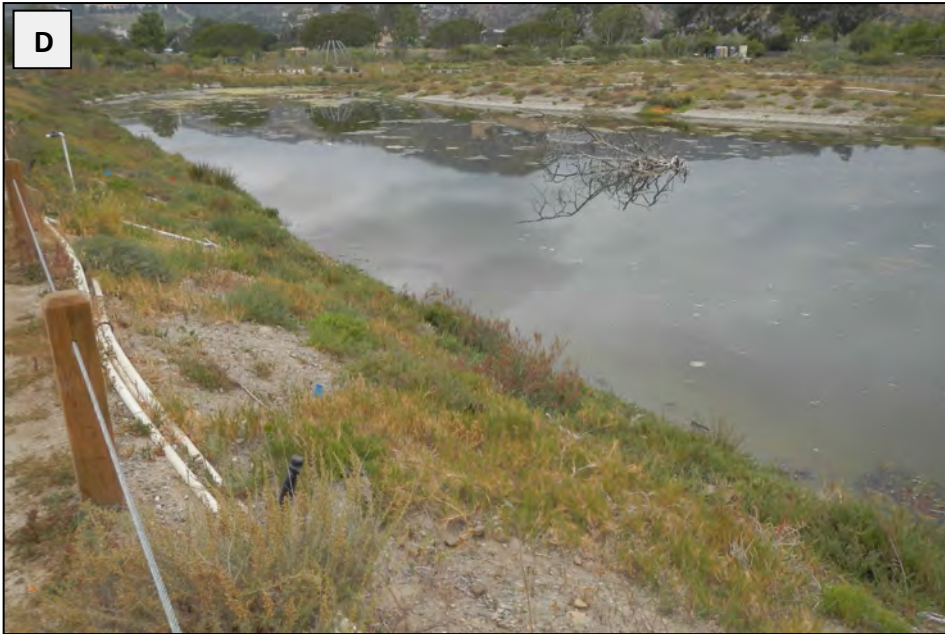
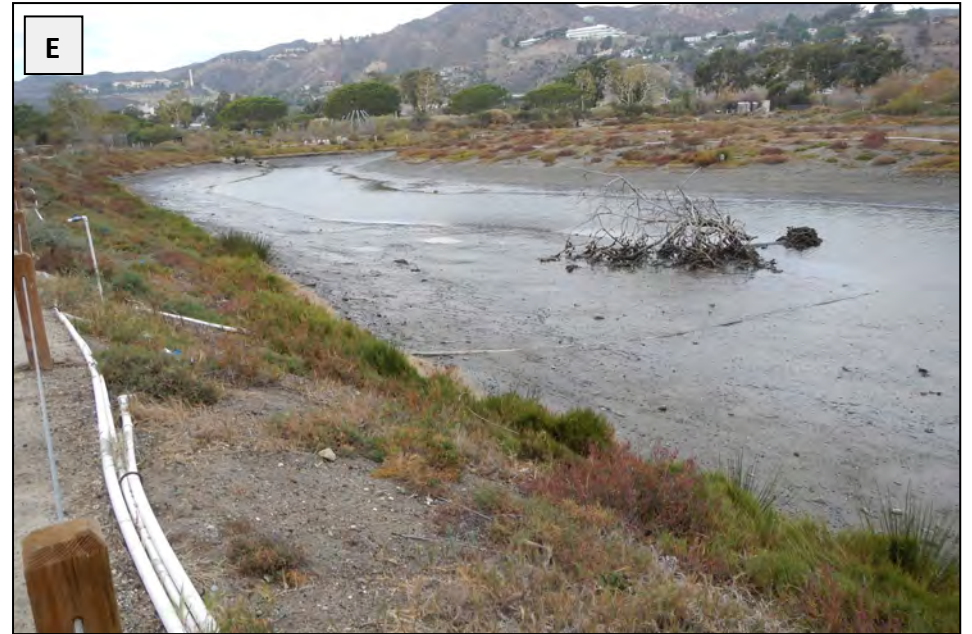
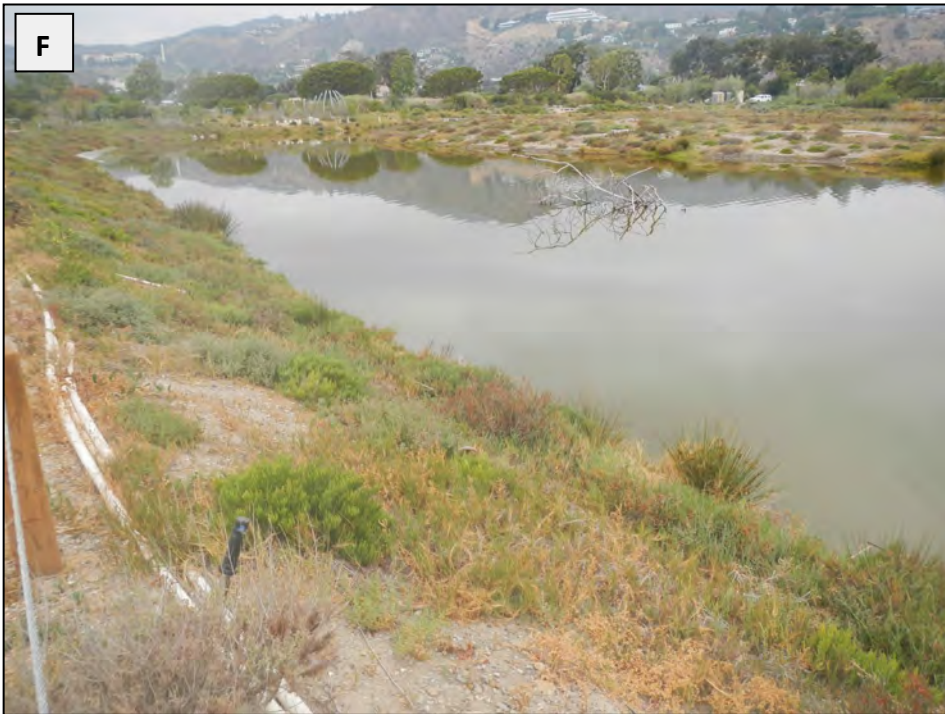
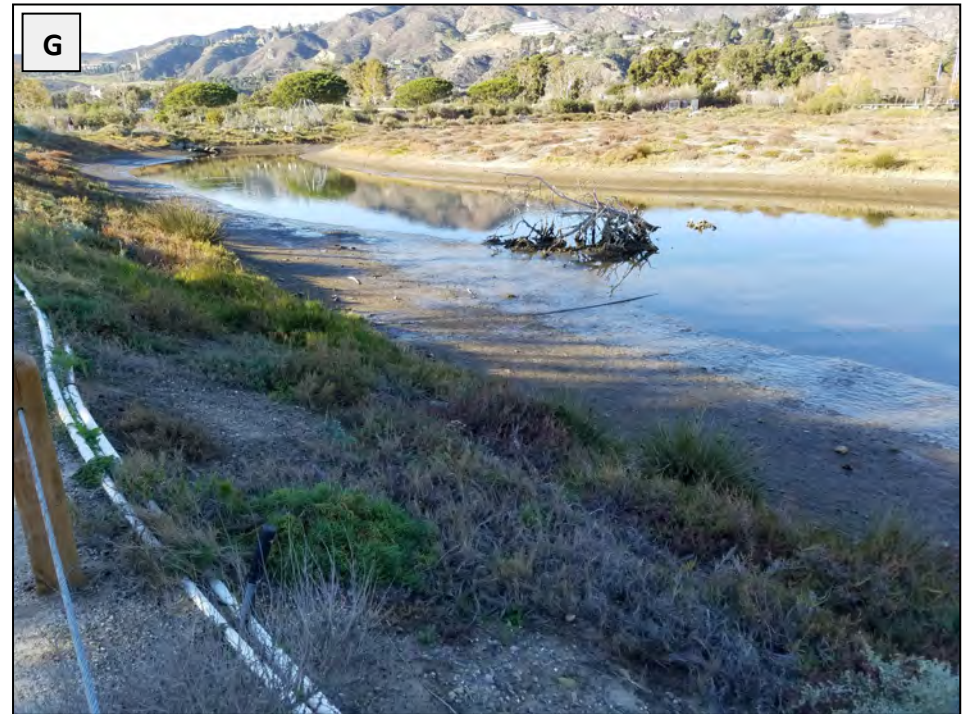
Figure 39. Photograph of Photo Point 2, bearing 300° on (A) 15 March 2013; (B) 7 May 2014; (C) 18 December 2014.

Figure 39 (continued). Photograph of Photo Point 2, bearing 300° on (D) 5 May 2015; (E) 22 December 2015; (F) 16 May 2016; (G) 27 December 2016.

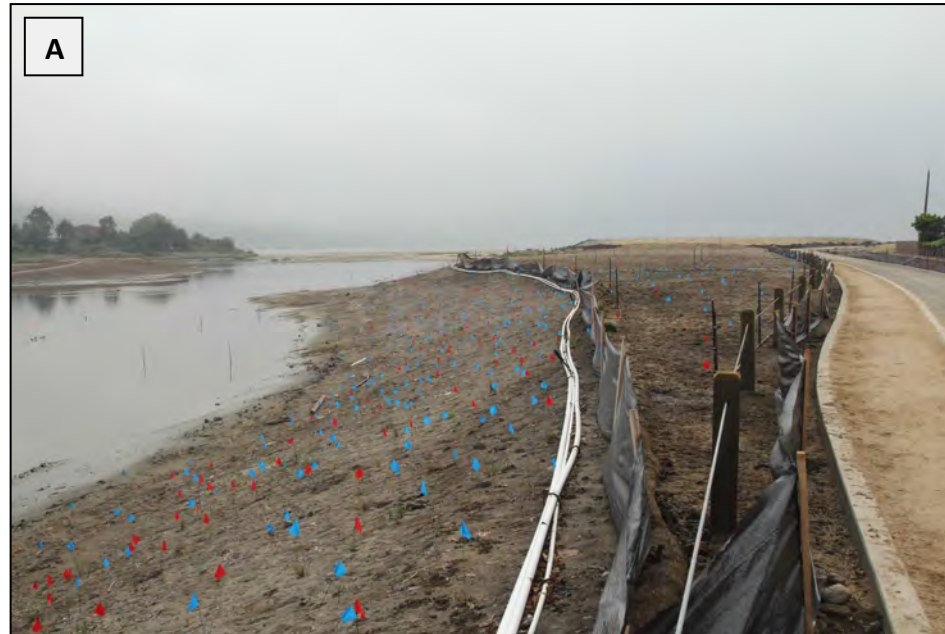
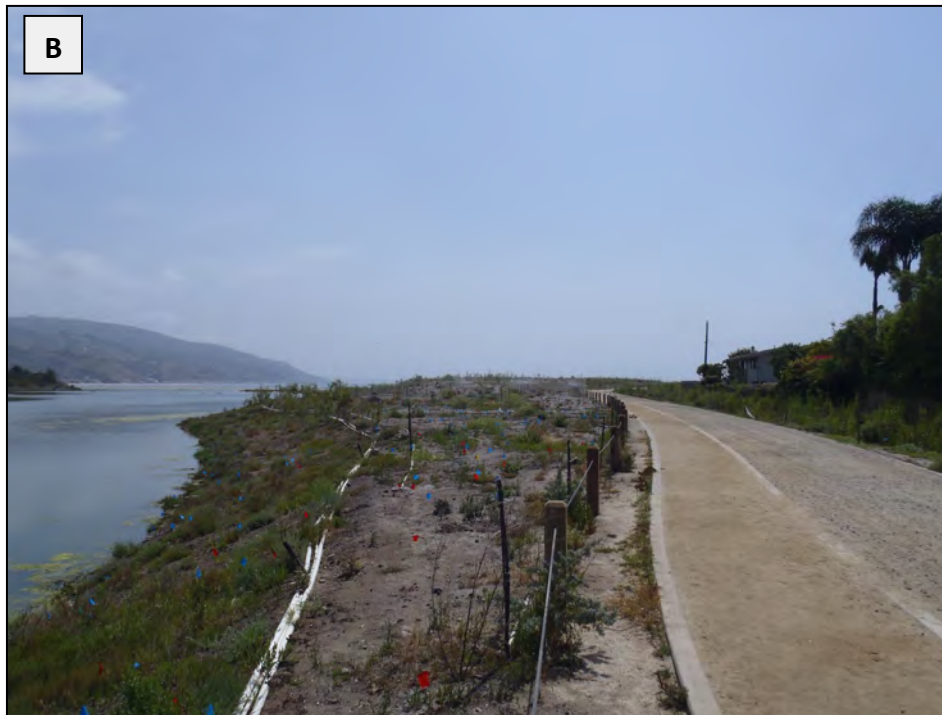
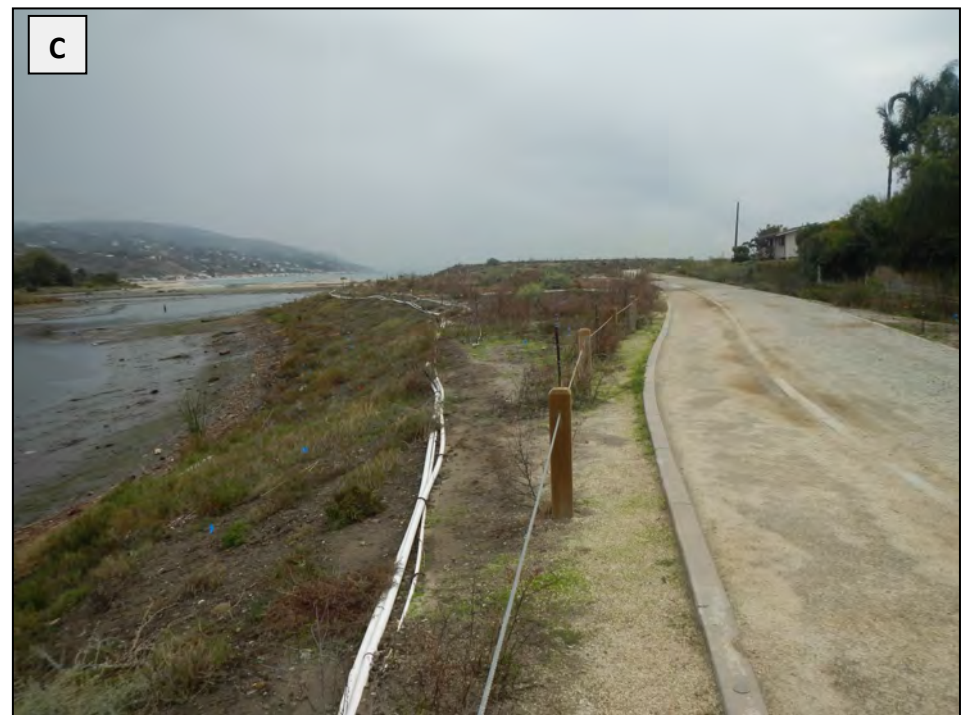
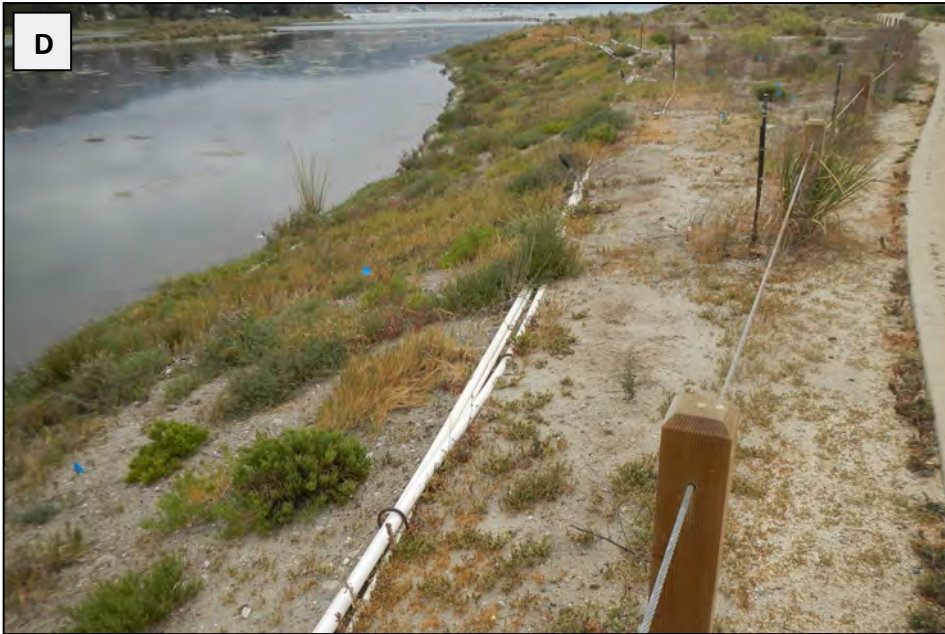
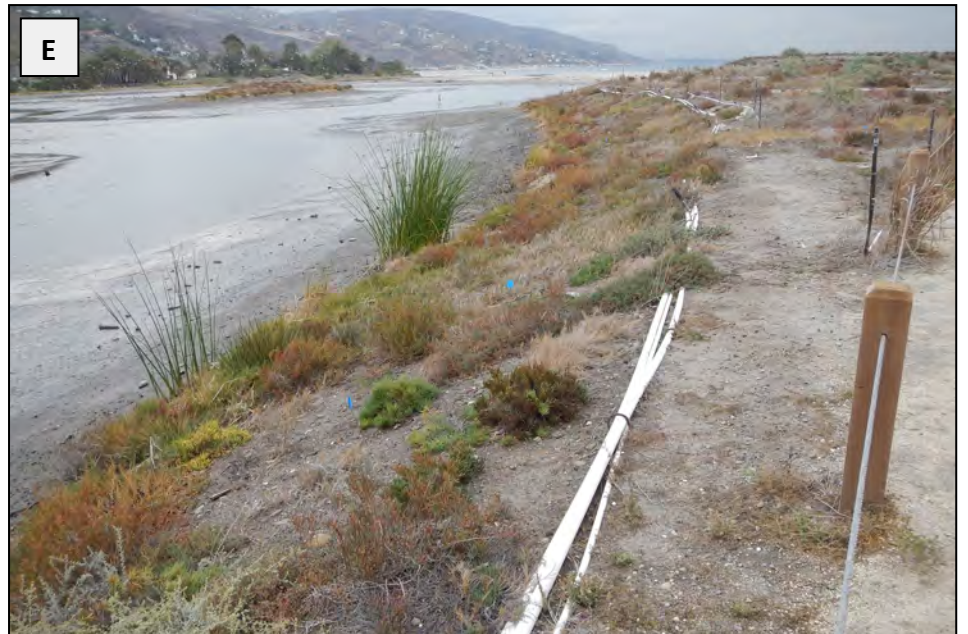
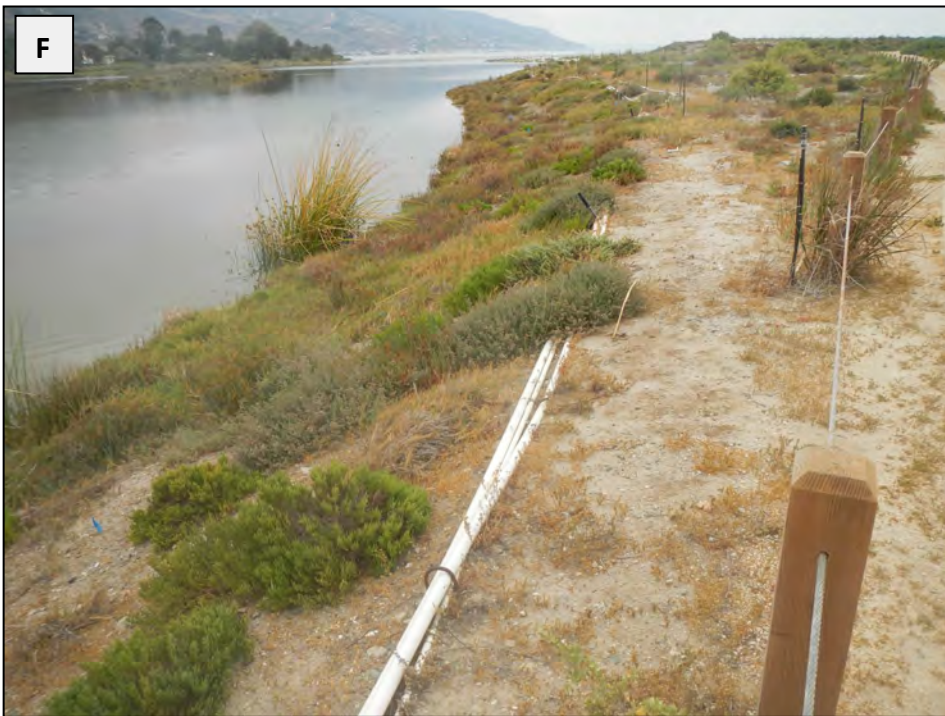
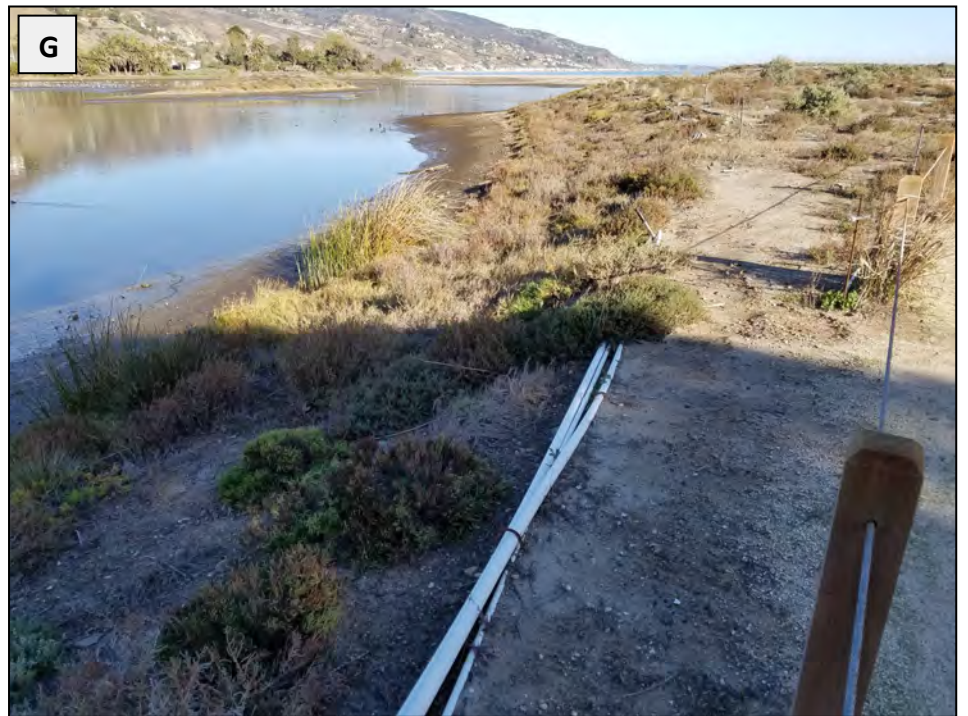
Figure 40. Photograph of Photo Point 2, bearing 75° on (A) 15 March 2013; (B) 7 May 2014; (C) 18 December 2014.

Figure 40 (continued). Photograph of Photo Point 2, bearing 75° on (D) 5 May 2015; (E) 22 December 2015; (F) 16 May 2016; (G) 27 December 2016.

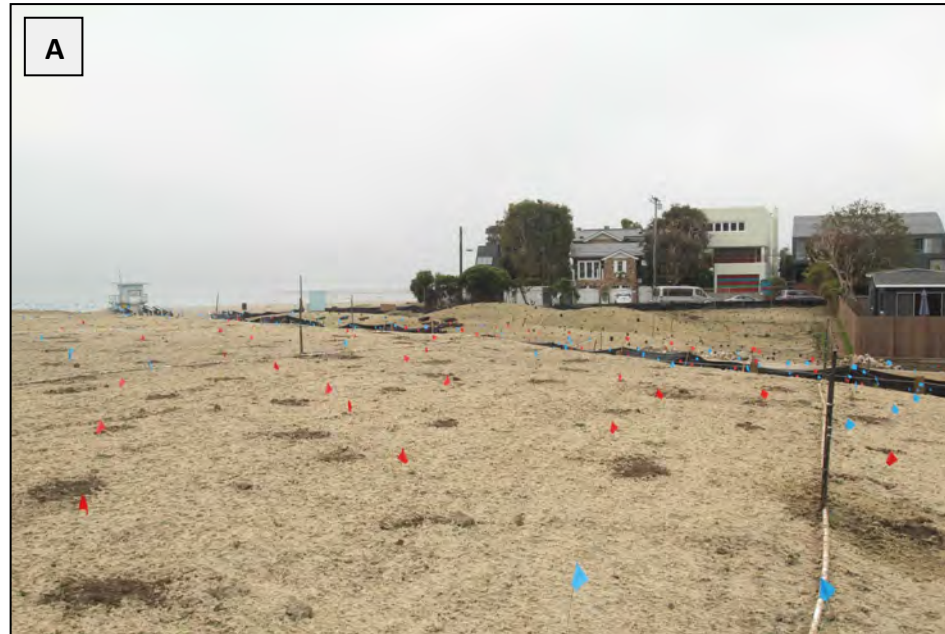
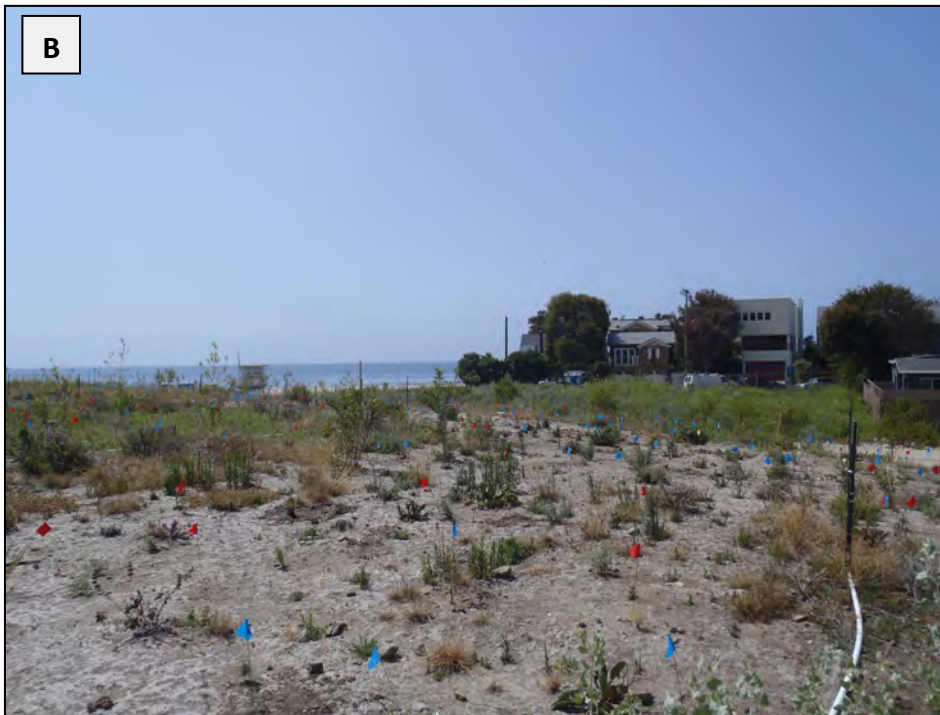
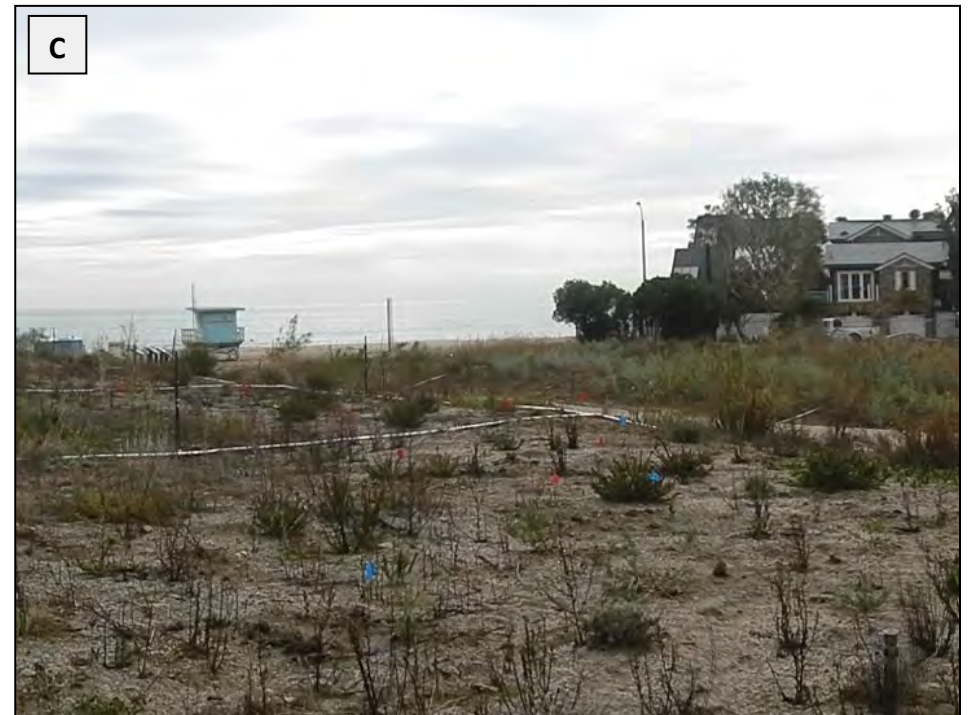
Figure 41. Photograph of Photo Point 3, bearing 220° on (A) 15 March 2013; (B) 7 May 2014; (C) 18 December 2014.

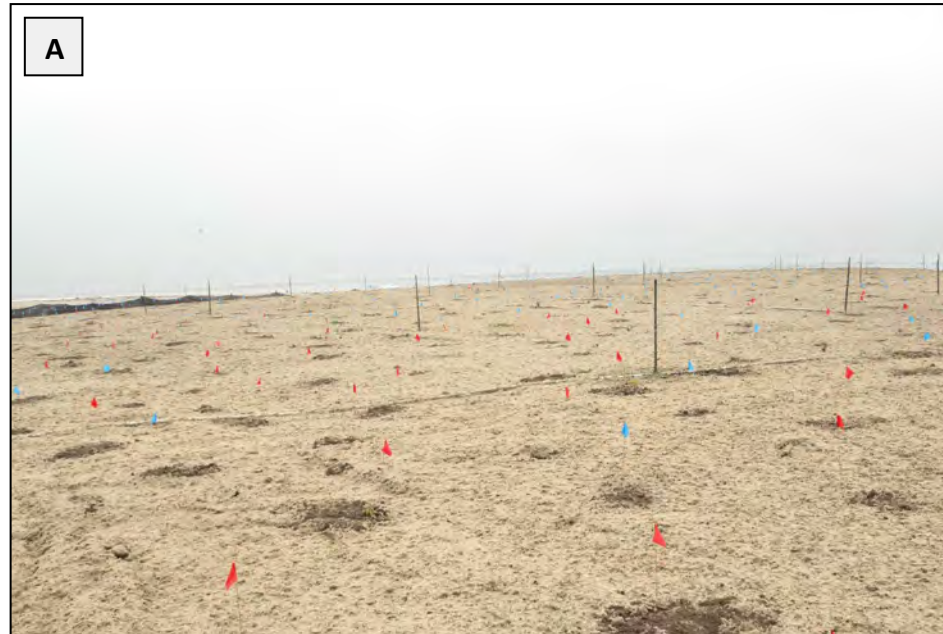
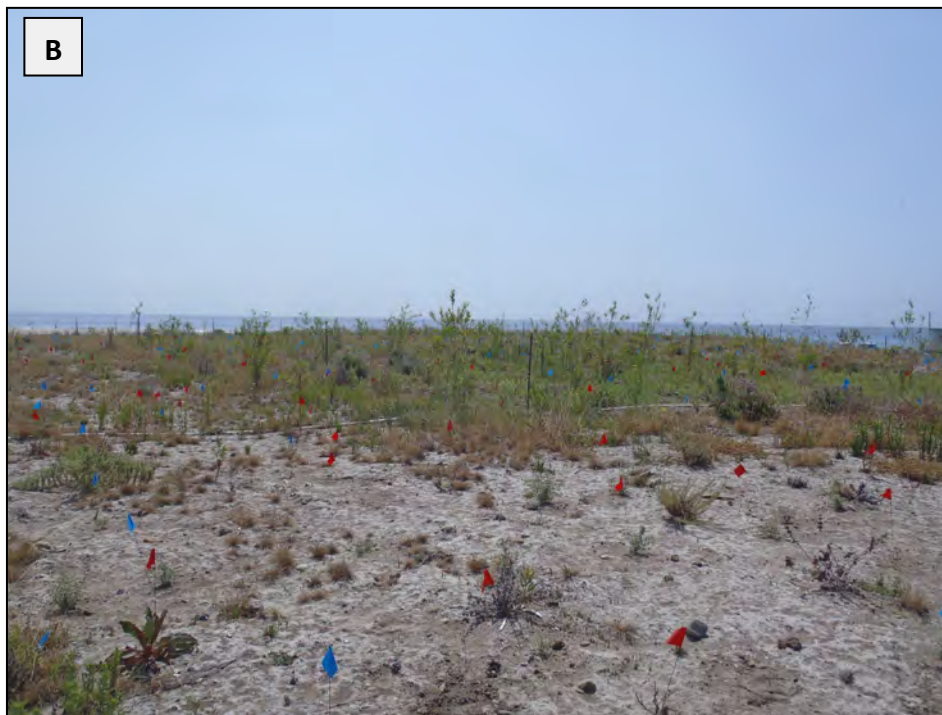
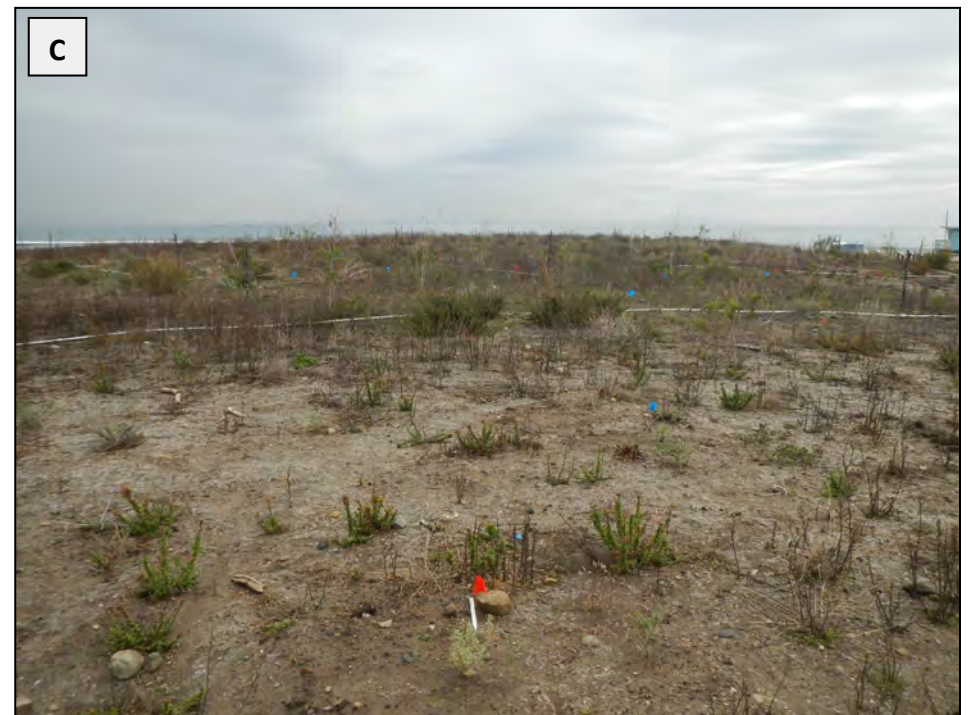
Figure 41 (*continued*). Photograph of Photo Point 2, bearing 220° on (D) 5 May 2015; (E) 22 December 2015; (F) 16 May 2016; (G) 27 December 2016.

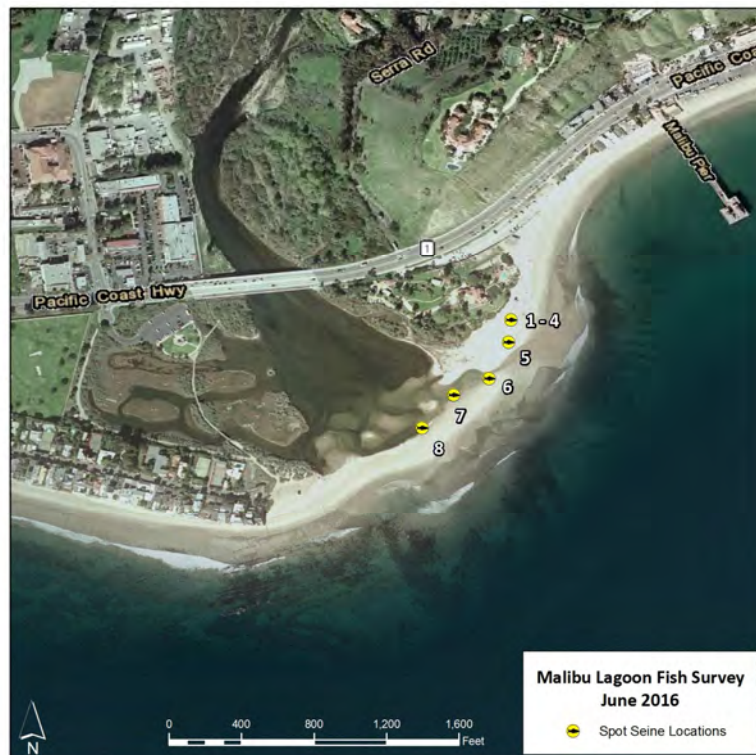
Figure 2. Locations of spot surveys 1 June 2016

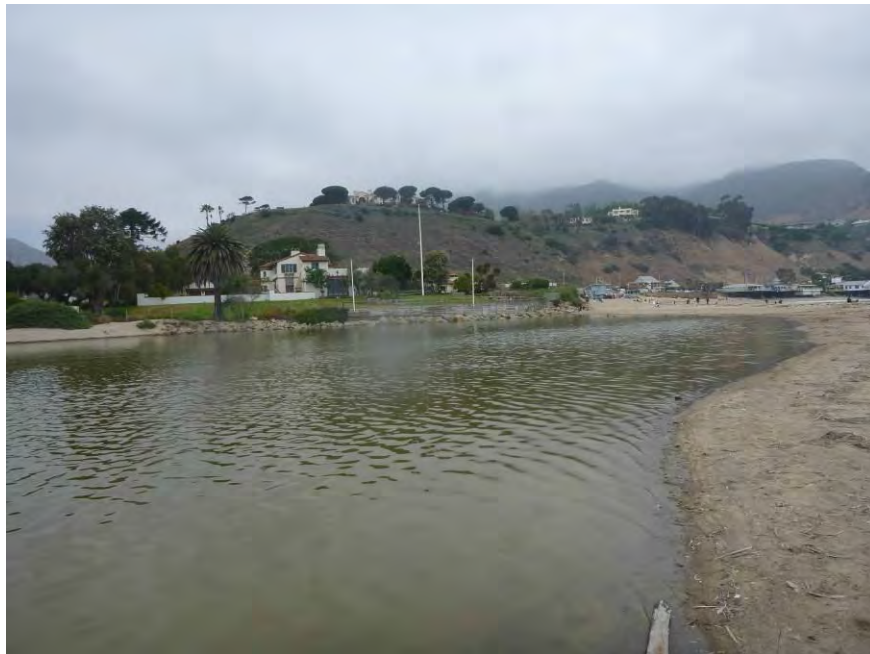
View east showing beach overwashed by lagoon

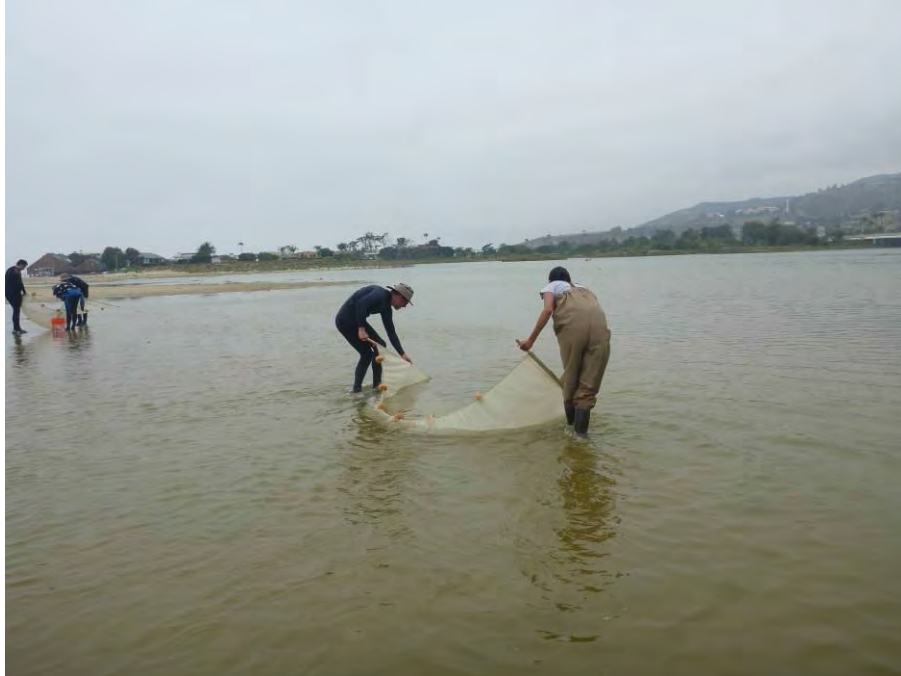
View east showing overwash by lagoon.

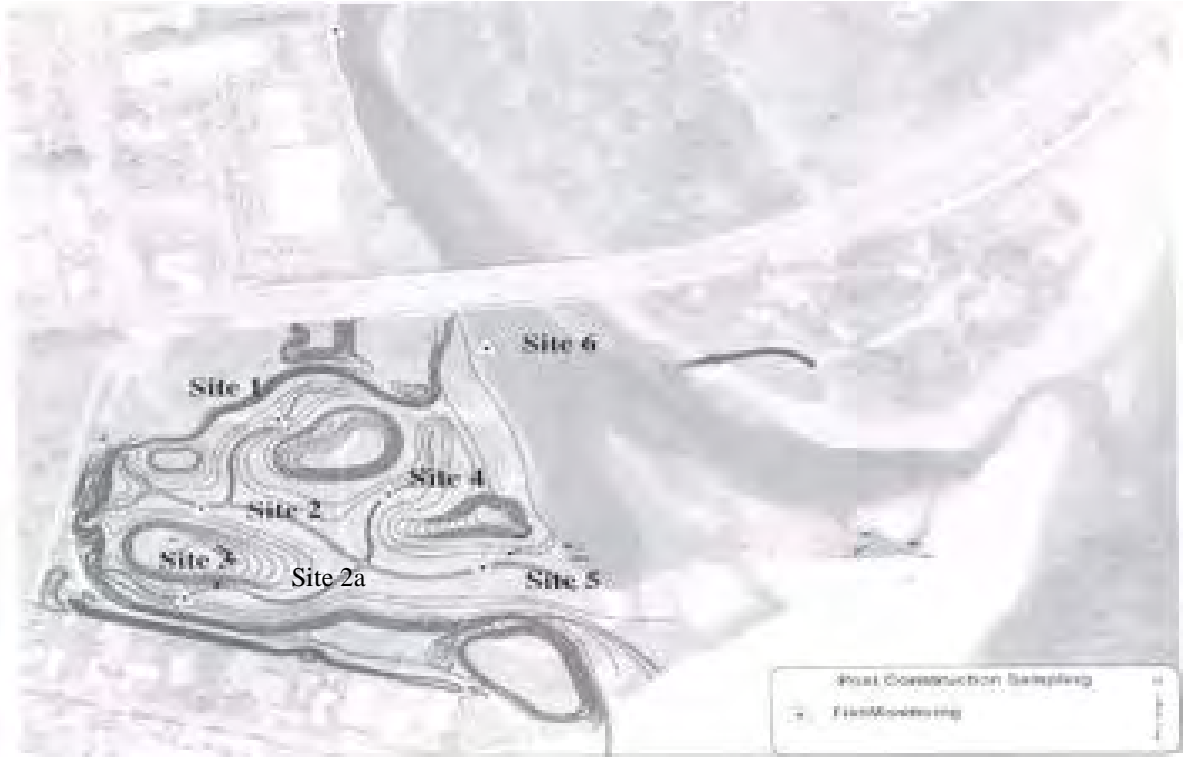
Figure 1. Map of the Permanent Monitoring Sites, Malibu Lagoon Restoration (Established in January 2013 and revised in May 2014)

Table 1. GPS Coordinates for permanent monitoring sites Malibu Lagoon Restoration (Decimal degrees)

Site	Latitude	Longitude
1	34.02.032	-118.41.054
2	34.01.983	-118.41.084
2a	34.01.970	-118.41.058
3	34.01.958	-118.41.086
4 (not sampled)	34.01.947	-118.40.963
5	34.02.000	-118.41.006
6	34.02.049	-118.40.974

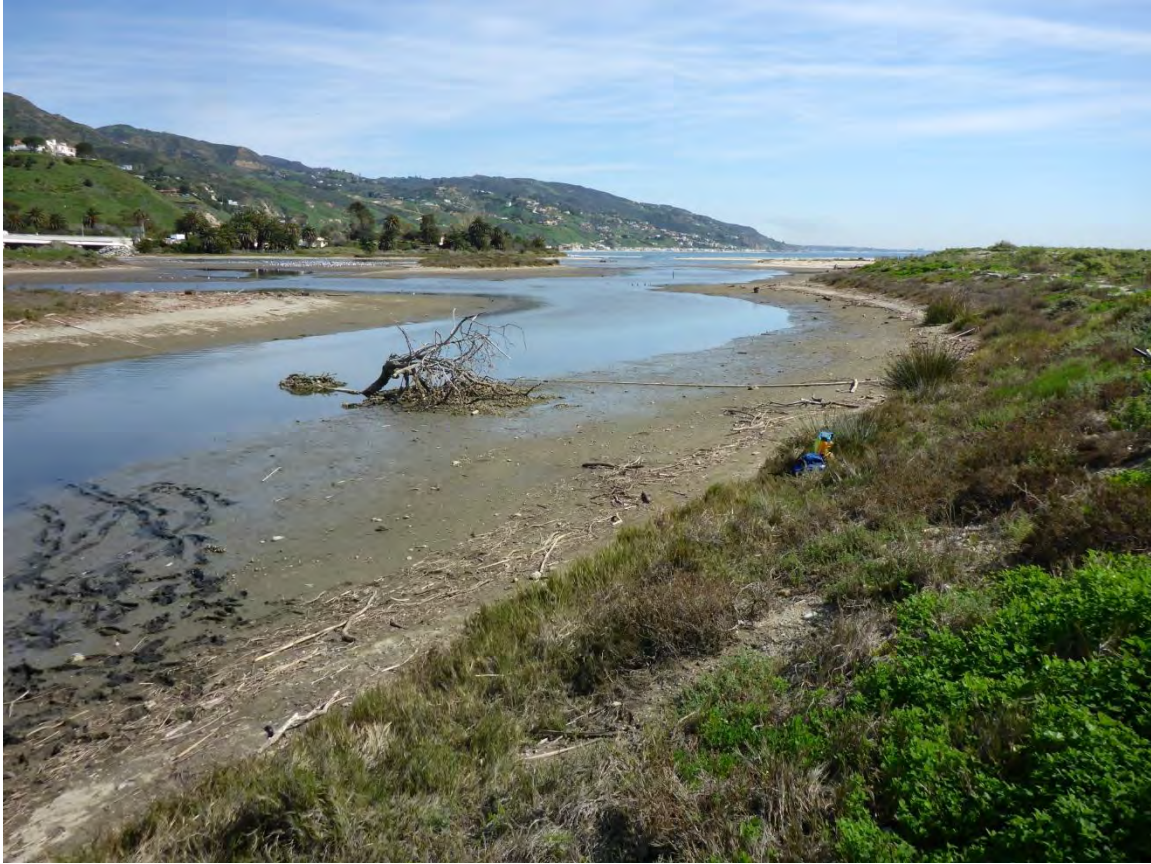
Spot Seine by tree snag Site 3

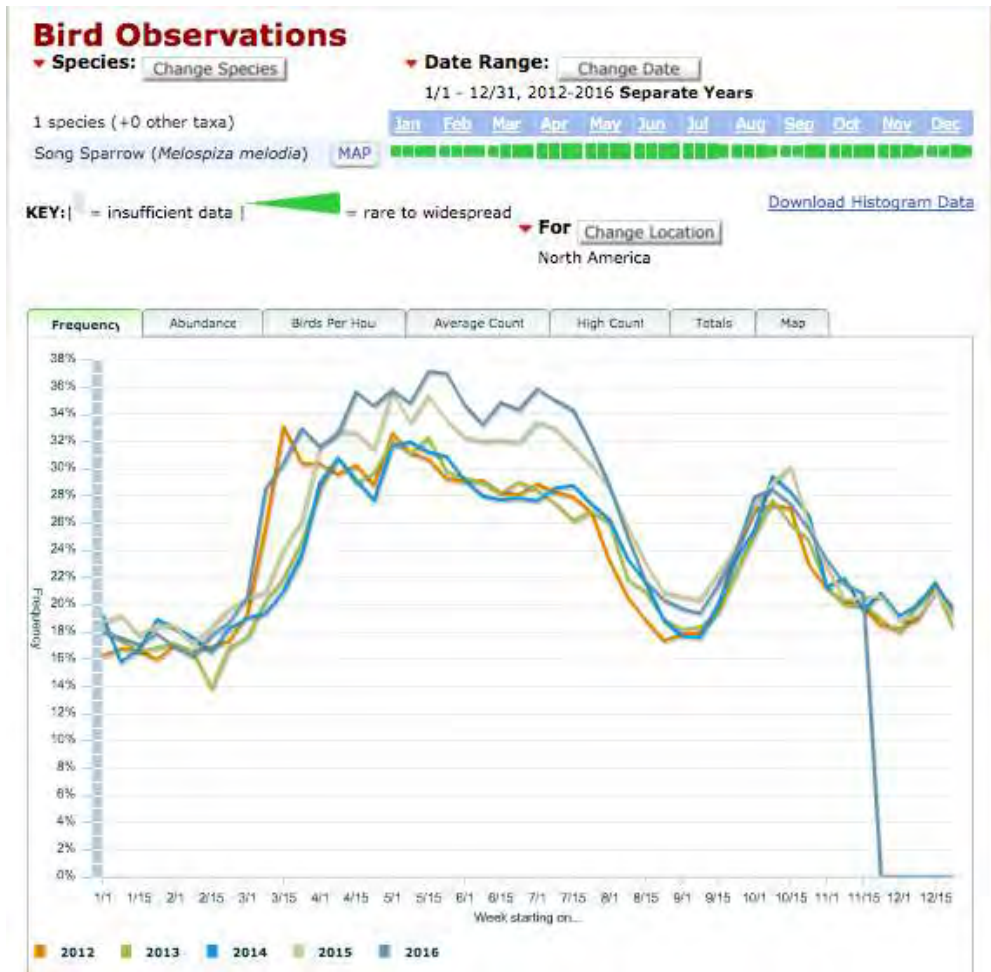
Figure 1. Counts of Song Sparrow at Malibu Lagoon, Jan. 2012 - Nov. 2016 (from eBird data).

These observations may be compared to a much larger database of birders’ reports to the eBird database (www.ebird.org); Figure 1 presents a graph of counts of one representative scrub-dwelling species, the Song Sparrow, at the site from multiple observers since 2012 (pre-restoration), which shows ever-increasing counts through the spring/summer nesting season in recent years. This suggests that the species has been able to adapt well to the scrub plantings on the site year after year.
