Malibu Lagoon Restoration and Enhancement Project Comprehensive Monitoring Report (Year 4)

August 2017

Prepared by: The Bay Foundation (TBF)

Prepared for: State of California, Department of Parks and Recreation

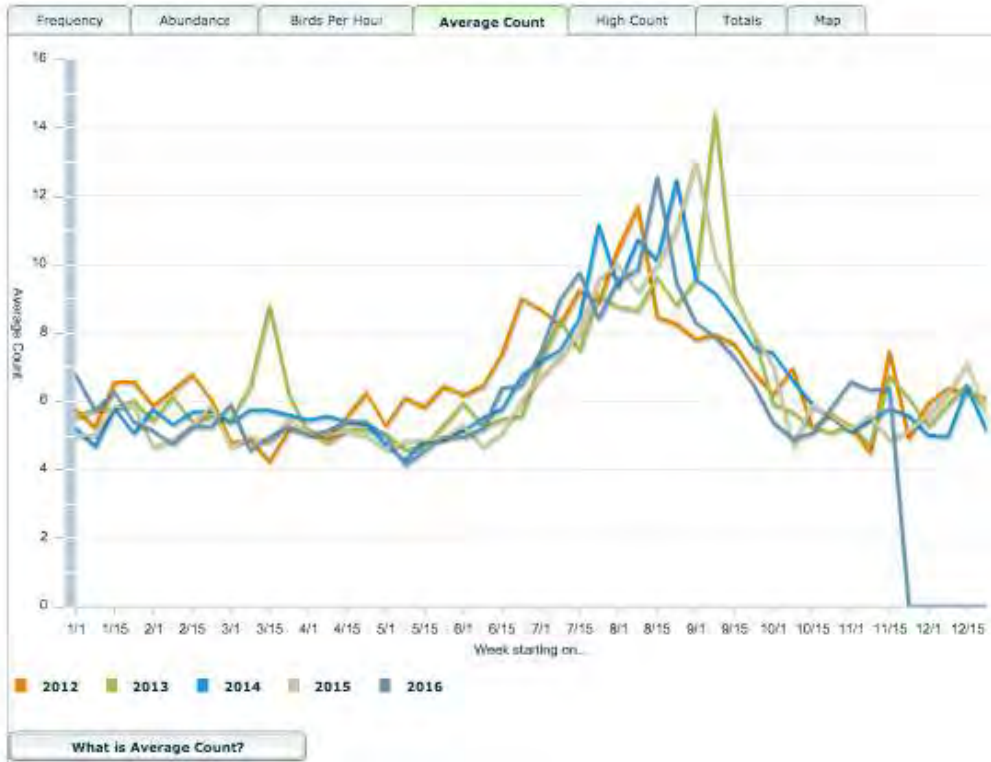
Figure 3. Counts of Snowy Egret at Malibu Lagoon, Jan. 2012 – Nov. 2016 (from eBird data).

Large waders (herons and egrets) and waterfowl numbers continued to drop at the lagoon, with counts of individuals in 2016 less than those of all prior years (waterfowl numbers bumped up slightly in 2013, likely caused by a surge in numbers of American Coot attracted to the open mud habitat exposed by the restoration construction). Figure 3 shows average counts for a representative large wader species (Snowy Egret), and Figure 4 shows counts for a typical waterfowl species, the Northern Shoveler, at the site, where numbers in the years before and just after restoration (2012-13) were higher than those in recent years.
