Ballona Wetlands Restoration: Community Iceplant Removal Project

Final Report

December 2016

Prepared for the Southern California Wetlands Recovery
Project and the California Department of Fish and Wildlife

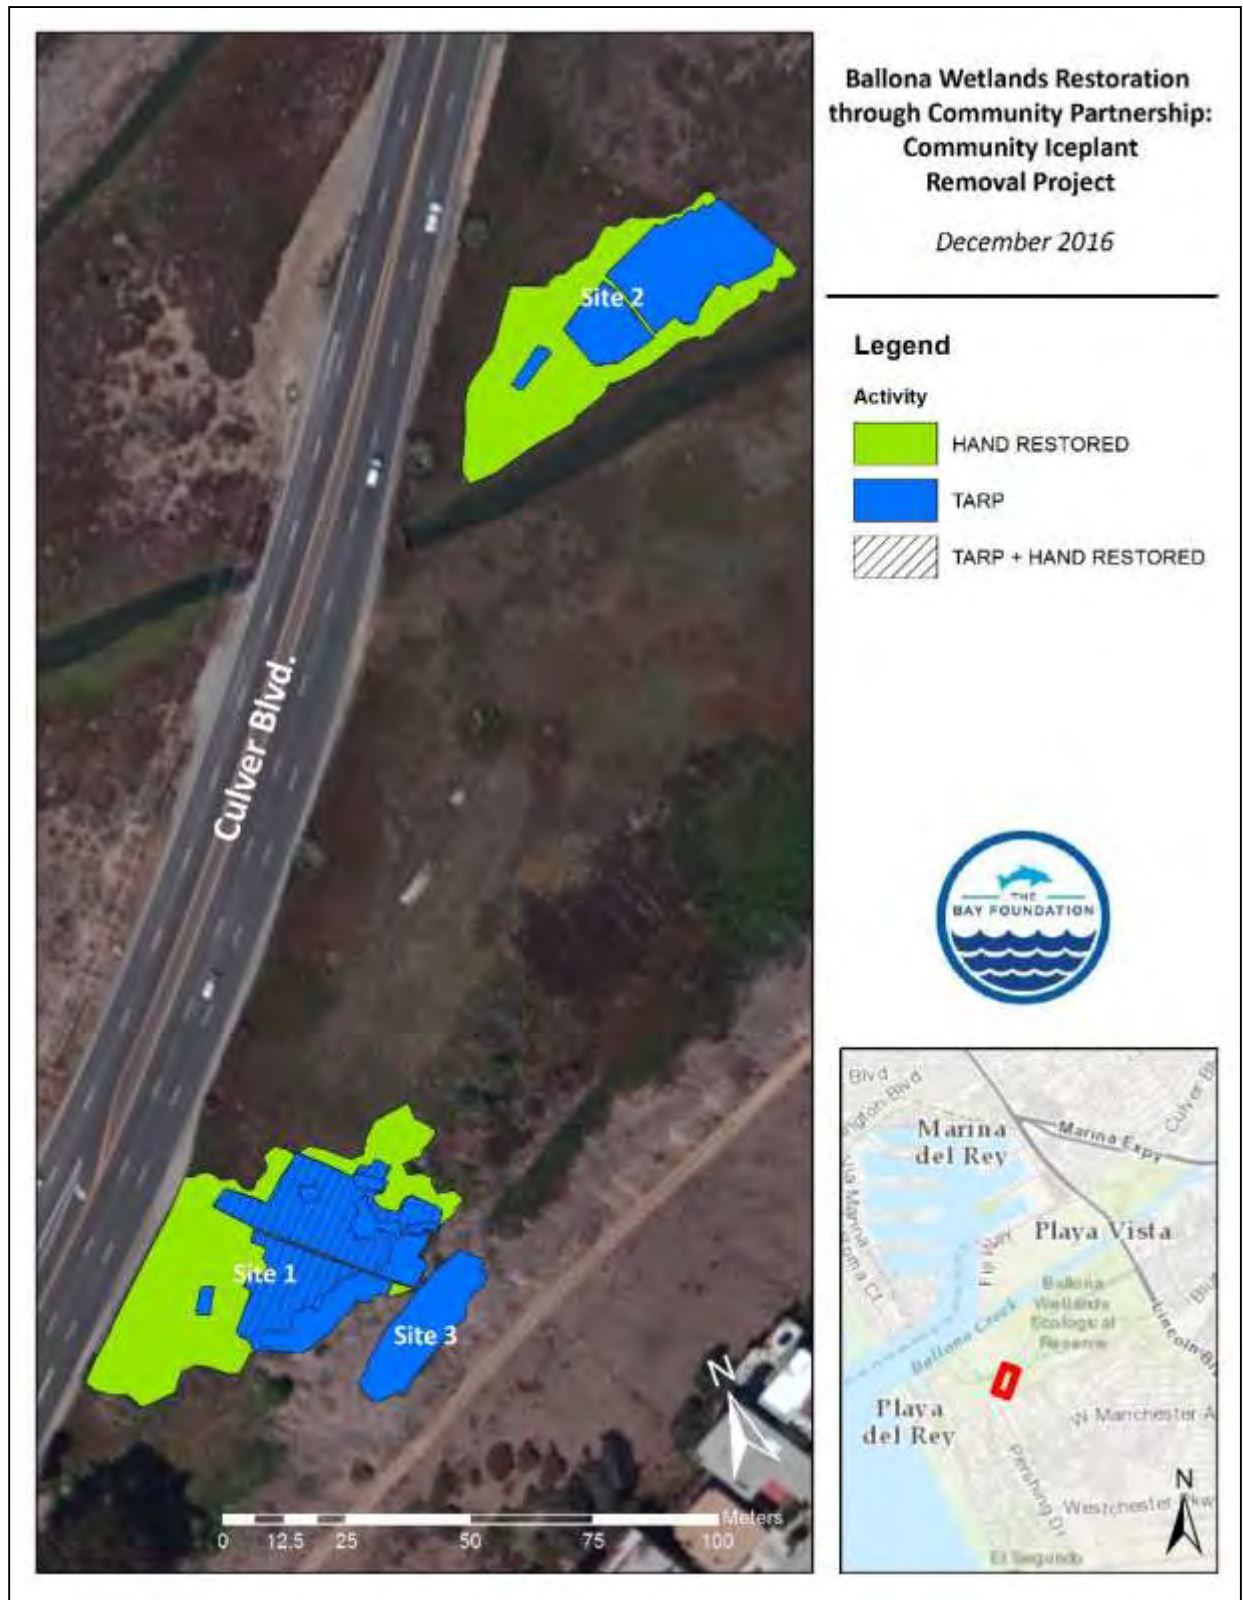
Exact total acreages of both the hand-restored and tarped restoration areas were calculated using a Trimble Geo7x GPS and mapped using GIS (Figure 2). Acreages are summarized in Table 2. Hand restoration efforts alone resulted in a restoration area of 0.39 acres (1,585 m²), and the total tarped restoration area was 0.36 acres (1,460 m²). Additionally, some of the tarped area also had to be hand-restored through additional restoration events in an area of 0.13 acres or 510 m². Collectively, hand-restored and tarped restoration areas covered a total of 0.88 acres (3,555 m²).

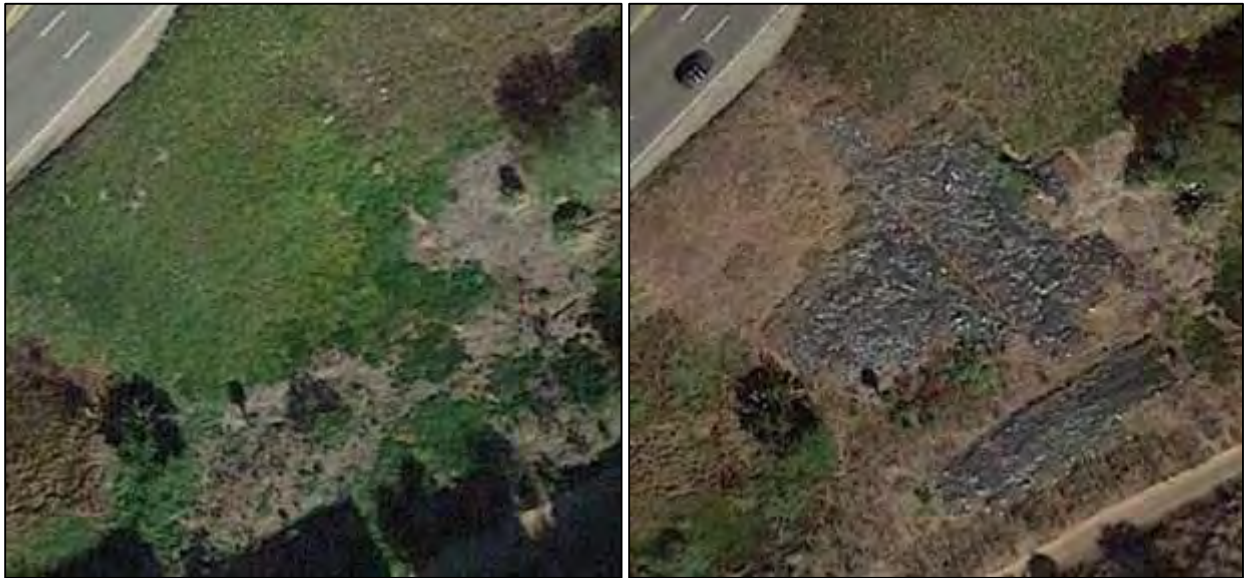
Figures 3 and 4 are composed of aerial imagery pulled from Google Earth prior to the implementation of the project and during the implementation of the project. The time series includes both restoration sites when covered in invasive iceplant (left) and after several tarping and hand-restoration events (right). The right-hand side photographs were taken right before the tarps were removed from site.

Figure 3. Site 1 and 3: pre-restoration before project implementation (left, 8 February, 2016) and after tarp installation and several restoration events (right, 2 October, 2016) (Google Earth).

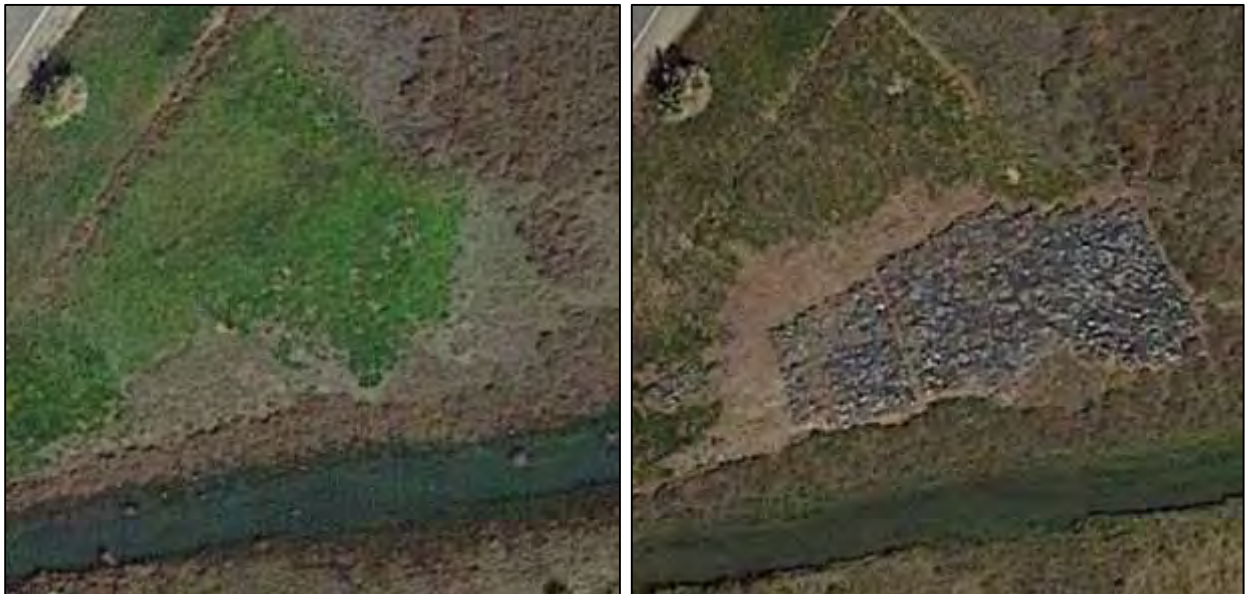
Figure 4. Site 2: pre-restoration before project implementation (left, 8 February, 2016) and after tarp installation and several restoration events (right, 2 October, 2016) (Google Earth).

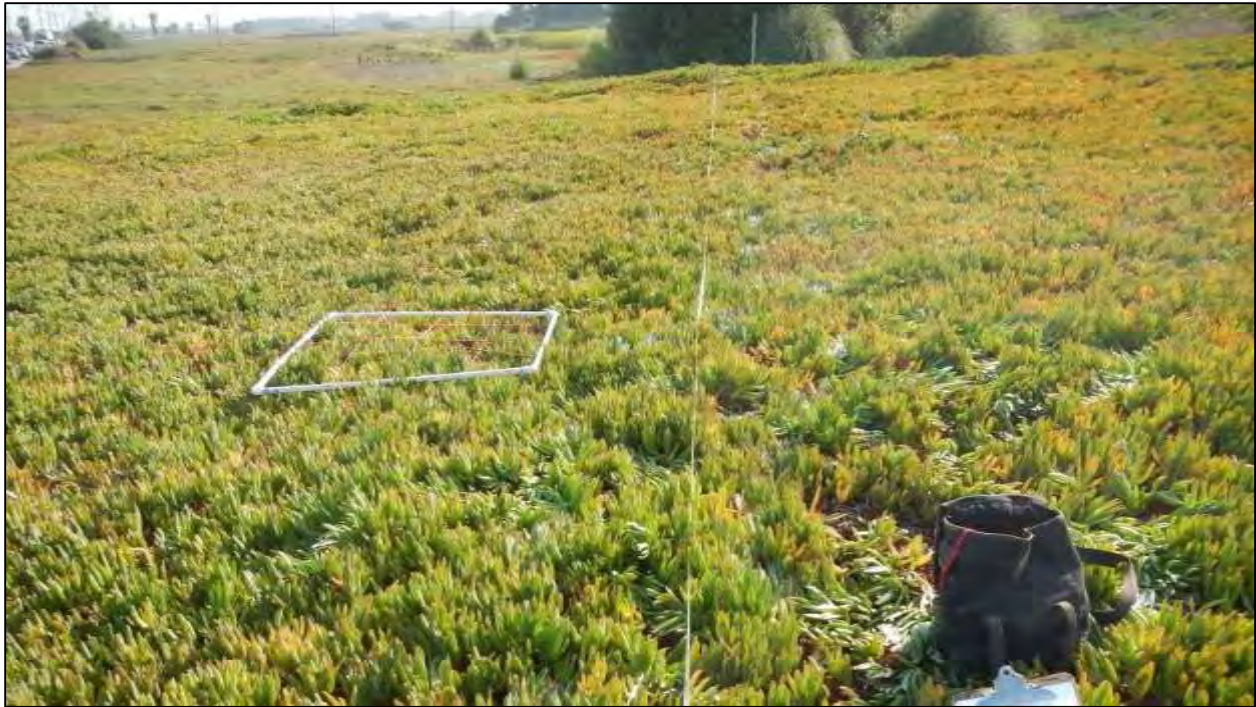
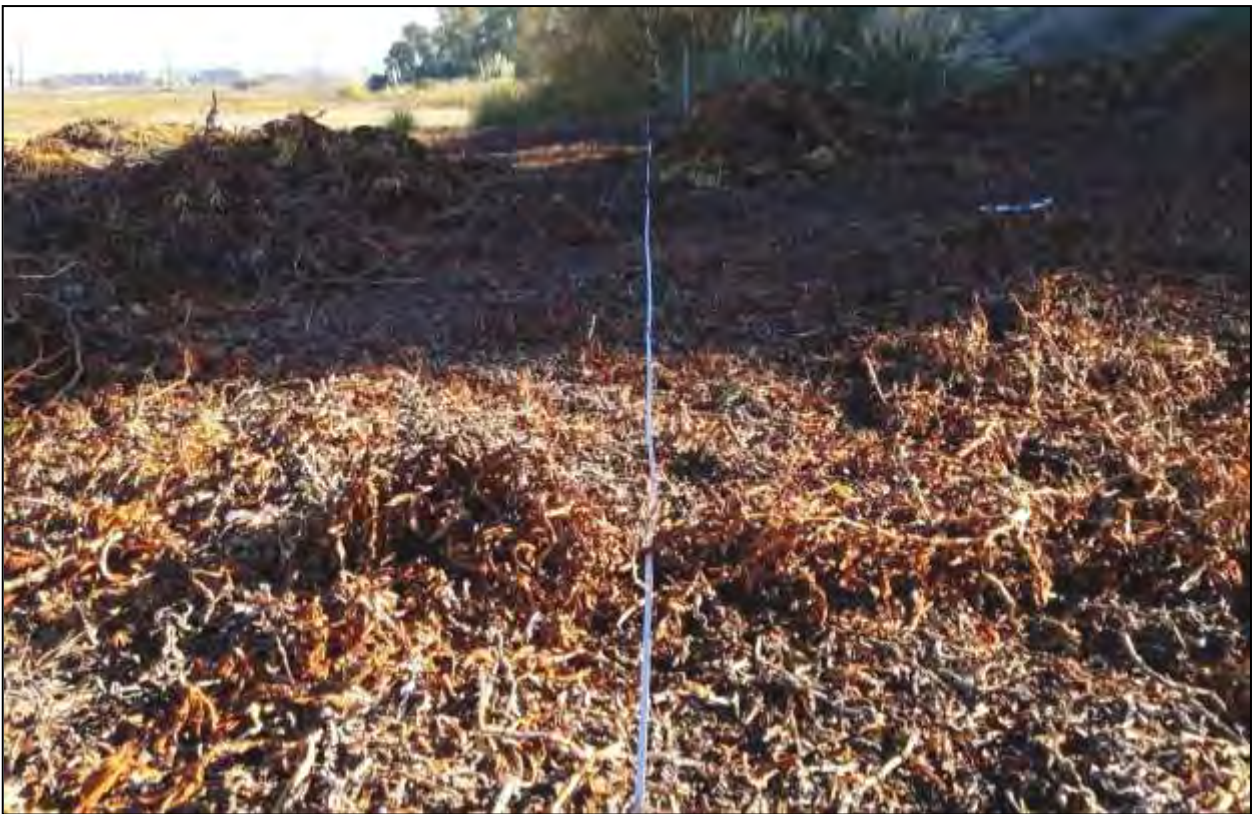
Vegetation transect data from Site 1 show a within-restoration area transition from 100% live iceplant pre-restoration to 100% dead iceplant and detritus post-restoration (Figure 8). No new seedlings had come in at the time of the final post-restoration survey (29 November 2016). The habitats surrounding Site 1 had a high diversity, including a depression area with freshwater input during the wet season that had a mix of native brackish and salt marsh species, non-tidal salt marsh, and adjacent sandy-soil habitats. Therefore, the adjacent “control” data show a wide diversity of native and non-native vegetation surrounding the project area both pre- and post-restoration. These included common native species such as saltgrass (*Distichlis spicata*), pickleweed (*Salicornia pacifica*), alkali weed (*Cressa truxillensis*), common rush (*Juncus patens*), and alkali heath (*Frankenia salina*). Additionally, several non-native species were found adjacent to the restoration area, including iceplant, Australian saltbush (*Atriplex semibaccata*), and castor bean (*Ricinus communis*).

Figure 8. Transect 5 before restoration (top) and after tarping and some iceplant removal (bottom).

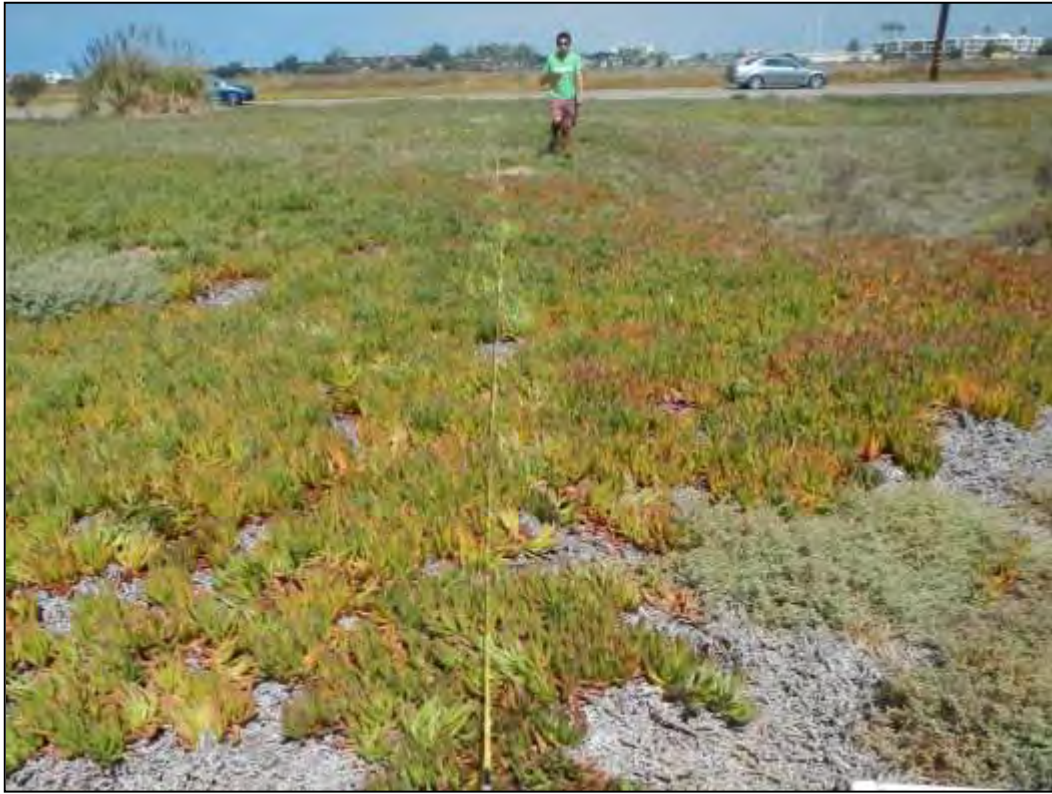
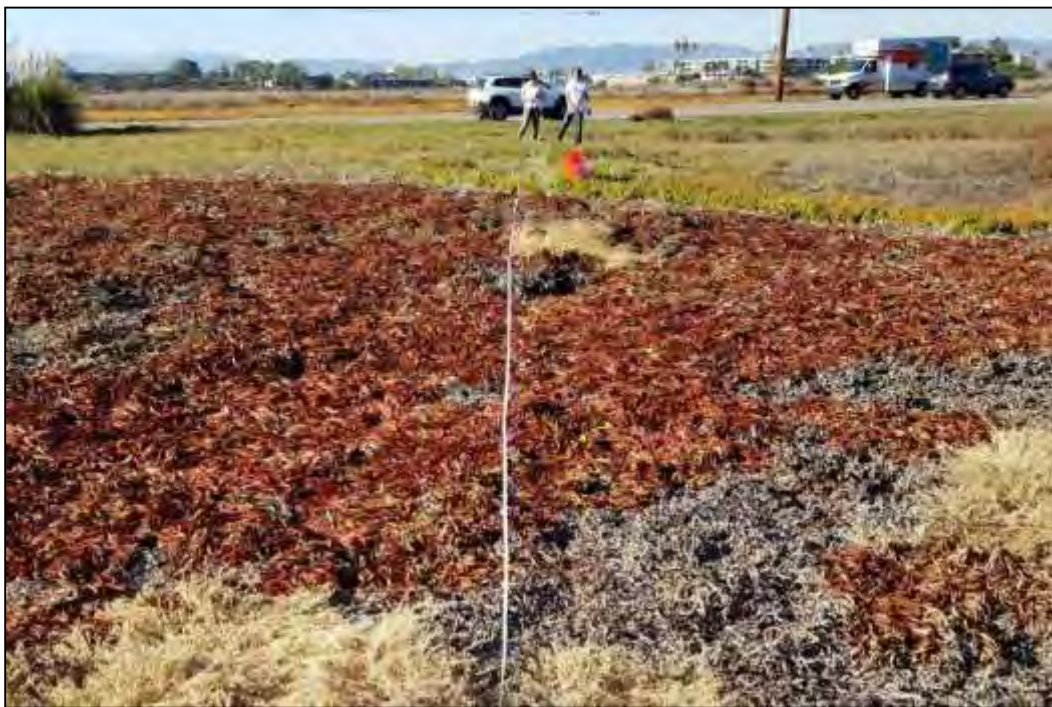
Vegetation transect data from Site 2 also showed a within-restoration area transition from 100% live iceplant pre-restoration to 100% dead iceplant and detritus post-restoration (Figure 9). Additionally, the tarped portion of Site 2 that was covering Australian saltbush also showed a 100% conversion from live saltbush to dead saltbush. No new seedlings had come in at the time of the final post-restoration survey (29 November 2016). Two shallow muted tidal channels and areas of non-tidal salt marsh surround the edges of Site 2 and are dominated by primarily native vegetation, including pickleweed, alkali heath, saltgrass, and alkali weed. Site 2 also has patchy iceplant remaining to the north and east of the project area, which will need to be removed in future restoration events. This area was not targeted during this phase of the project due to time constraints, but will be restored in 2017.

Figure 9. Transect 4 before restoration (top) and after tarping (bottom).

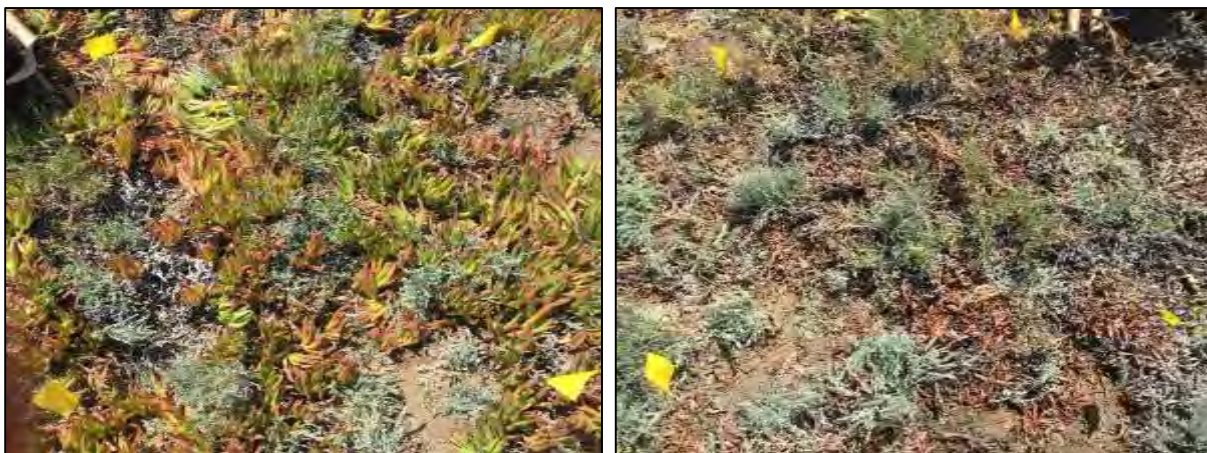
Figure 14. Photo point of pre-restoration square meter area of iceplant with intermixed native salt marsh species (top) and post-restoration photograph of the same square meter area after hand-pulling (bottom).

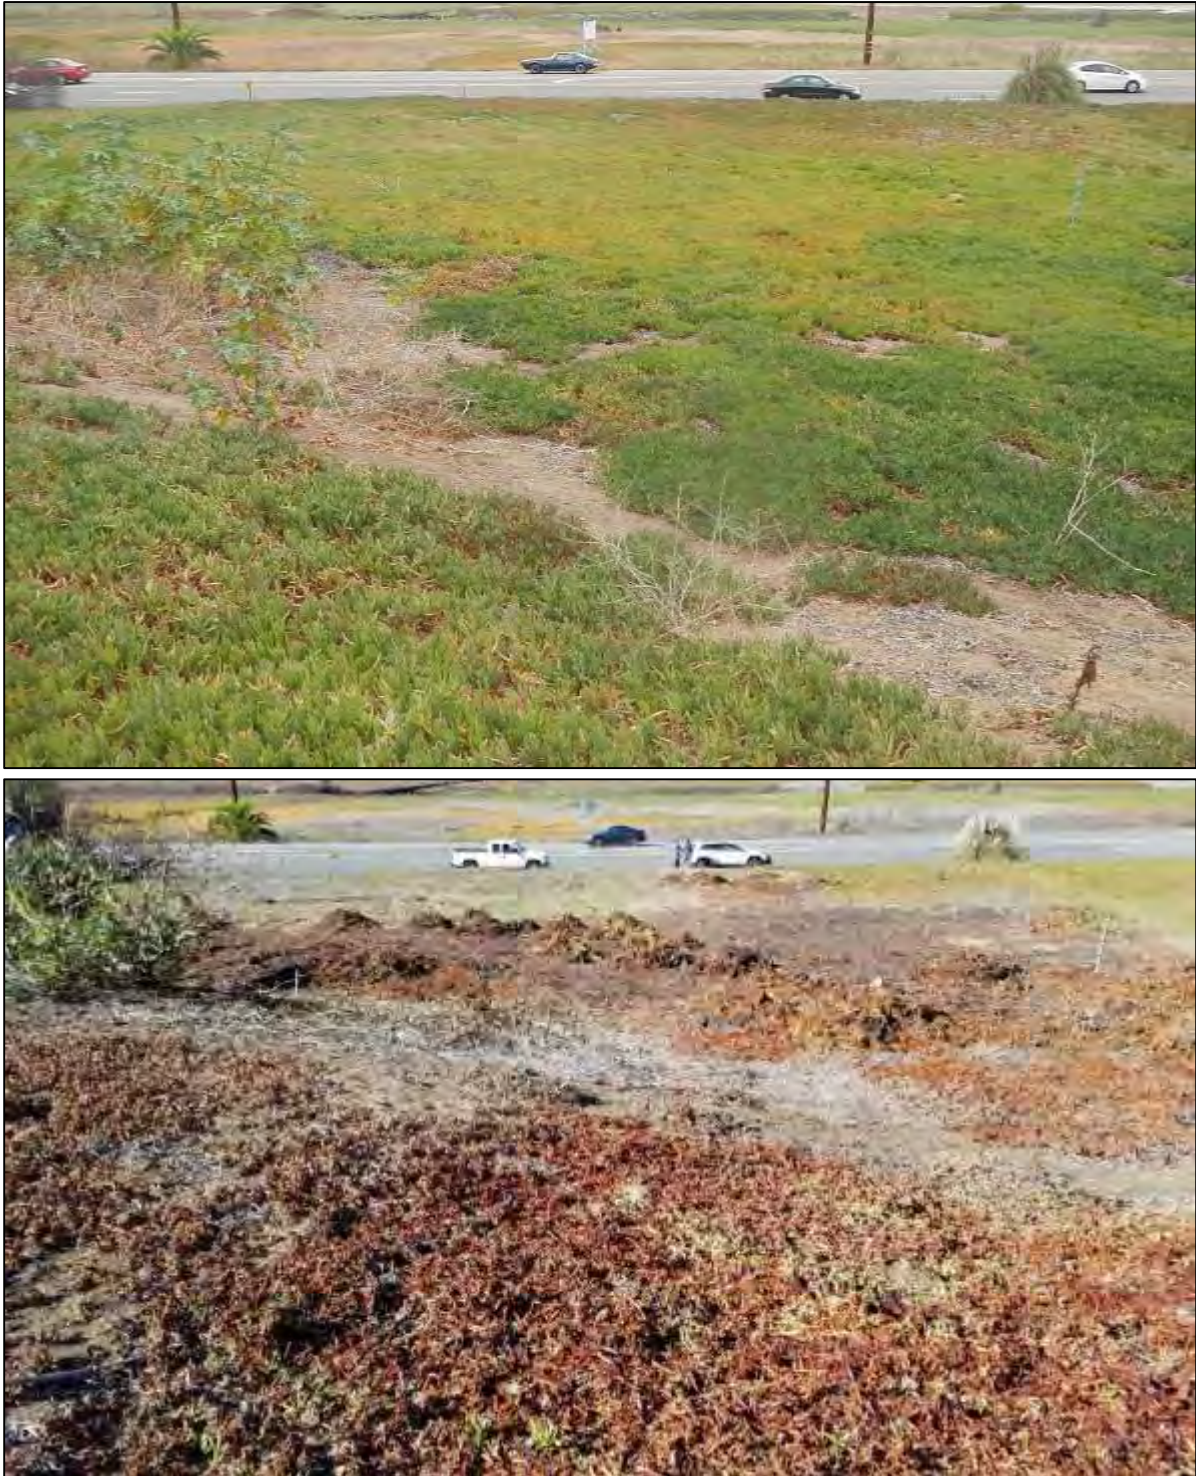
Figure 15. Photo point of Site 1 and 3 pre-restoration on 9 August 2016 (top) and post-restoration on 29 November 2016 (bottom).

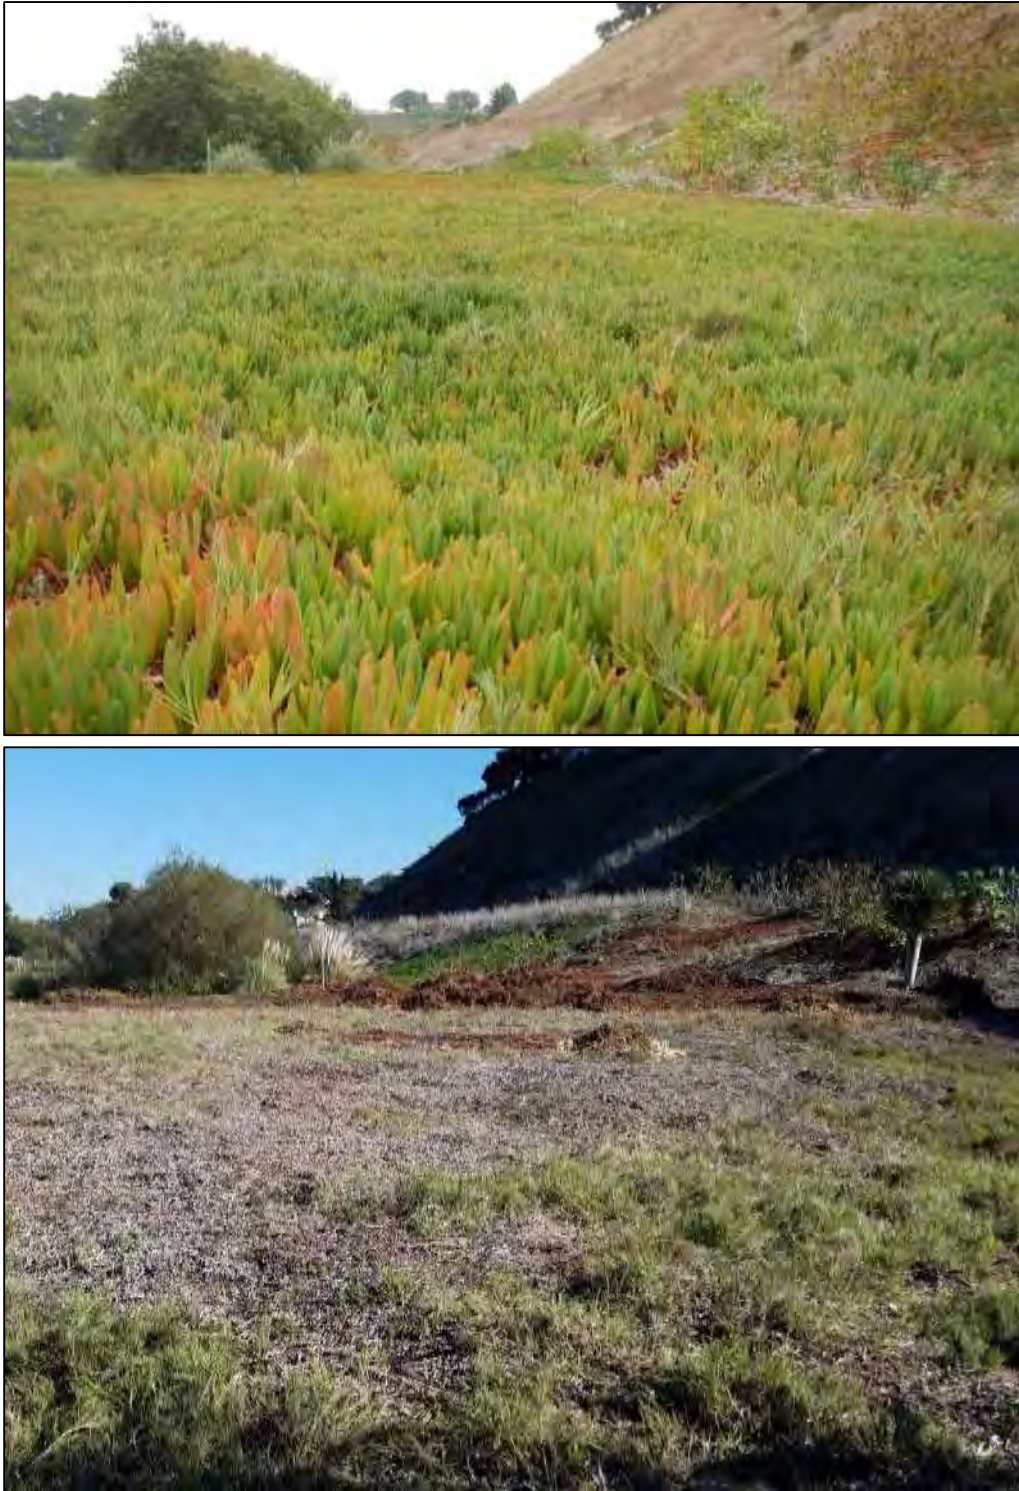
Figure 16. Photo point of Site 1 and 3 pre-restoration on 1 September 2016 (top) and post-restoration on 29 November 2016 (bottom). Site 3 can be seen at the base of the bluff hill.

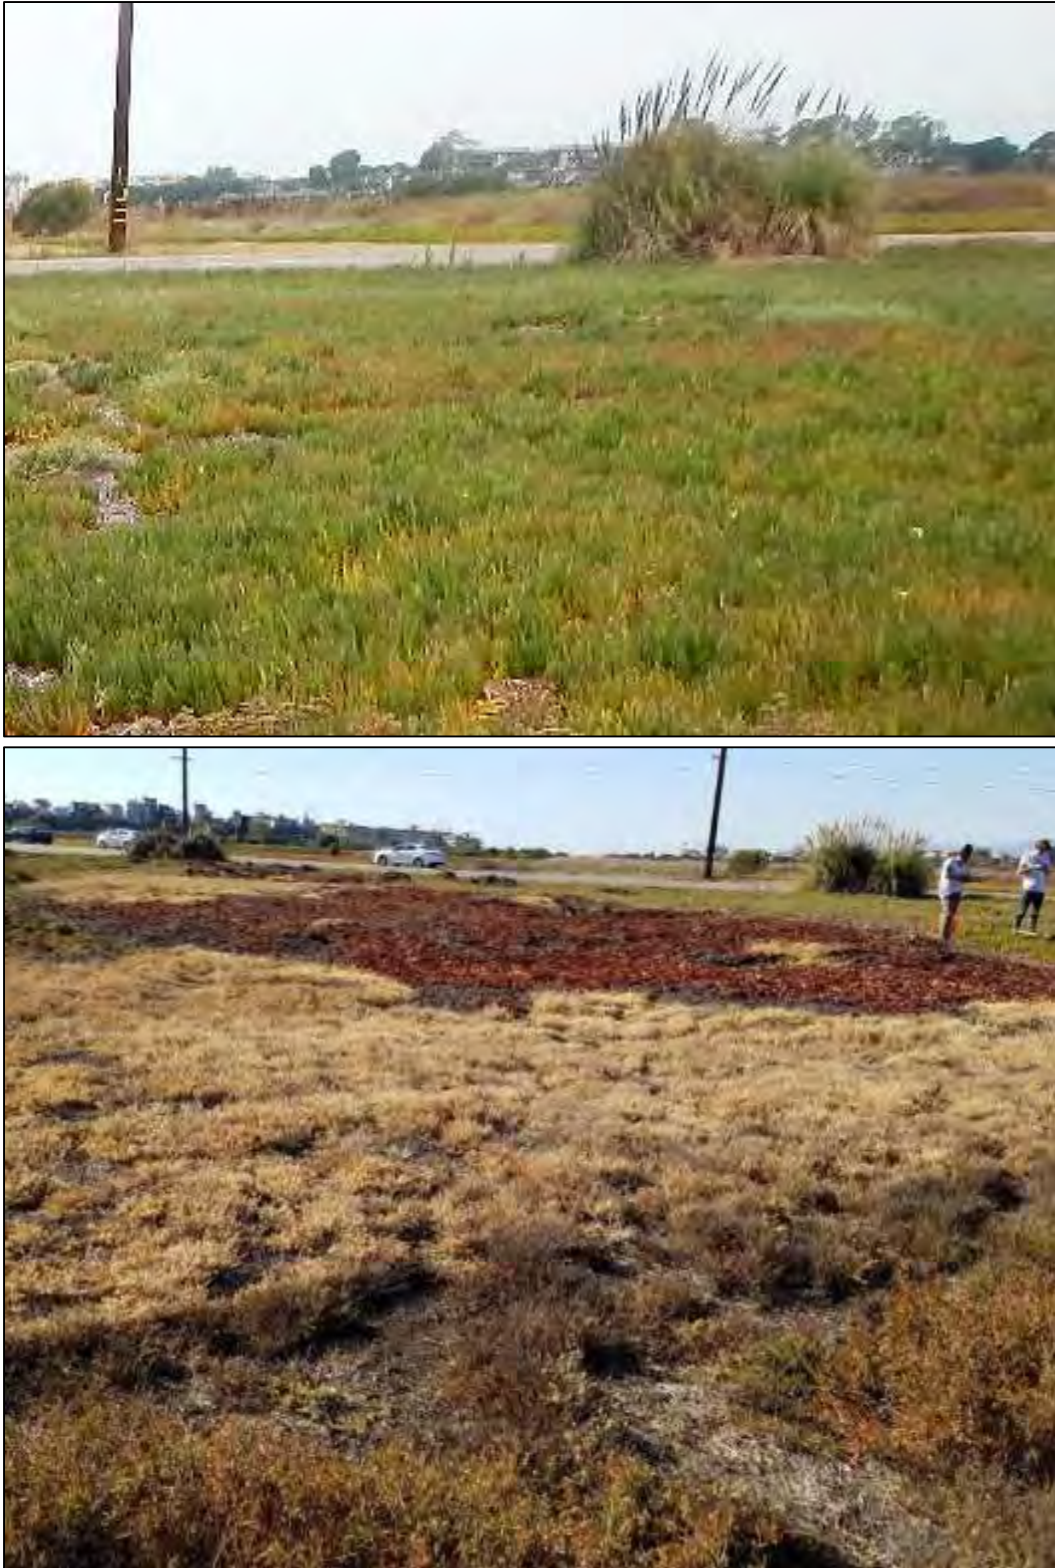
Figure 17. Photo point of Site 2 pre-restoration on 9 August 2016 (top) and post-restoration on 29 November 2016 (bottom).

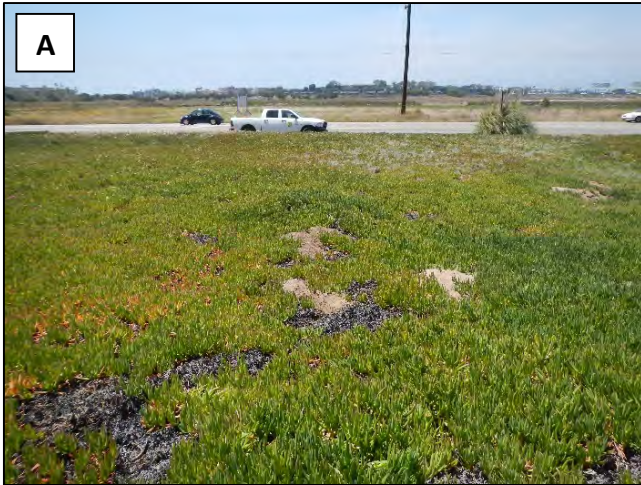
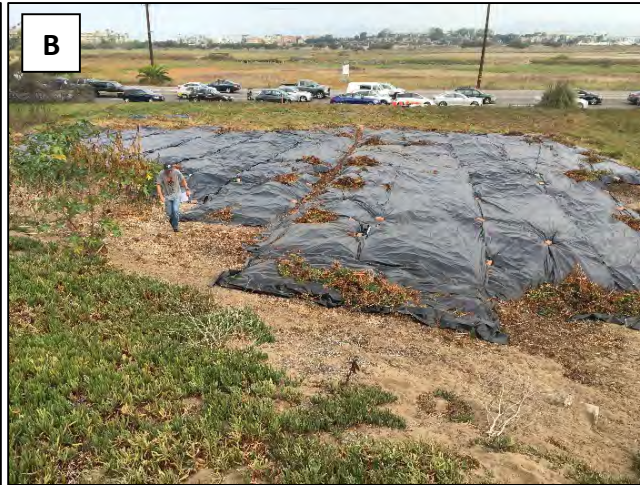
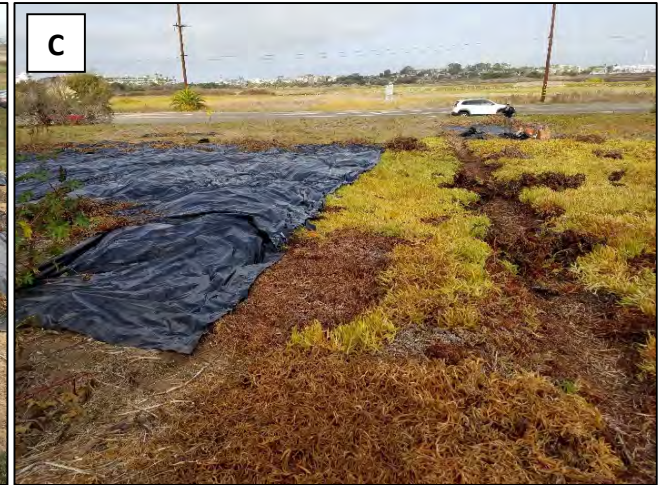
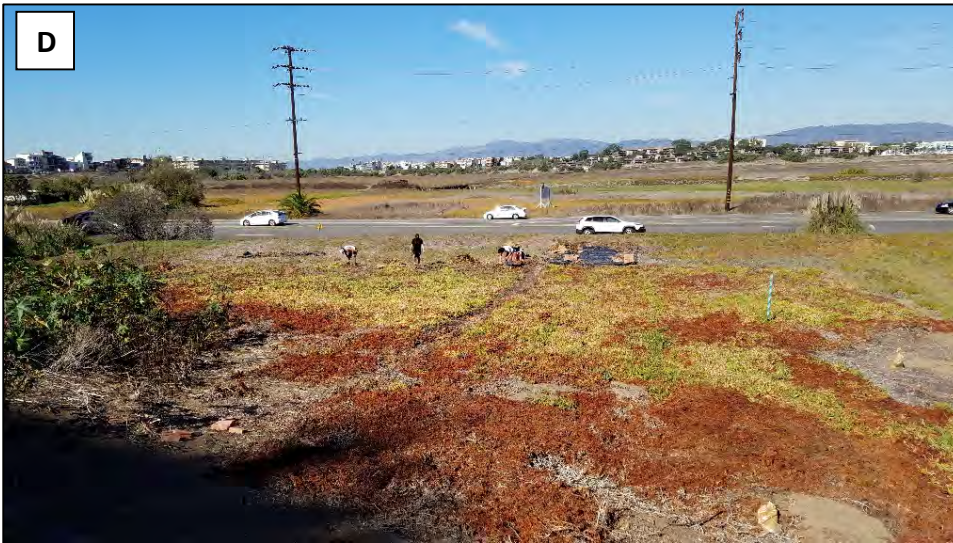
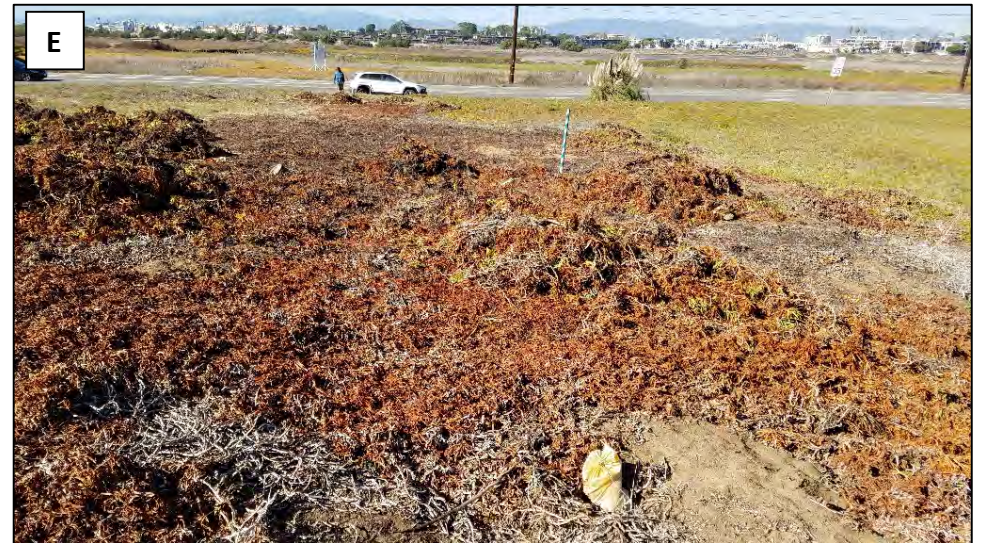
Photographs of Site 1 on (A) 28 May 2015; (B) 8 September 2016; (C) 26 October 2016; (D) 10 November 2016; (E) 29 November 2016

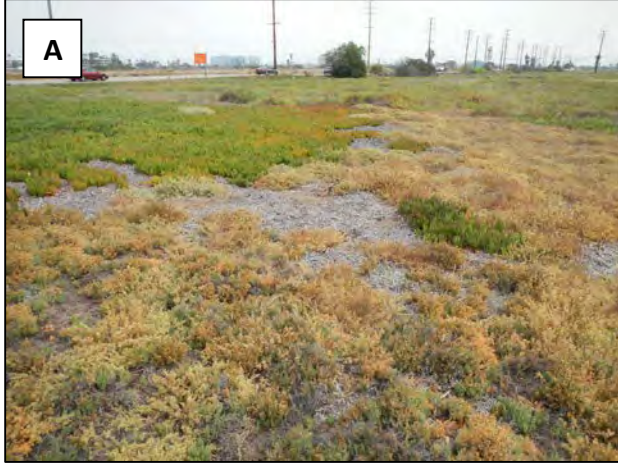
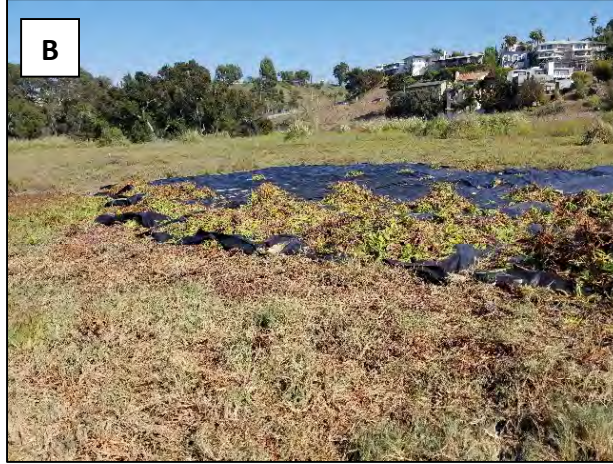
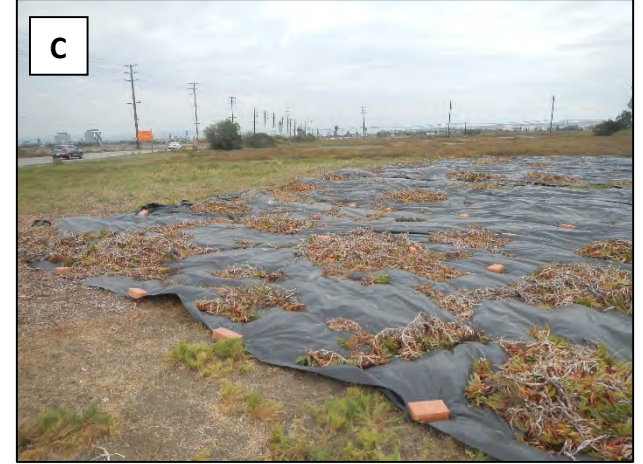
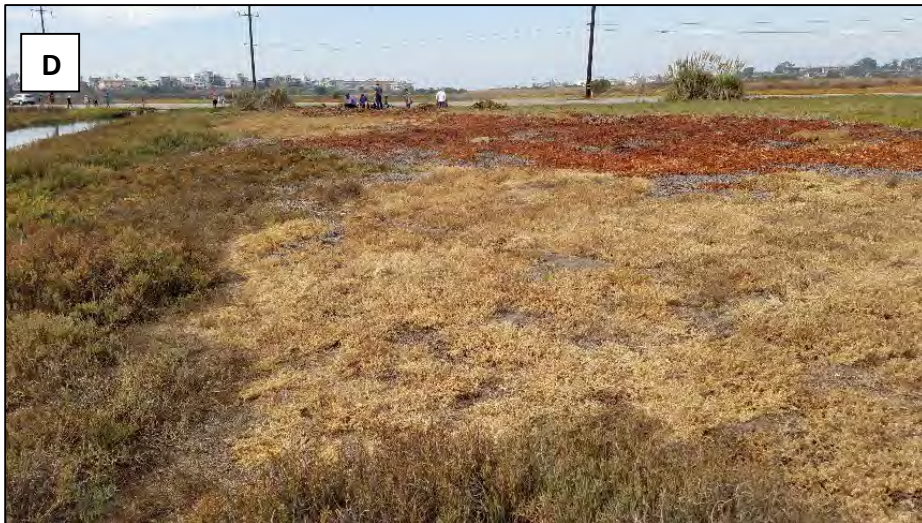
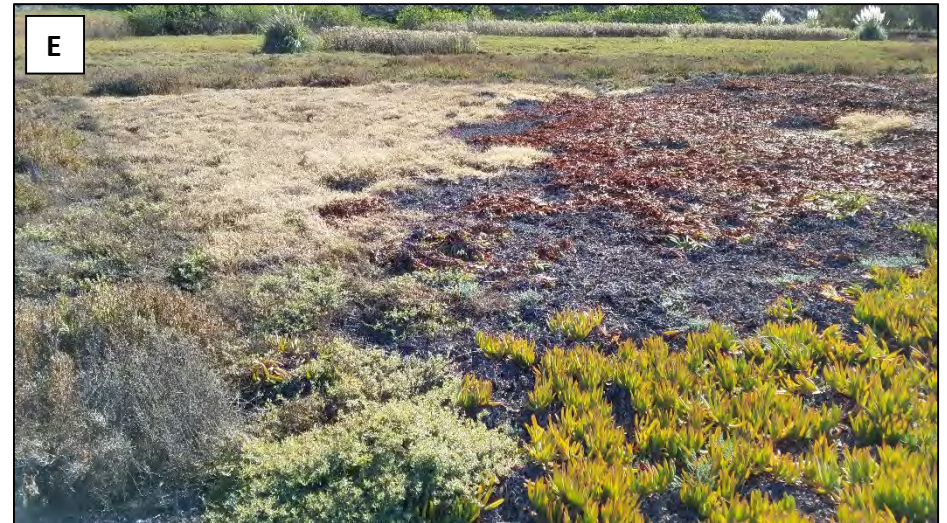
Photographs of Site 2 on (A) 9 August 2016; (B) 6 September 2016; (C) 24 October 2016; (D) 15 November 2016; (E) 29 November 2016

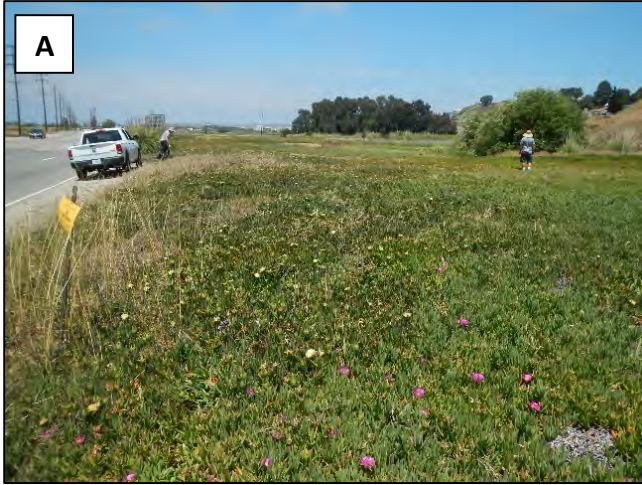
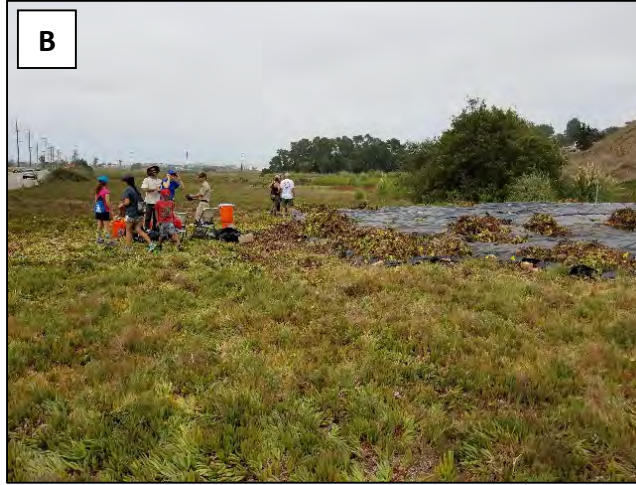
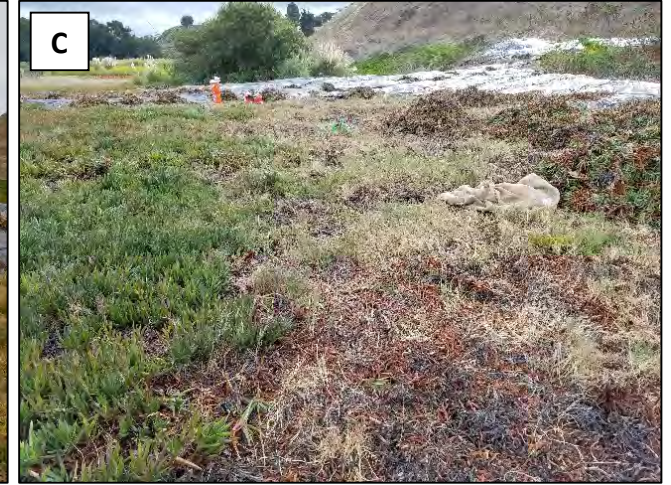
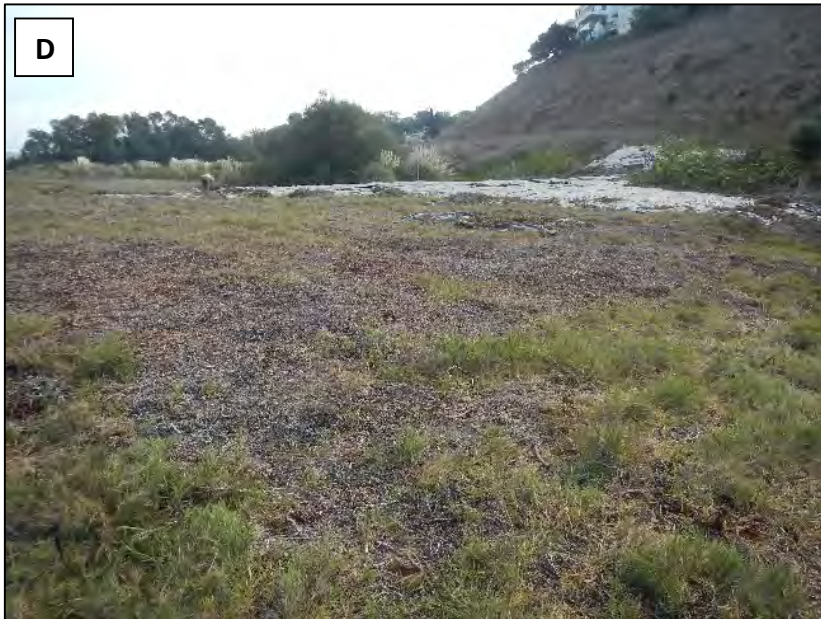
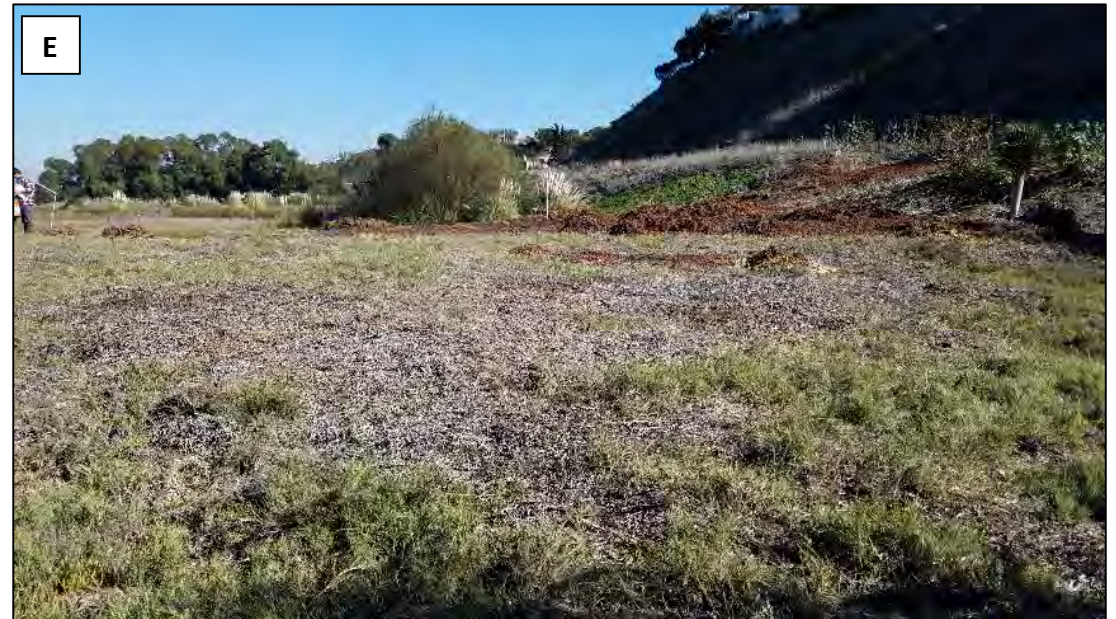
Photographs of Site 1 and 3 on (A) 28 May 2015; (B) 1 September 2016; (C) 13 September 2016; (D) 24 October 2016; (E) 29 November 2016
