Malibu Living Shoreline Project: Baseline Assessment and Site Characterization

May 2020

Coastal Restoration Consultants

Site Assessment for Zuma Beach and Point Dume Beach

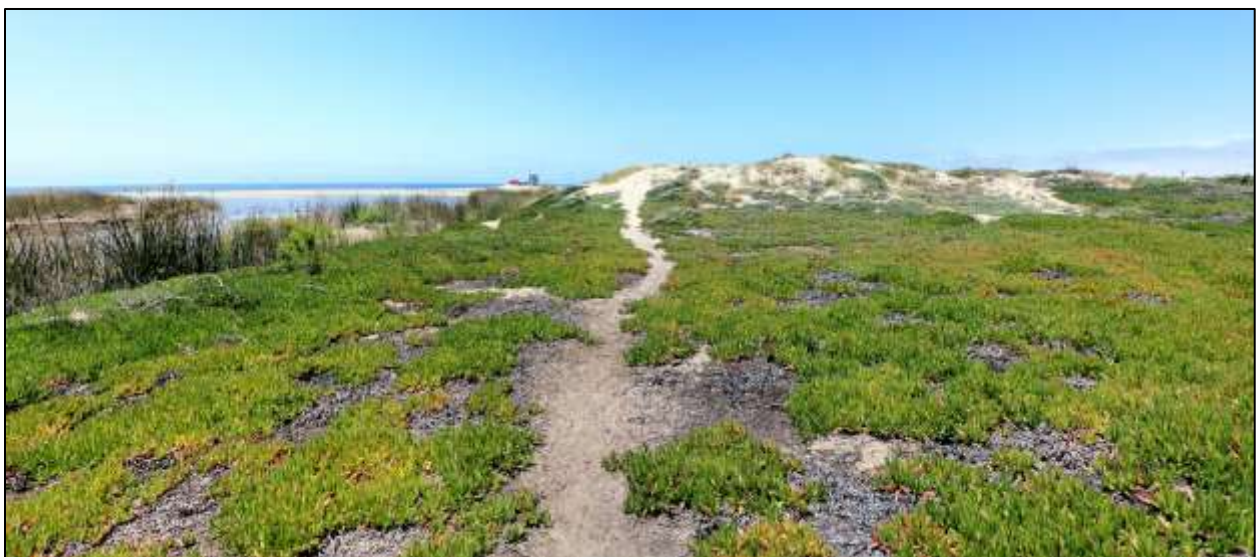
Figure 1a. Photograph of Zuma Beach restoration area adjacent to Zuma Lagoon (left).

The proposed restoration sites at Zuma Beach and Point Dume Beach have good potential for supporting more natural coastal habitats because they retain mostly intact coastal processes. Restoration actions that remove impediments to natural functioning and restore native plant communities will lead to habitats that support native species and make the coast more resilient as sea level rises. The remnant coastal dunes at Zuma Beach and Point Dume Beach seem to have somewhat stable sediment fluxes and are perhaps the best examples of natural dunes in the 17-mile long (27 km) Zuma Littoral Cell (Griggs and Patsch 2018), which lies between Point Mugu and Point Dume. On the other hand, the proposed restoration areas are under pressure from compromised sediment supplies from up-coast sources (estimated to be at approximately 75% of historical levels by Griggs and Patsch (2018)), localized driving and trampling, negative interactions with infrastructure and current management, and invasive non-native plants (Figure 1a).

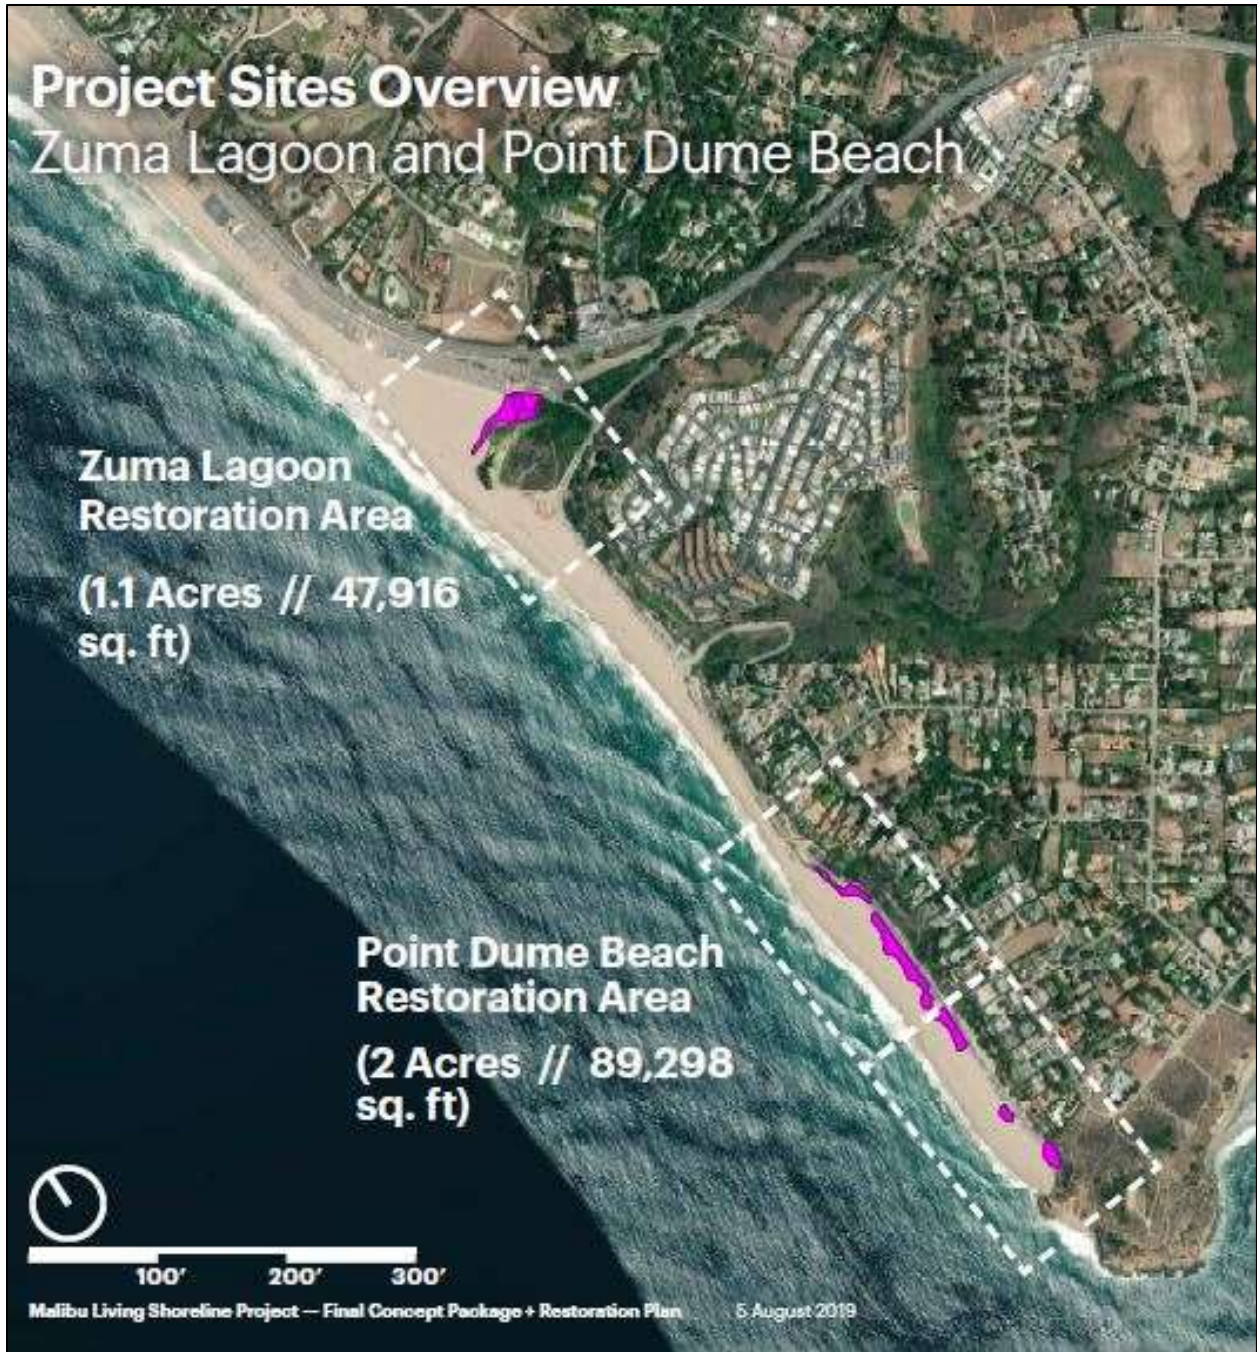
Figure 1b. Overview map of both restoration areas as part of the Malibu Living Shoreline Project (Rios and CRC 2019).

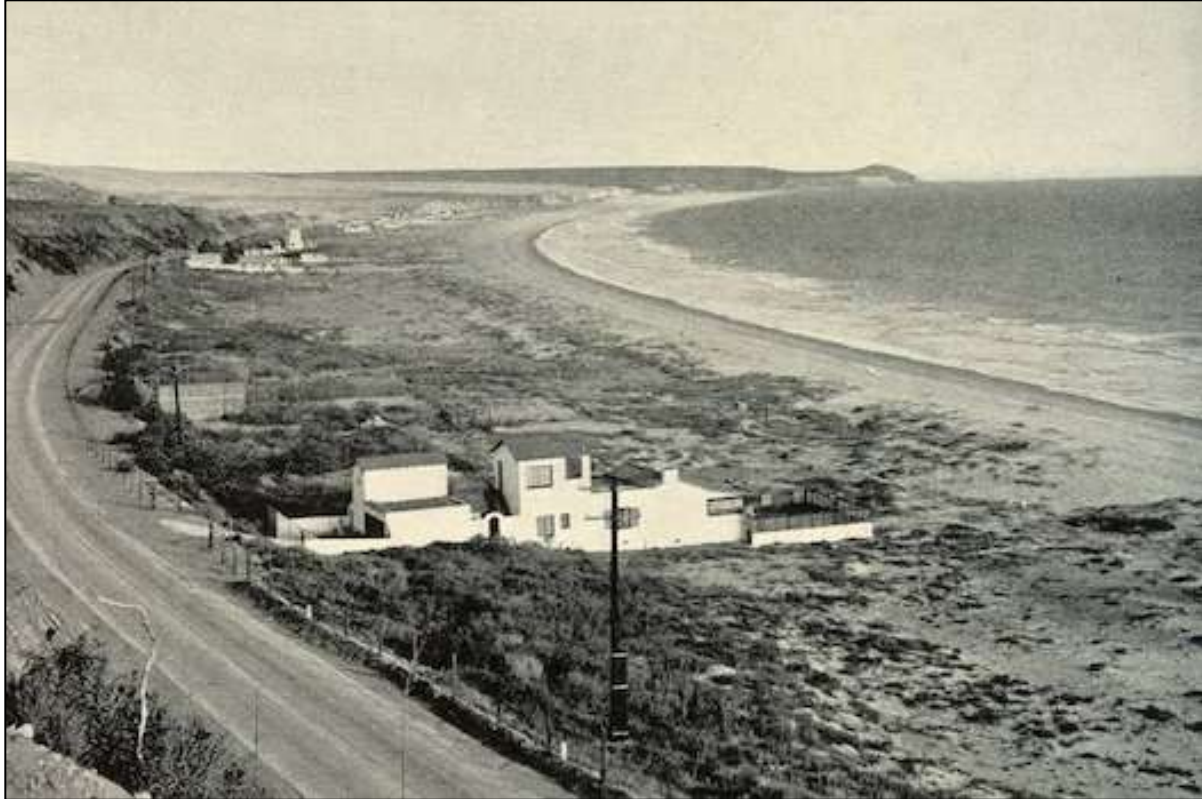
Figure 5. 1936 photo of Trancas Beach (~2 miles north of Zuma Lagoon). Note wide zone of vegetated dunes extending nearly to the high tide line. Dunes were likely much taller than these at Zuma Beach and Point Dume Beach.

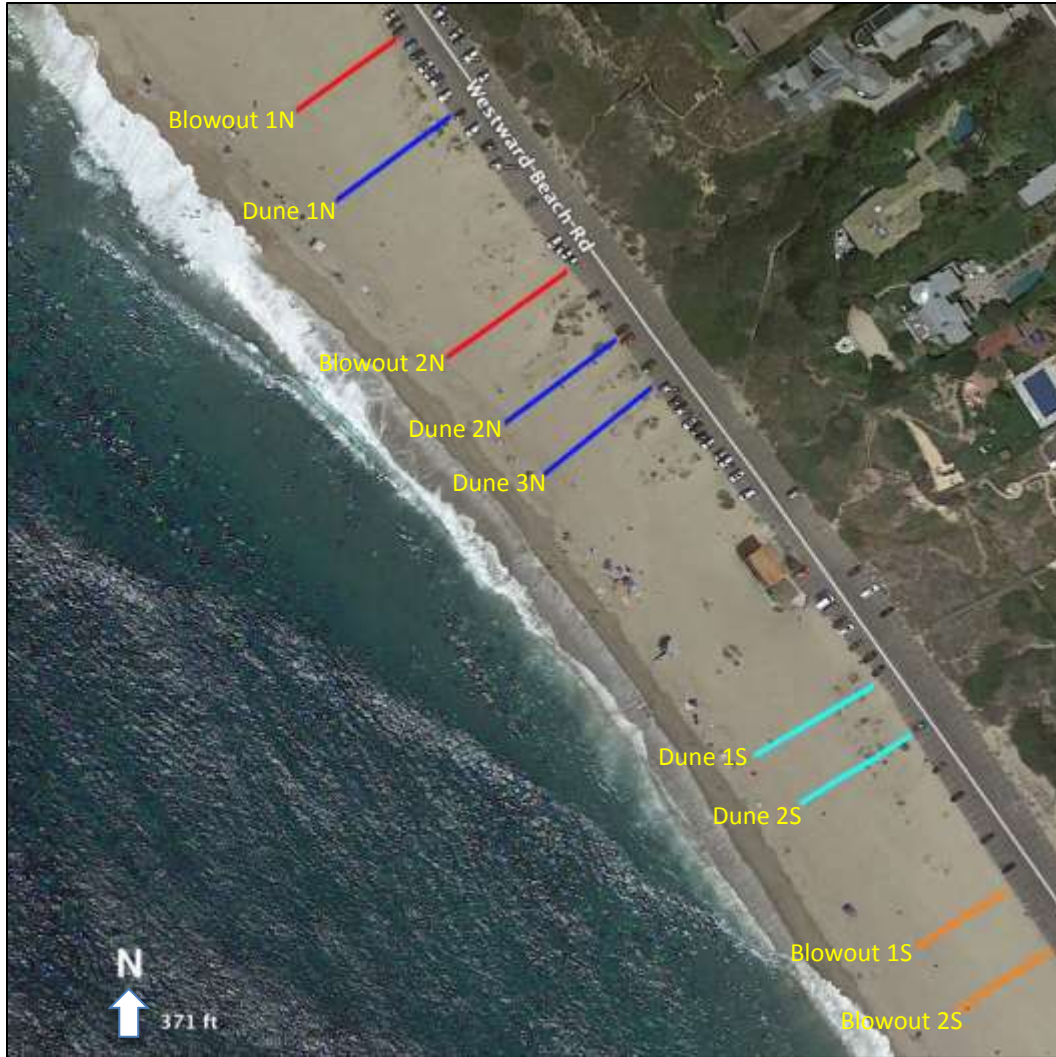
At Point Dume Beach, CRC measured vegetation cover and elevations along nine transects, extending from the seaward edge of the parking lot to the high-tide line (Figure 6). Blue and light blue transects extended through vegetated dunes. Red and orange transects were surveyed through blowouts that had little or no vegetation. Vegetation percent cover was estimated for each species in 1-m² quadrats placed every two meters along each transect. Elevations for the parking lot edge, landward limit of dunes, dune crest, toe of dunes, and the high-tide line were surveyed using an auto level. The surveys were not tied in to any U.S. Geological Survey benchmarks (the closest one was too far away for practical use) but were all assessed relative to the elevation of a landmark (corner of the parking lot) and that elevation was estimated from Google Earth elevations of pavement surfaces. The elevations presented here are within +/- 2 feet of NAVD. Blue and light blue transects extended through vegetated dunes. Red and orange transects were surveyed through blowouts that had little or no vegetation. Transects are numbered north to south. TBF also conducted two elevation profile surveys with a higher resolution that illustrate relative change.

Figure 6. Point Dume Beach showing locations of vegetation/topography transects (CRC). Transects are numbered north to south.

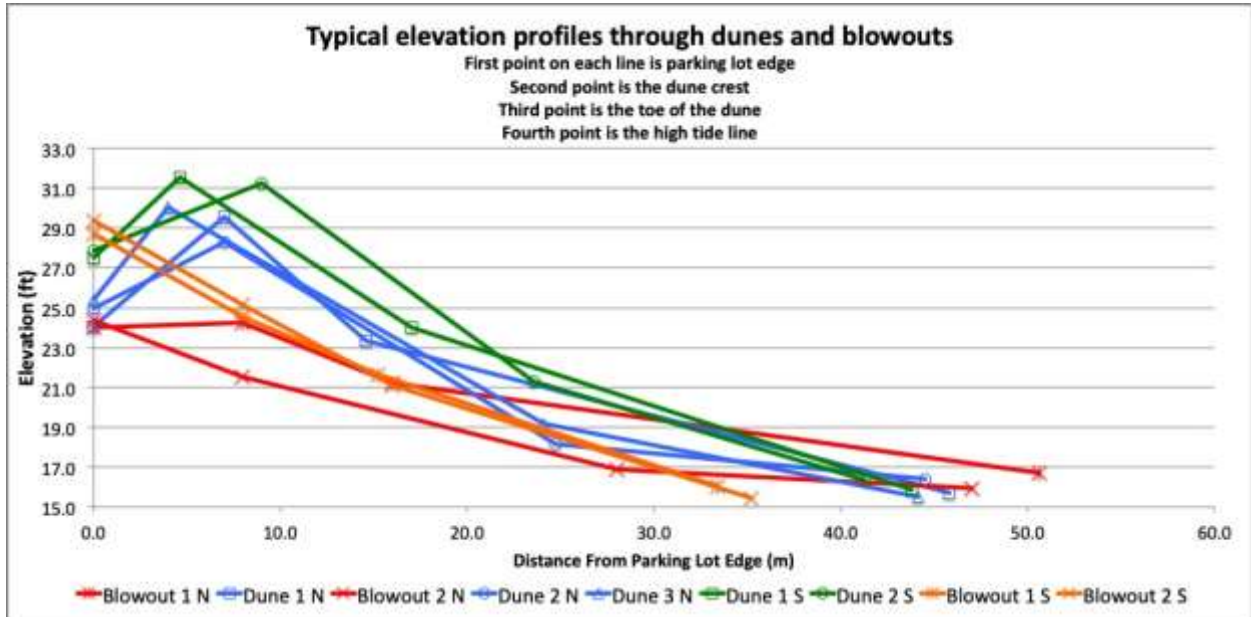
The unvegetated blowouts at Point Dume Beach showed a continuous downslope from the seaward edge of the parking lot to the high tide line on the beach (Figure 7). Vegetated transects through dunes showed four to five feet of relief above the elevation of the parking lot before dropping down to beach elevations (Figure 7). These data suggest there is an opportunity to build four to eight feet of topography in blowout areas by trapping blowing sand. This increase in sand storage and elevation would provide a basis for assessing increasing resiliency to storm events and sea level rise. Blowouts (red and orange lines) were essentially unvegetated, did not have distinct dune crests, and were overall lower in elevation. Dunes (blue and green lines) were vegetated and had distinct crests. Elevations are approximately NAVD 88.

Figure 7. Elevations in feet at four points along nine shore-normal transects at Point Dume Beach vs. distance in meters (approximately 3 feet) from the seaward edge of the parking lot to the high tide level on the beach in March 2019 (CRC).

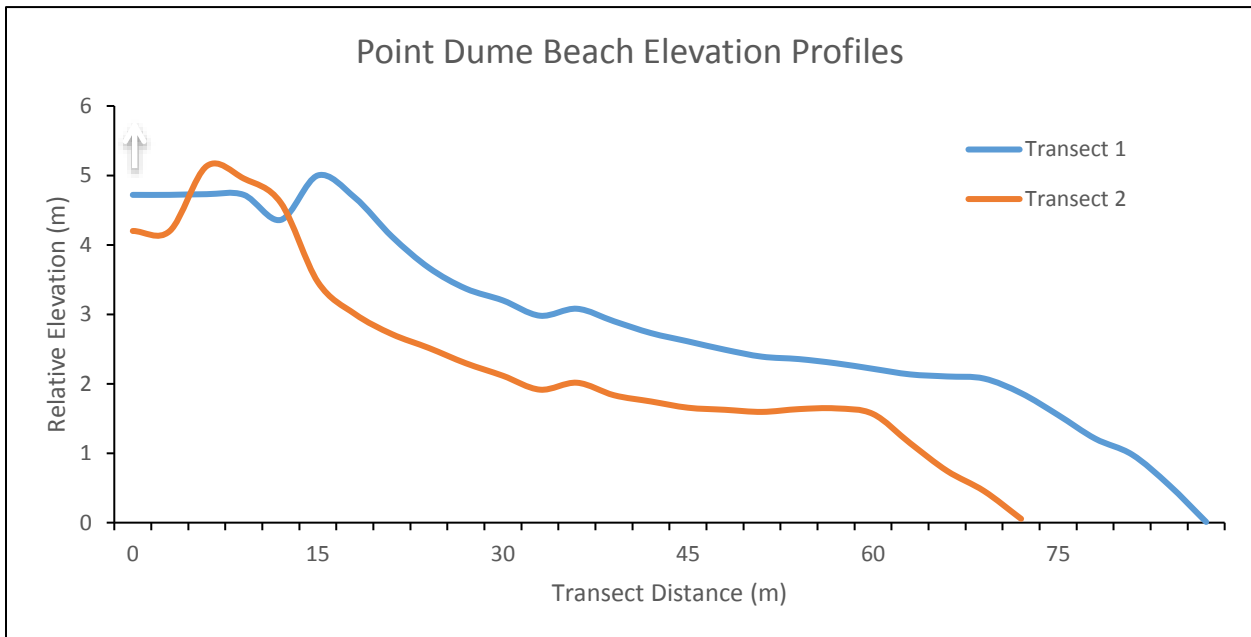
Figure 8 illustrates the elevation profiles from the two TBF elevation transects, which are in similar locations as the blue and green line transects by CRC (Figures 6 and 7), but with a higher resolution survey method, with a point taken approximately every 3 meters. Elevation profiles exhibit peaks in elevation due to the dunes adjacent to the parking lots but then a consistent and swift decline approaching the water with few other dune/hummock features.

Figure 8. Two elevation profiles in similar locations as Figure 7, above, but with higher resolution (TBF).

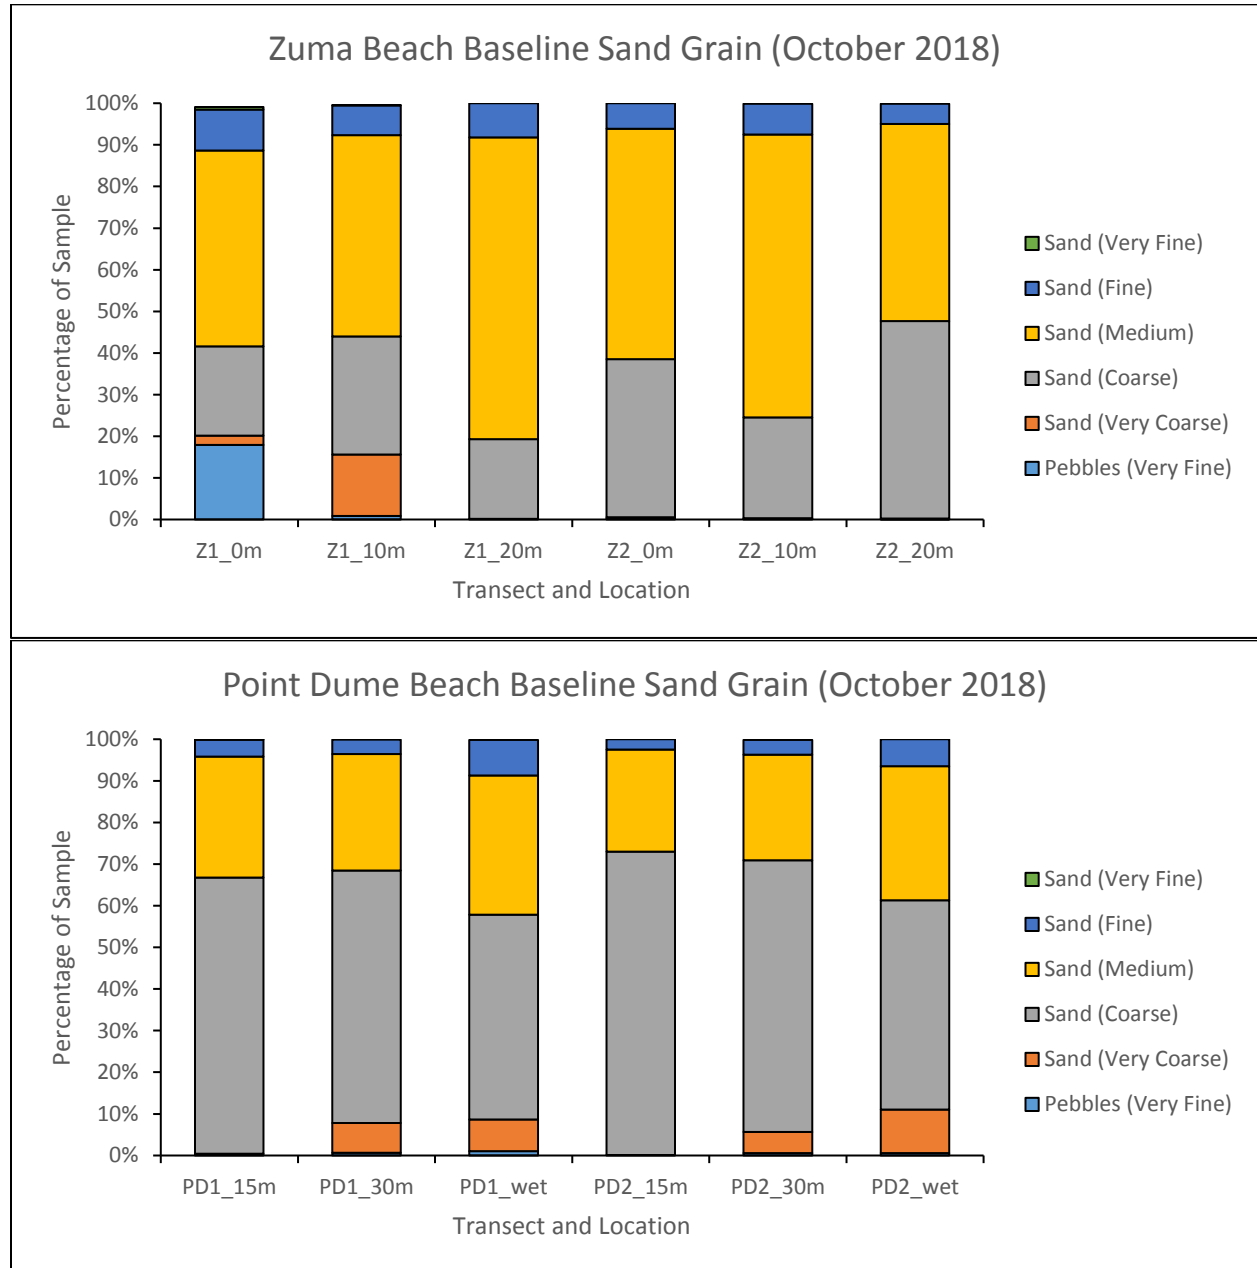
Sand at the two restoration sites varied from very fine pebbles to very fine sand (Figure 9). Dominant sand types varied by site. At Zuma Beach, medium sand was the most dominant grain size type; at Point Dume Beach, coarse sand was the most dominant grain size type (Figure 9). Soil moisture of dry sand samples was seven-fold greater at the Zuma site (1.12%) than at the Point Dume site (0.15%). Average percent organic content was almost three-fold greater at the Zuma site (0.57%) than at the Point Dume site (0.20%). Both sites exhibited sand grain size and organic content reflective of southern California beaches. Higher soil moisture and organic content at the Zuma site may be attributed to different plant communities or soil conditions.

Figure 9. Grain size data from October 2018 for Zuma Beach (top) and Point Dume Beach (bottom) (TBF).

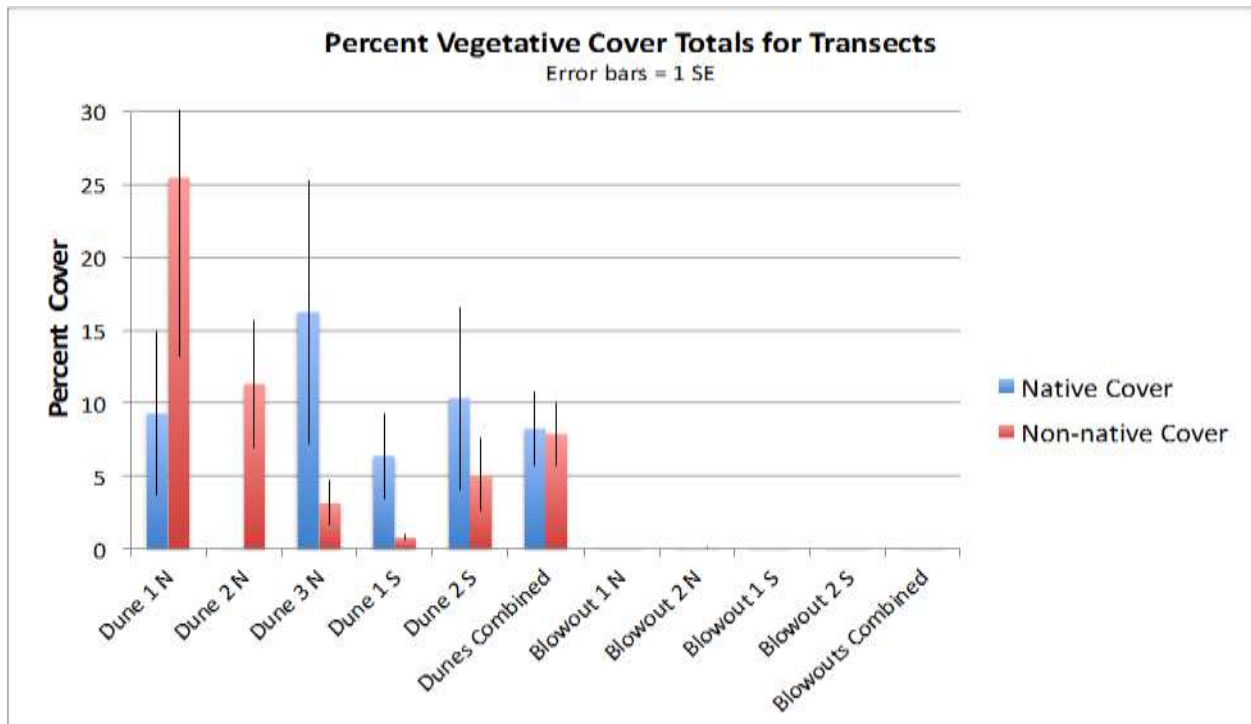
There were large differences in vegetative cover between transects in dune areas and blowouts at Point Dume Beach (Figure 10, CRC). This was due in large part to the methodology used for choosing transect locations (intentional variability in dune formation). The only plant species found in blowout areas was very small patches of the non-native annual plant European sea rocket (*Cakile maritima*), though it was not captured within the transects. As an annual species, European sea rocket does not typically produce dune topography. In the dune transects overall, there was a roughly equal mix of native (8.3% cover) and non-native (7.9% cover) species, but there was high variability between transects, with one transect identifying > 25% non-native cover, dominated by iceplant (*Carpobrotus edulis*). The four blowout transects all had zero vegetation cover. The majority of the native plant cover, when present, was beach bur (*Ambrosia chamissonis*) in small patches.

Figure 10. Percent cover of native and non-native plants in nine shore-normal transects at Point Dume Beach in March 2019.

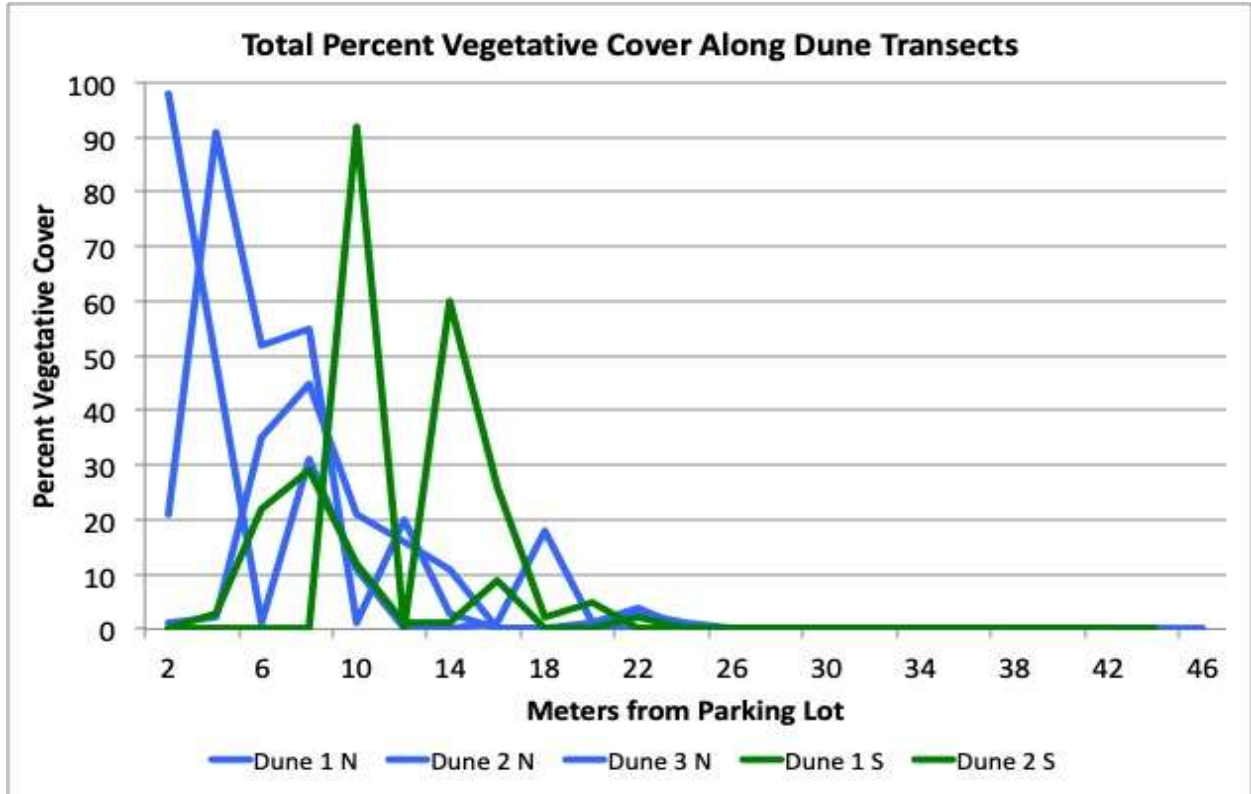
The majority of vegetation in dune transects was concentrated towards the inland end of the system (Figure 11 and top picture in Figure 12). The lack of vegetative cover on the seaward end of the transects (i.e., seaward of dunes) was primarily due to beach management actions, such as grooming, that kill seedlings. Widely scattered seedlings of European sea rocket were observed seaward of the dunes down to the high tide strand line (though our transects did not capture cover of any of these). This supports the idea that these areas seaward of existing dunes can support native vegetation under different management regimes. Appendix 1 includes a list of all plant species encountered during field work.

Figure 11. Percent cover along each vegetated dune transect estimated in one-meter square quadrats every two meters along each transect at Point Dume Beach.

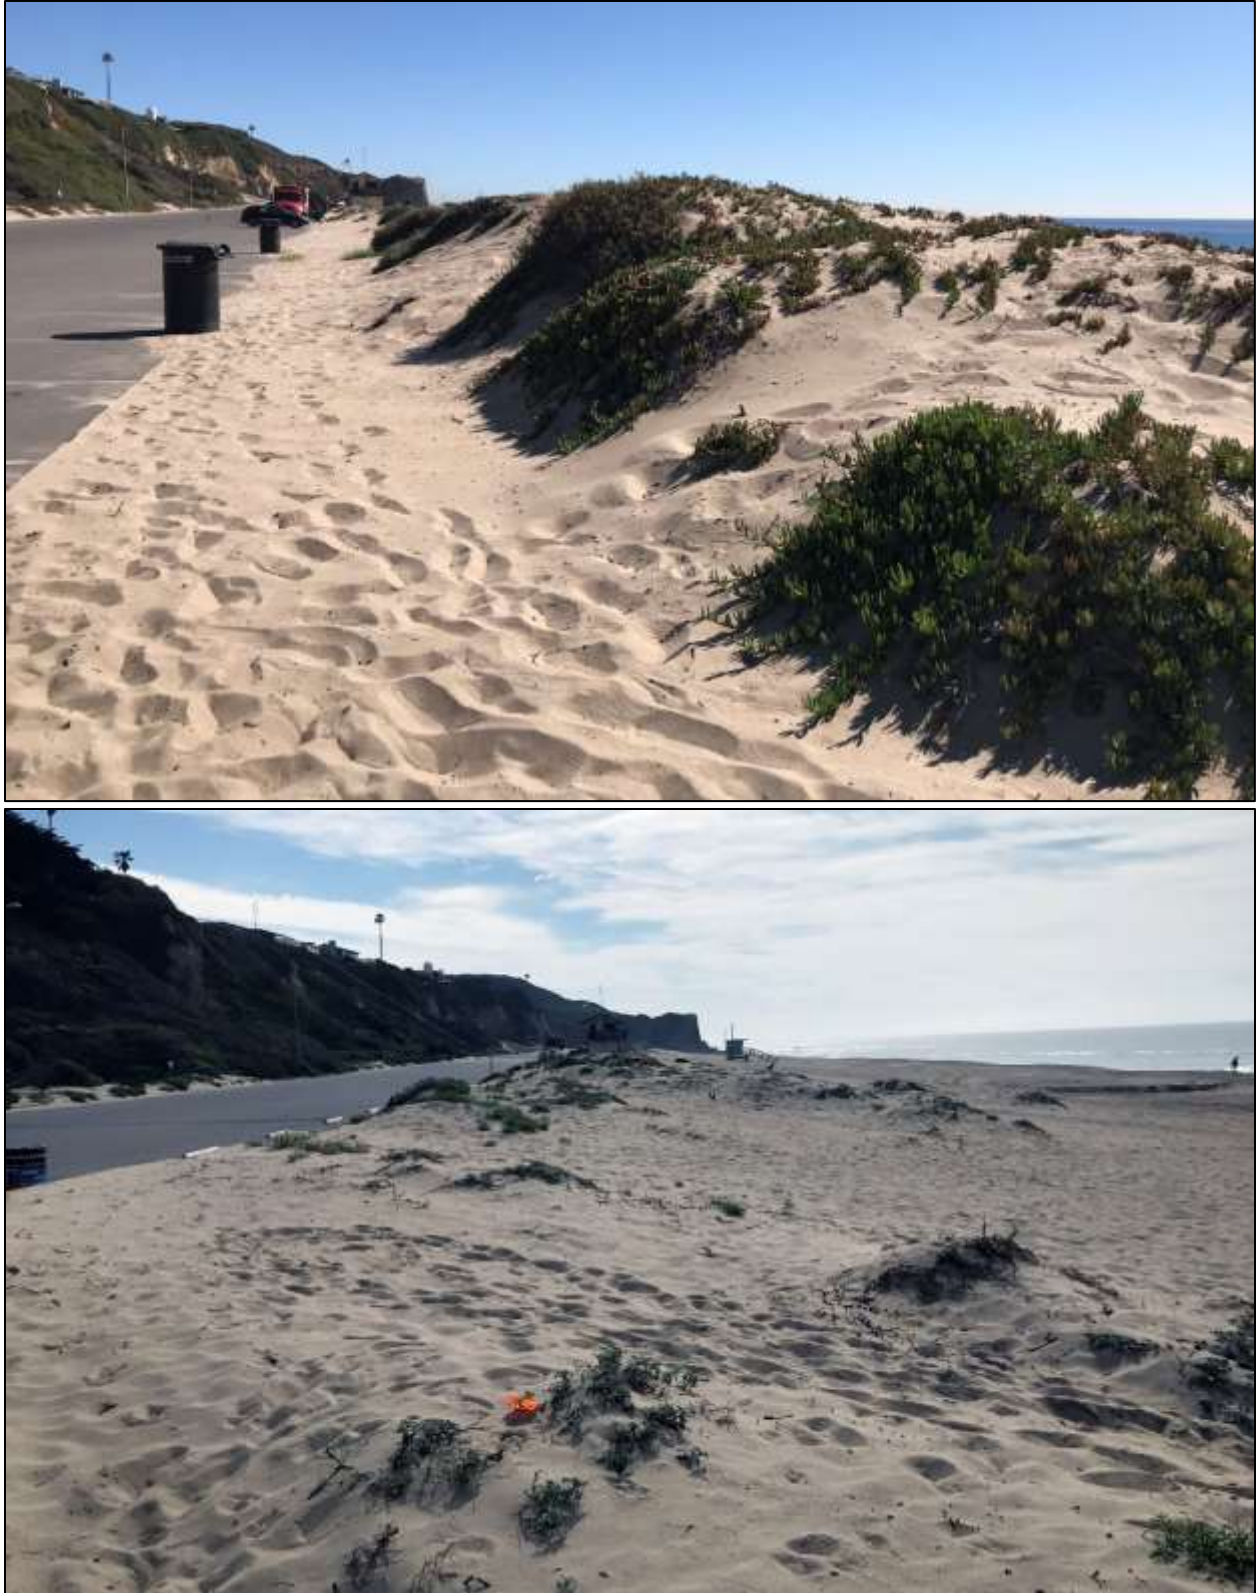
Figure 12. Photographs from Point Dume Beach at representative locations adjacent to a vegetated dune (top) and a blowout area with little vegetation (bottom).

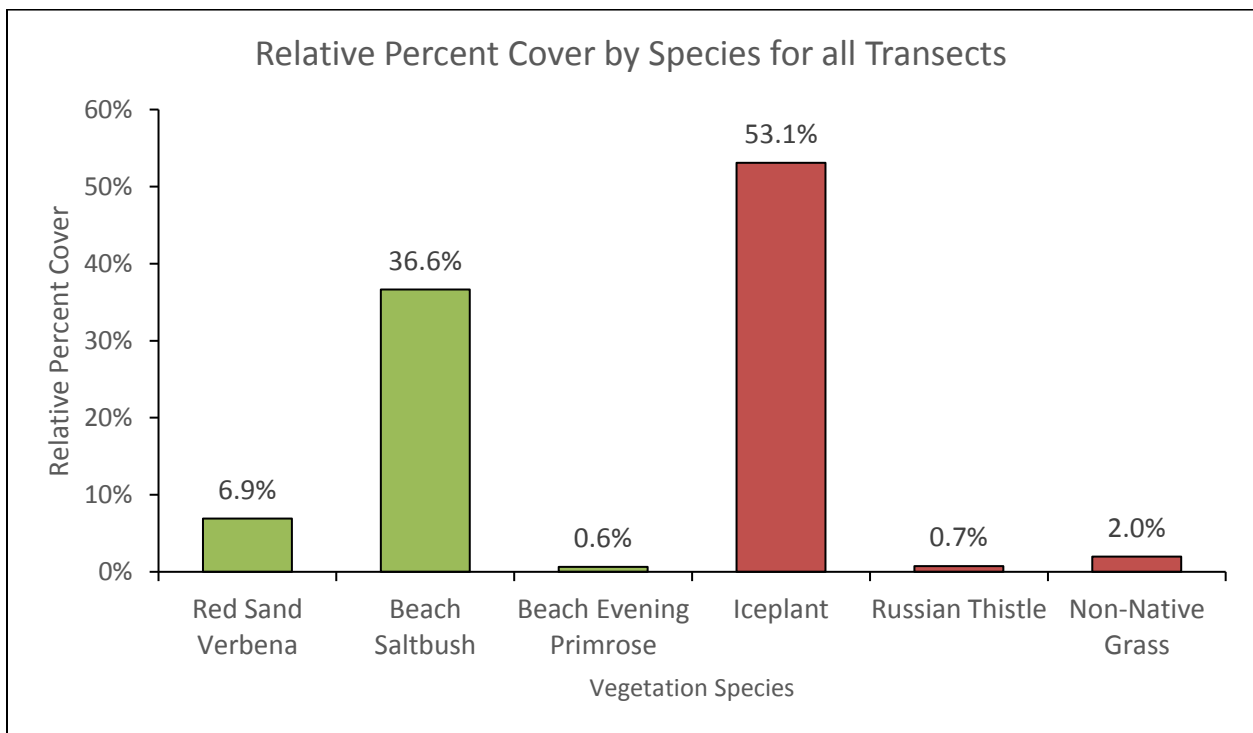
Average absolute cover of native species at Zuma Beach along two transects was found to be 9.2%, with 25.6% average non-native cover. Iceplant was found to be the predominant non-native species, individually contributing to the highest proportion of relative cover (53.1%) (Figure 13). The highest proportions of cover by native species were found to be beach saltbush (36.6%) and red sand verbena (6.9%). Overall, combined for both transects, relative non-native cover was 55.8% and native cover was 44.2%. Figures 14 and 15 are baseline photographs of representative areas within the Zuma Beach portion of the Malibu Living Shoreline Project restoration. Native vegetation (beach bur) can be seen in the foreground of both pictures, with invasive iceplant in the background.

Figure 13. Relative cover by species for all transects at Zuma Beach combined (green indicates native species, red indicates non-native).

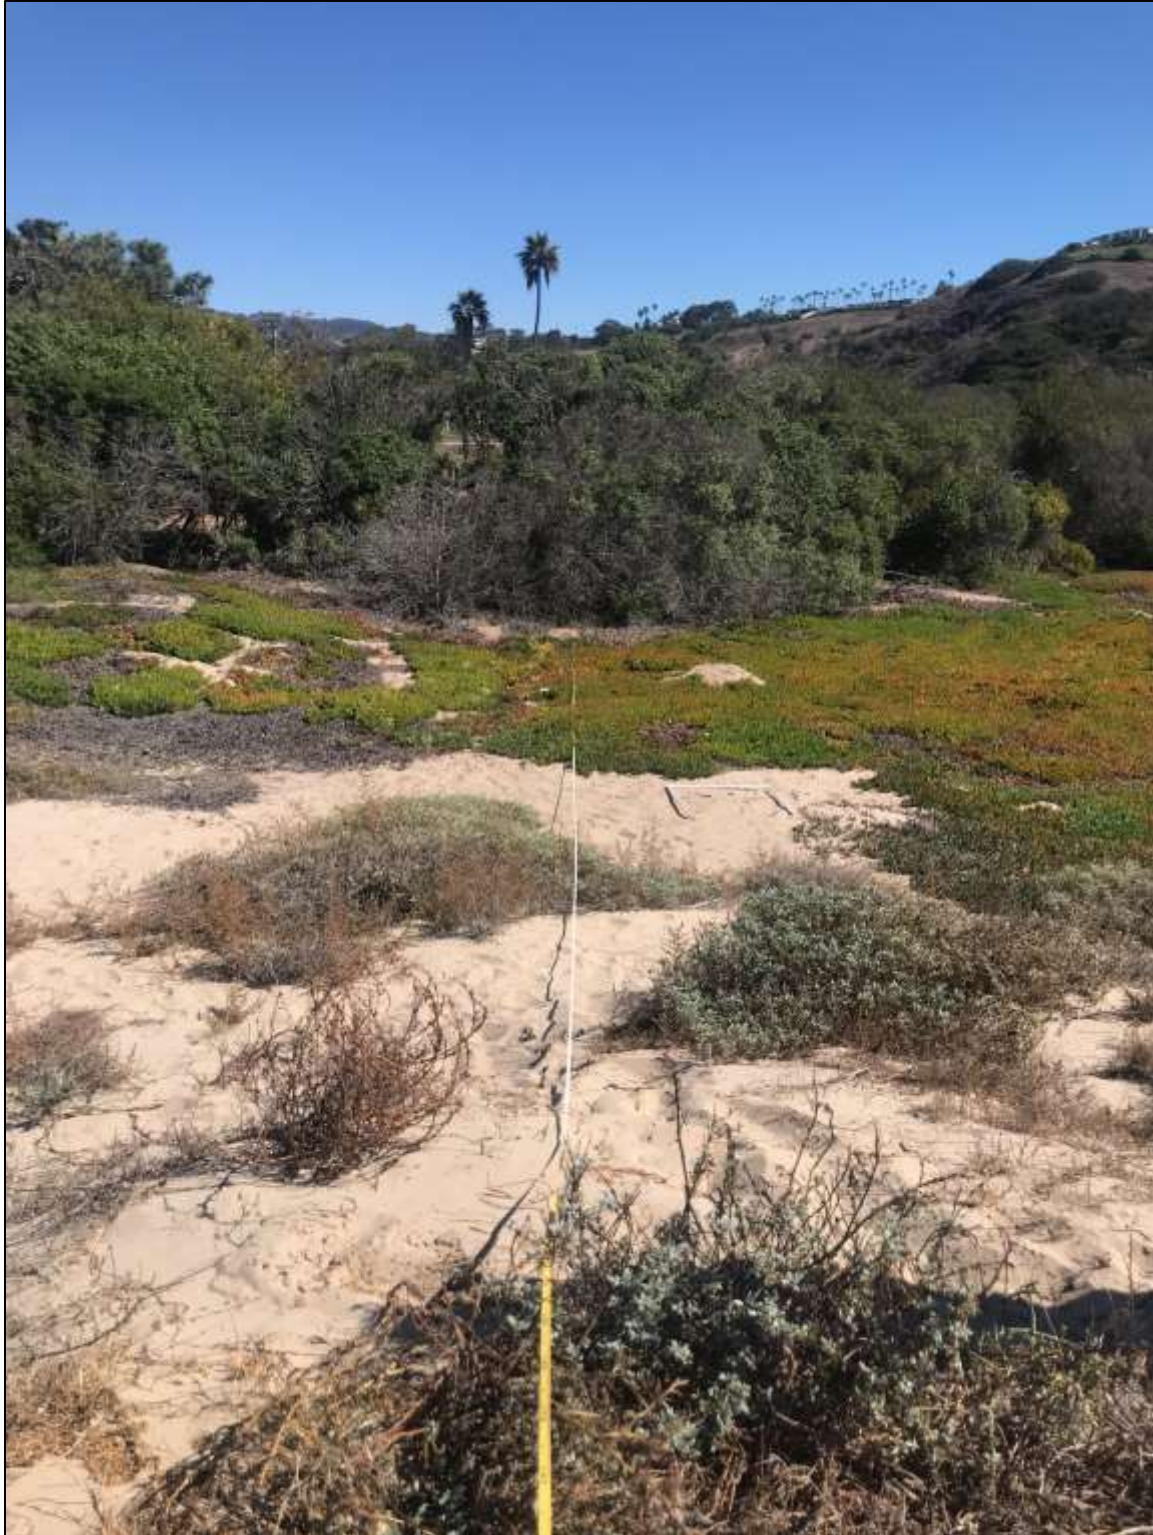
Figure 14. Photograph of one of the Zuma Beach transects showing mixed native and non-native vegetation cover.

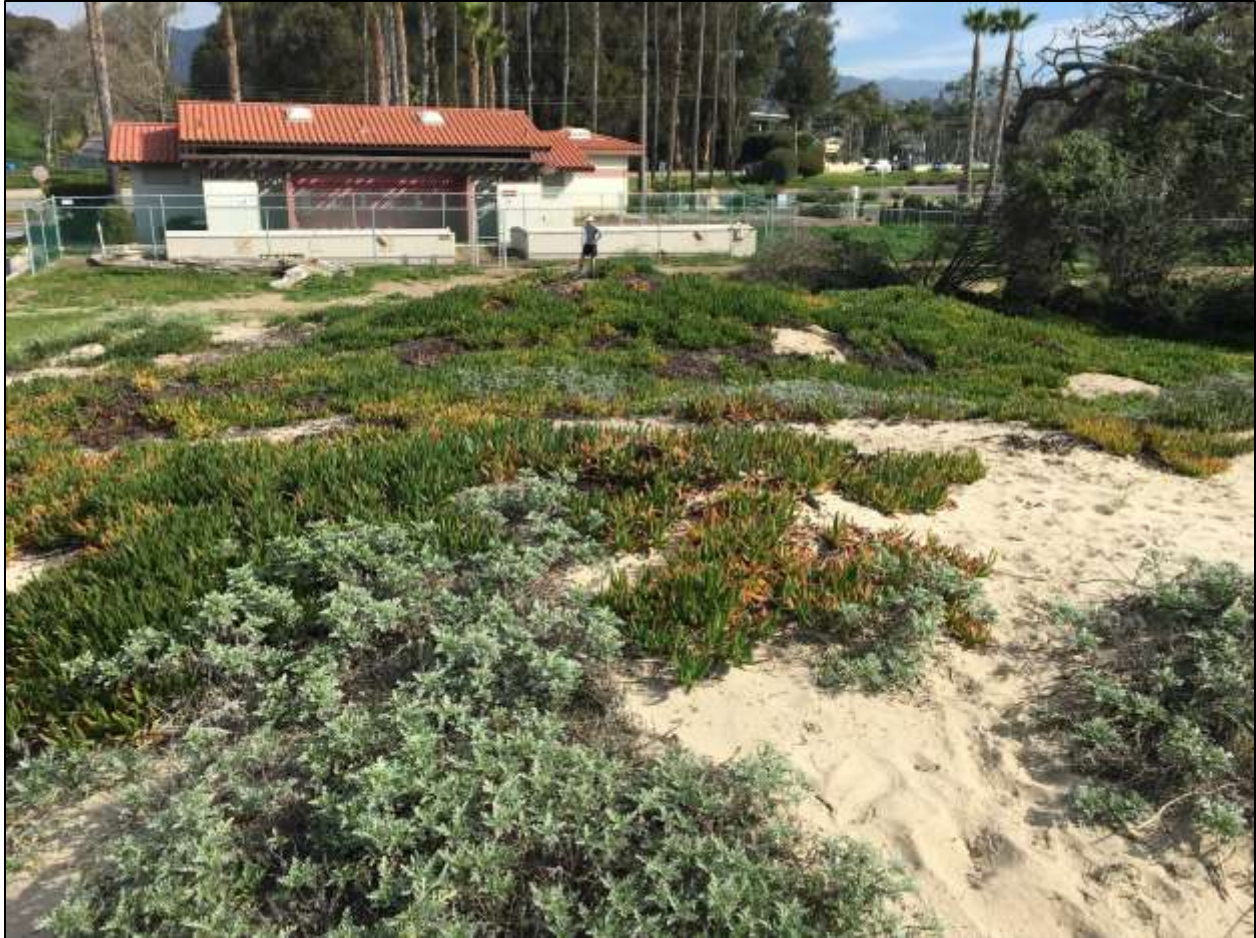
Figure 15. Photograph within the restoration area facing the public restroom facilities at Zuma Beach.

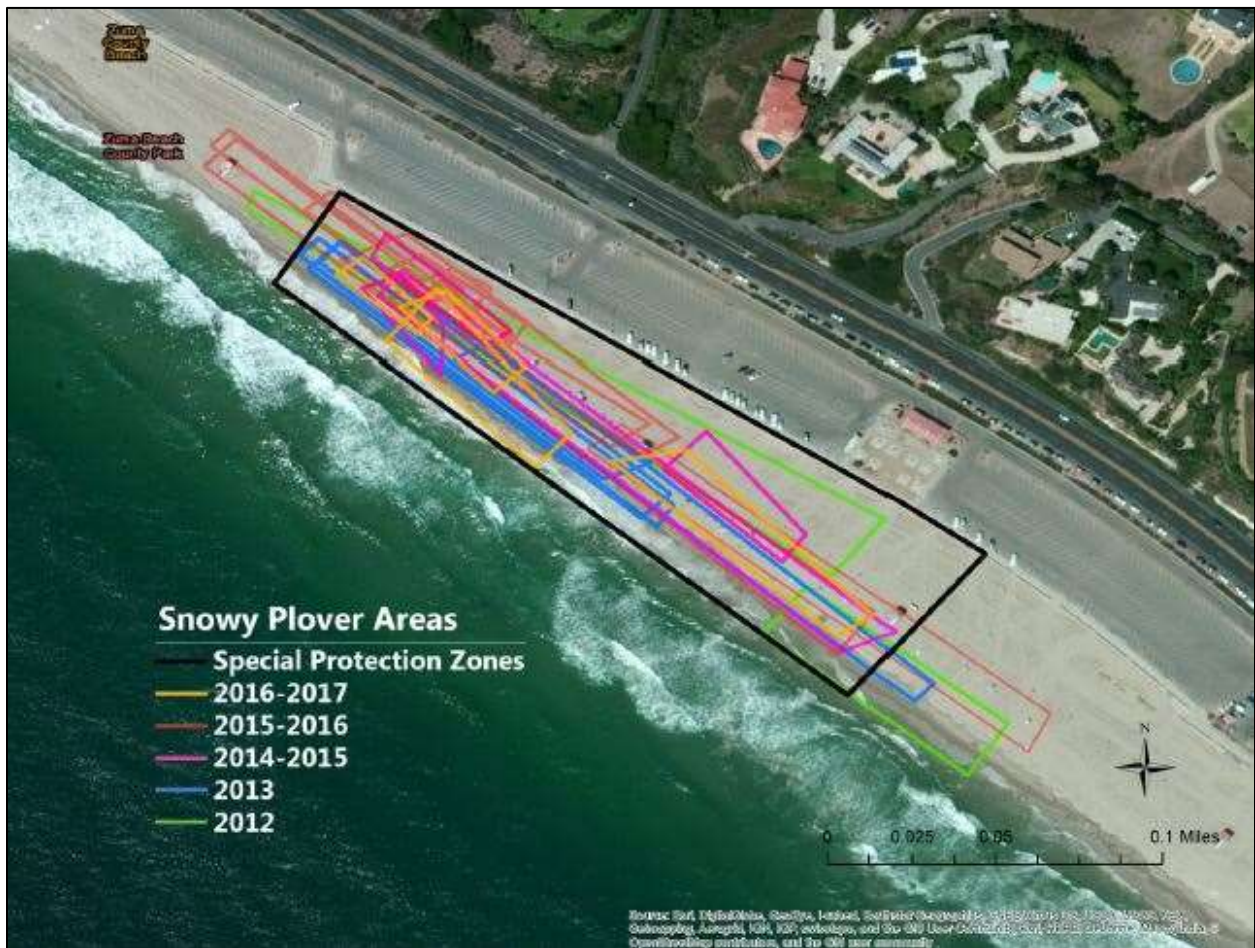
However, the Zuma Beach plover roost site is northwest from the proposed restoration area by approximately 1,300 meters. Figure 17, replicated from Ryan et al. 2017, identifies plover roosting locations from 2012-2017, showing a high site fidelity. Plovers have not been previously identified within the restoration project footprint area (T. Ryan and S. Vigallon, pers. comm, 29 April 2020).

Figure 17. Roosting plover areas at Zuma Beach northwest of the restoration project area.

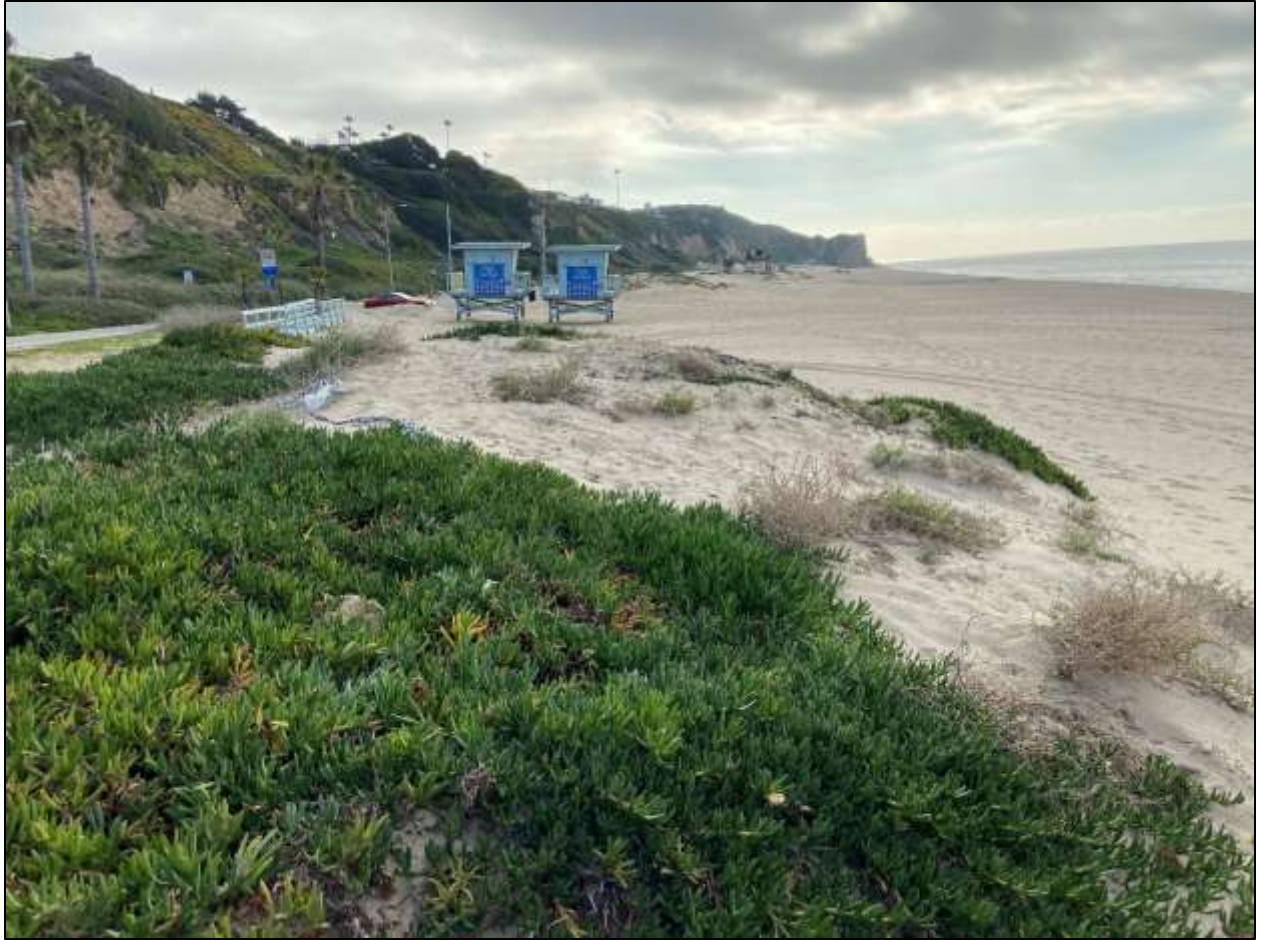
Figure 19. Photograph of Point Dume Beach restoration area taken on 11 January 2020.
