Malibu Living Shoreline Project

Implementation and Monitoring Plan

May 2020

Malibu Living Shoreline Project Implementation and Monitoring Plan

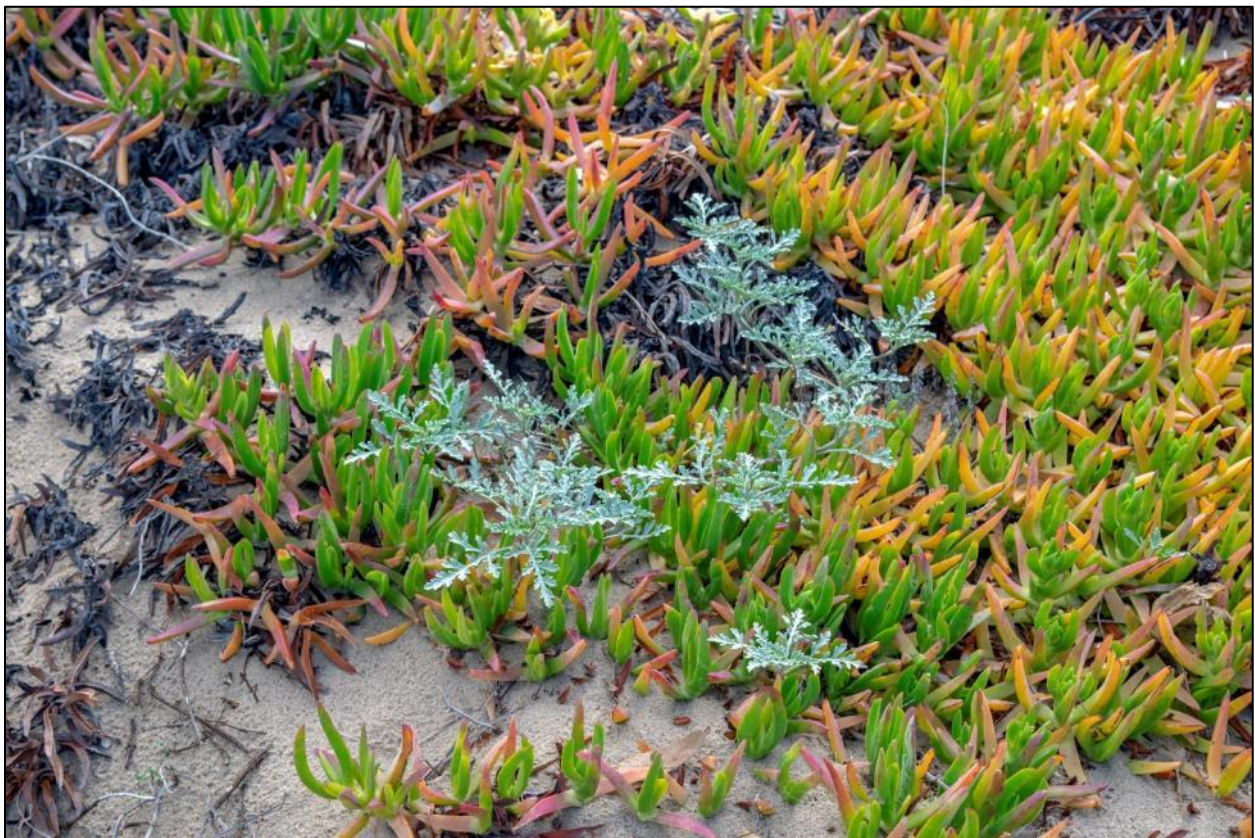
Photograph of non-native iceplant in project area (bright green/orange) with native beach bur in the middle (light blue-green) in the Zuma Beach project area.

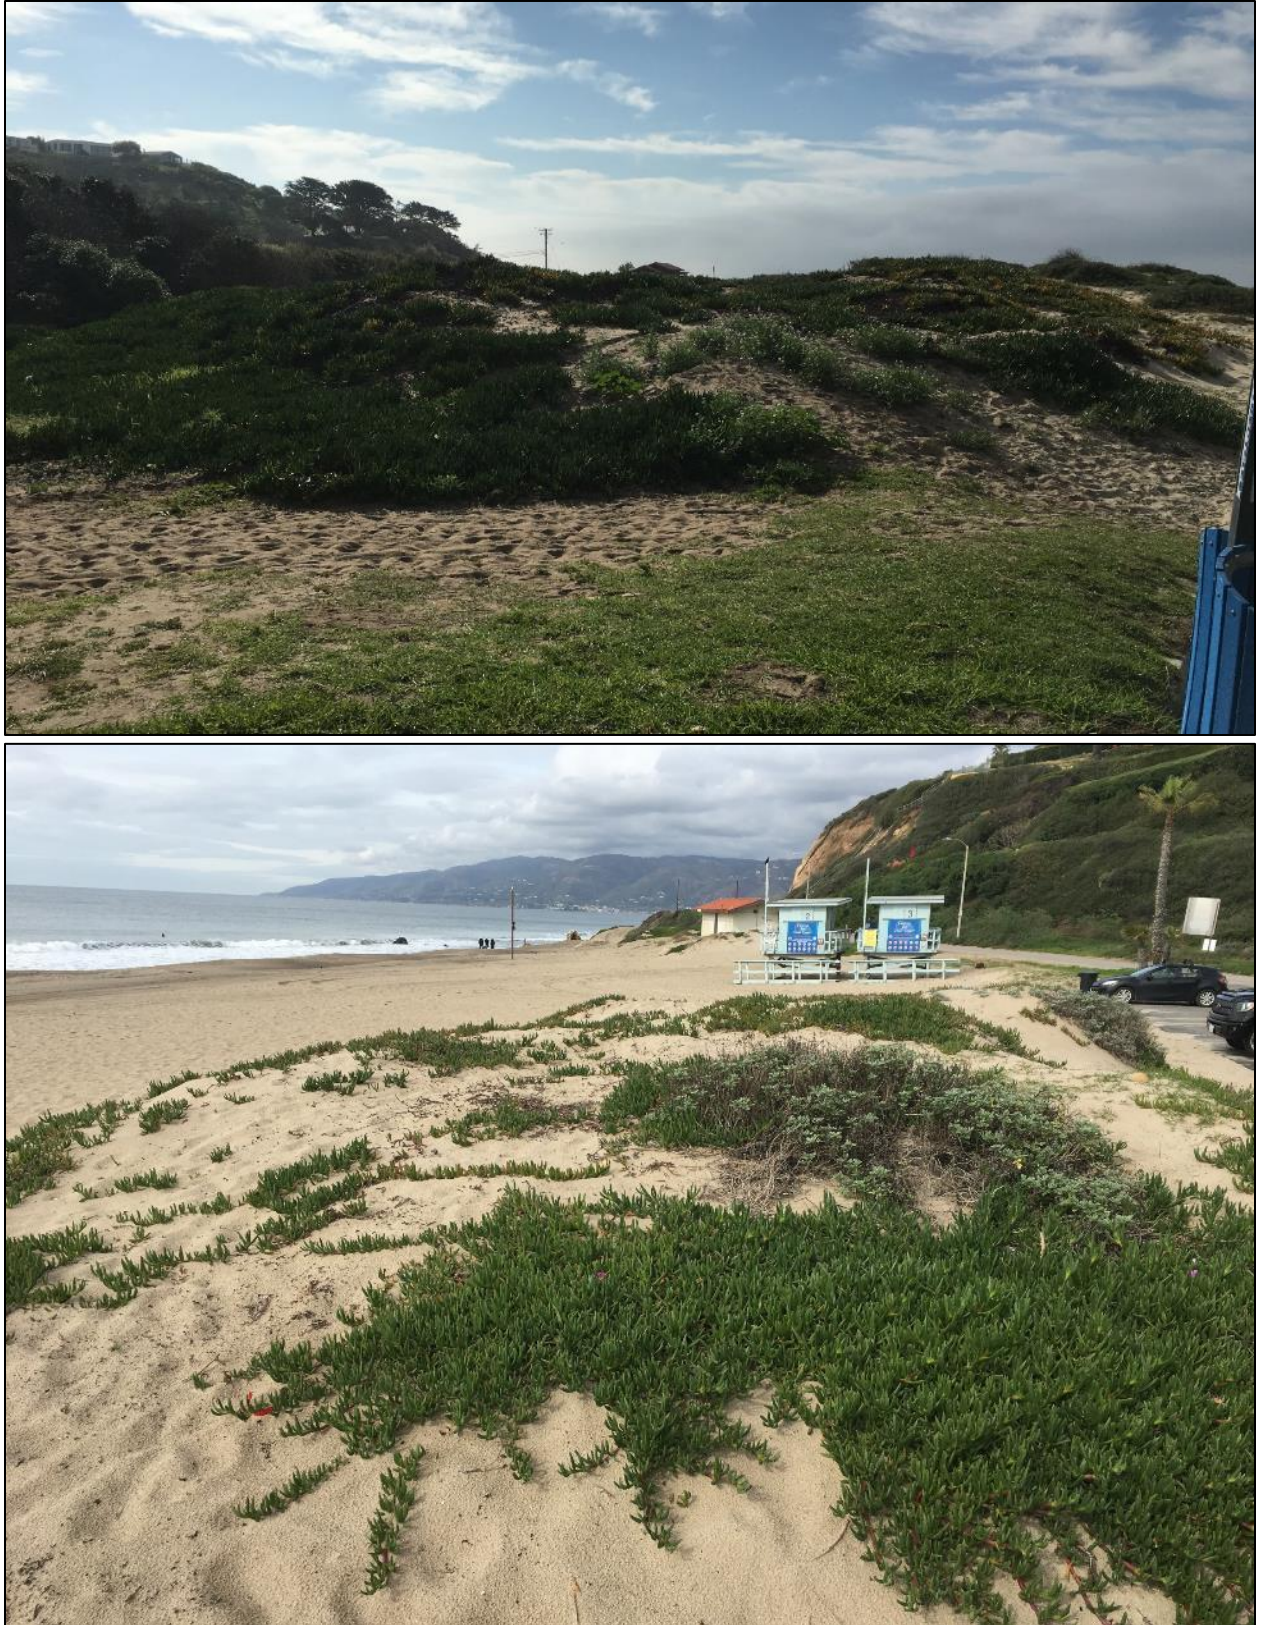
Figure 3. Representative site photographs from Zuma Beach adjacent to the lagoon (above) and Point Dume Beach adjacent to the parking lot (below).

This project aims to enhance the existing dunes by replacing the invasive plants with native dune species as well as enhancing the footprint of ungroomed areas (Figure 3). After seeding and planting vegetation, sandy coastal strand habitats and foredunes would naturally develop, which will then support higher levels of the ecological community (e.g., invertebrates, birds). Scientific literature highlights the need for ecosystem-level, rather than species-level, beach restoration planning to achieve the greatest ecological benefits (e.g., Schlacher et al. 2008). The ecosystem benefits that living shorelines projects provide are not limited to a narrow time period but continue over time as the shoreline establishes, compared to hard shorelines that require maintenance and often result in the loss of beach.

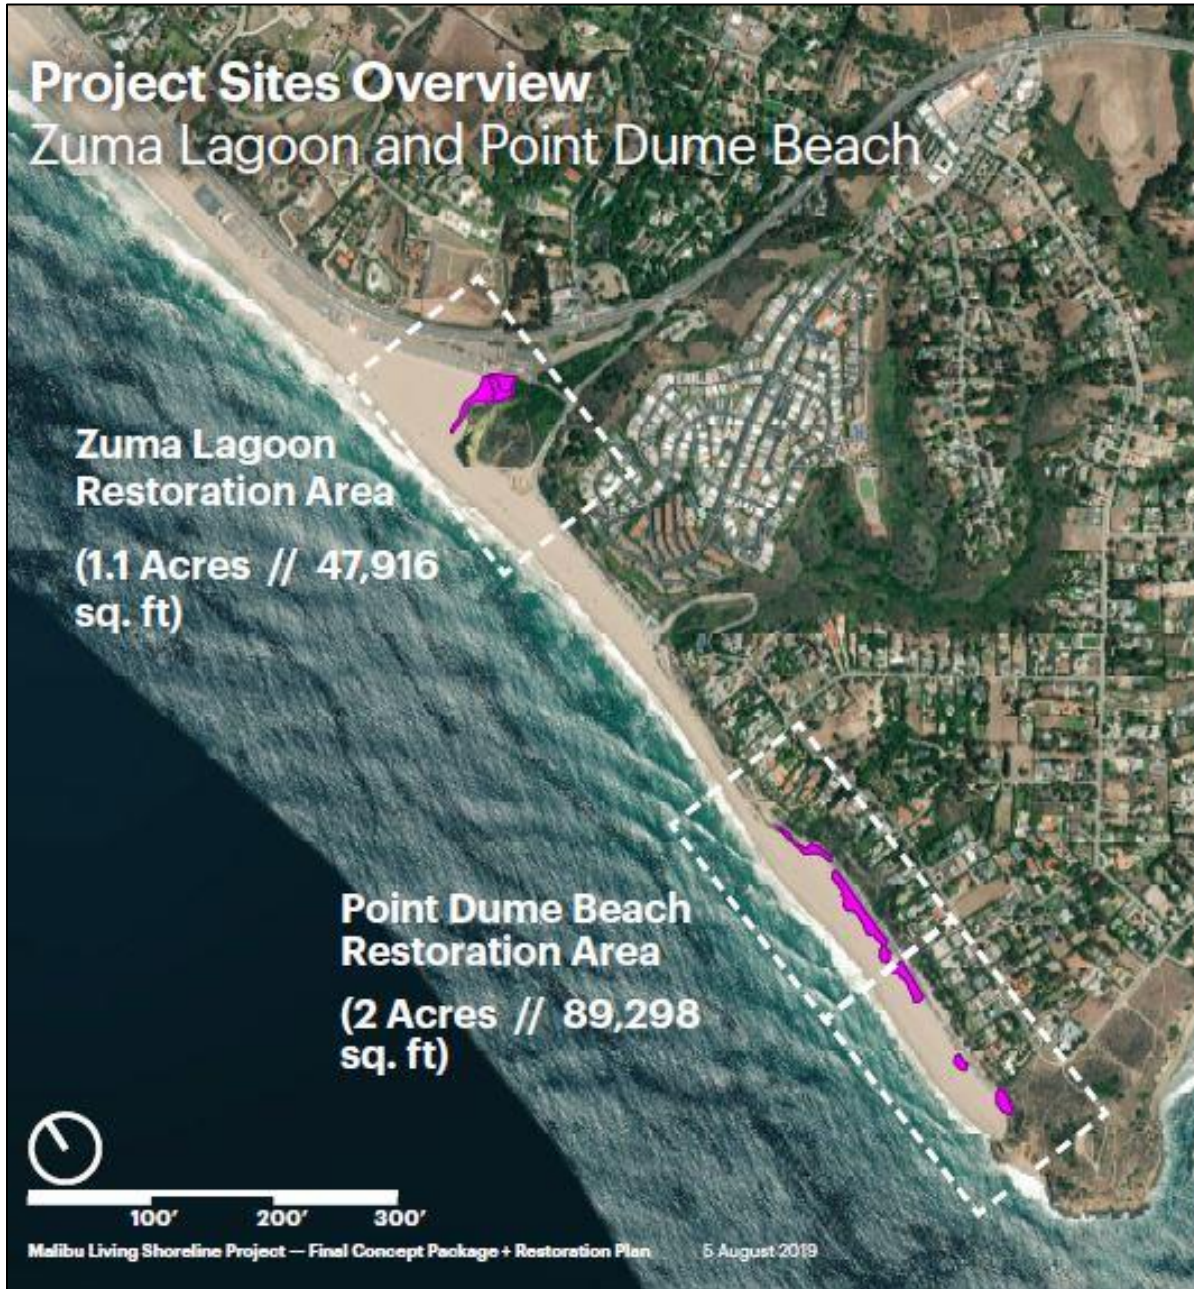
Figure 4. Overview map of both restoration areas as part of the Malibu Living Shoreline Project (Rios and CRC 2019).

Both Zuma Beach and Point Dume Beach reside in the City of Malibu and are managed by the Los Angeles County Department of Beaches and Harbors. Historically, dune systems were a prominent feature of this area; over time with increased development and urbanization, these dune features disappeared. The project site consists of approximately three total acres of sandy beach and foredune restoration. Restoration activities are proposed on just over one acre at the Zuma Beach site, adjacent to Zuma Lagoon, and approximately two acres at the Point Dume Beach site (Figure 4).

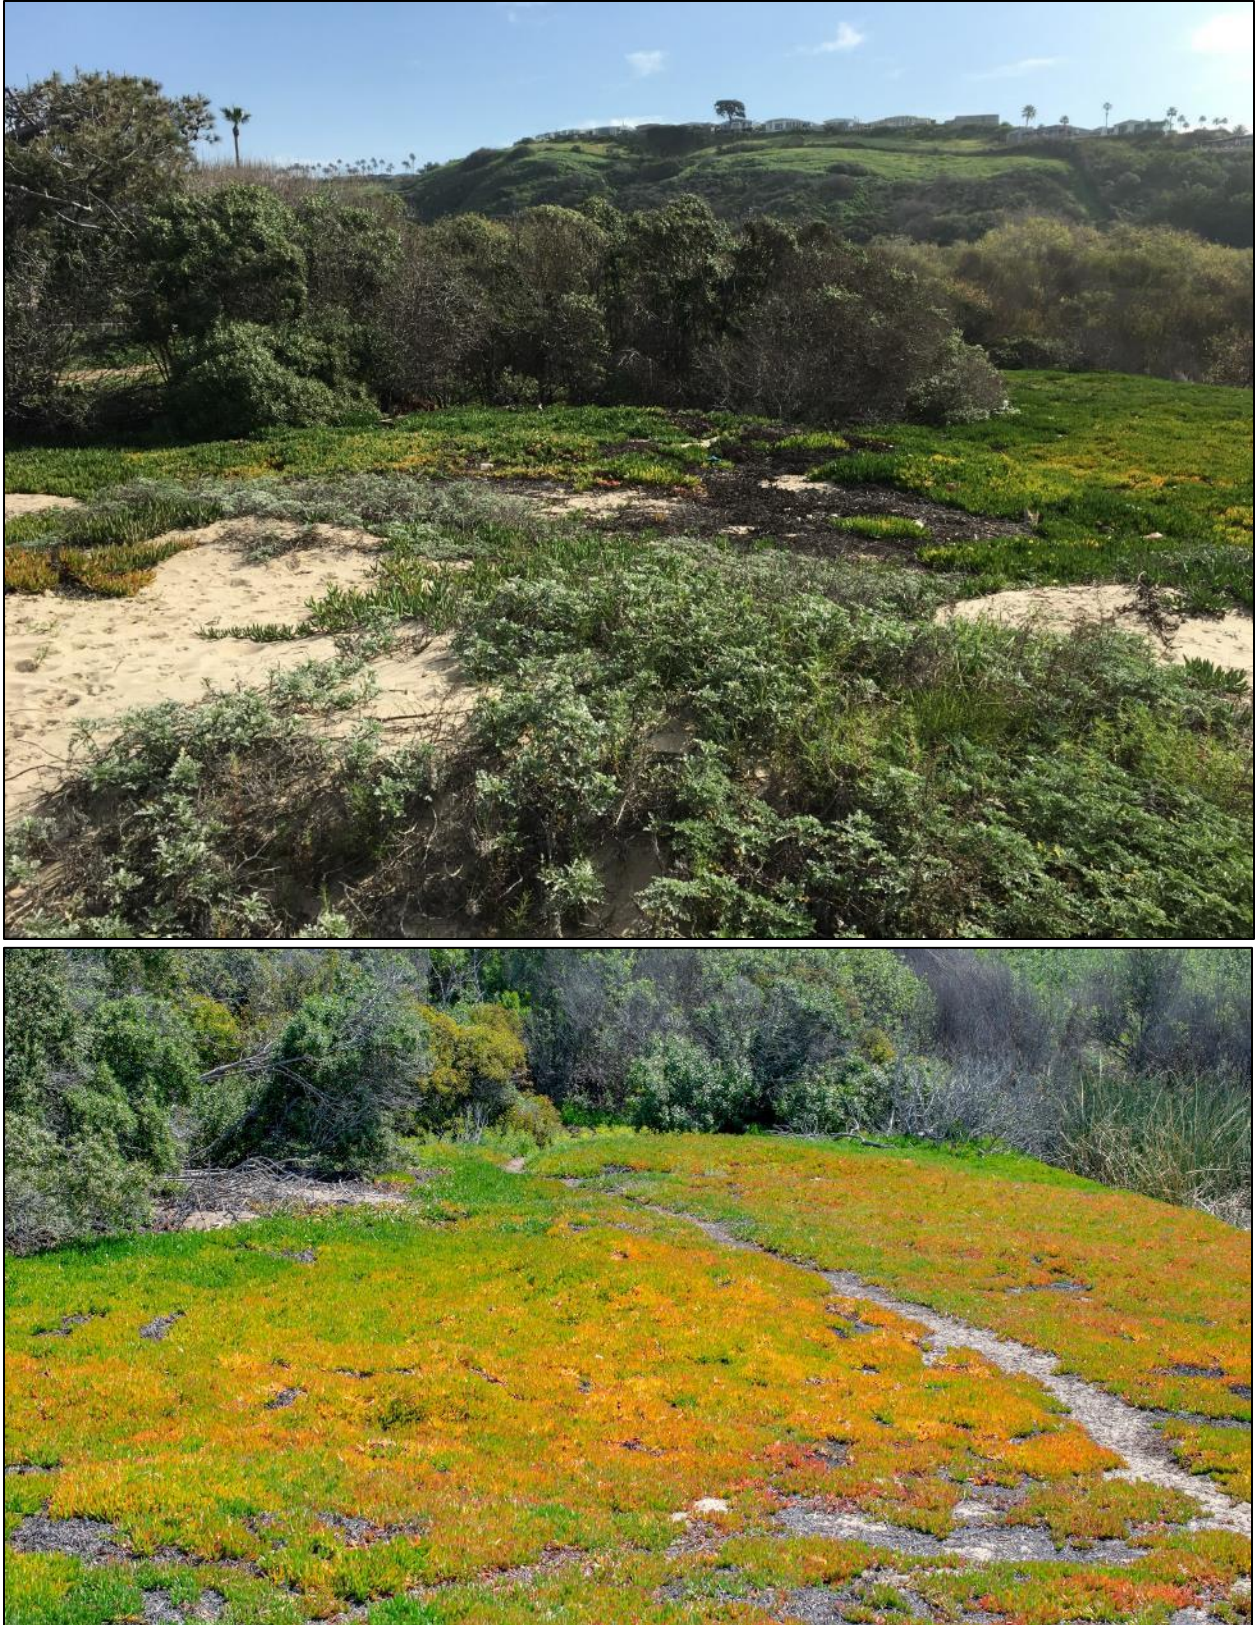
Figure 5b. Representative photographs from Zuma Beach and transition habitats.

Major habitats in the restoration area for Zuma Beach include upland transition, back dune, southern foredune, and mechanically groomed beach (Figure 5a). Back dunes and upland transition habitats on site occur on sandy soils that are sufficiently stabilized (i.e., little or no blowing sand) due to their position in the lee of foredunes. The lack of sand movement leads to a buildup of nutrients and inclusion of some fine sediments (i.e., silt, clay, or organic components) in the soil. This soil structure allows for the potential to restore a wide range of native forbs and shrub species not found in foredunes or coastal strand areas. In Figure 5b, the top photograph foreground is a mix of native and non-native species in a more stabilized dune area, with iceplant in the background. The bottom photograph is closer to the transition habitat area and is dominated by iceplant.

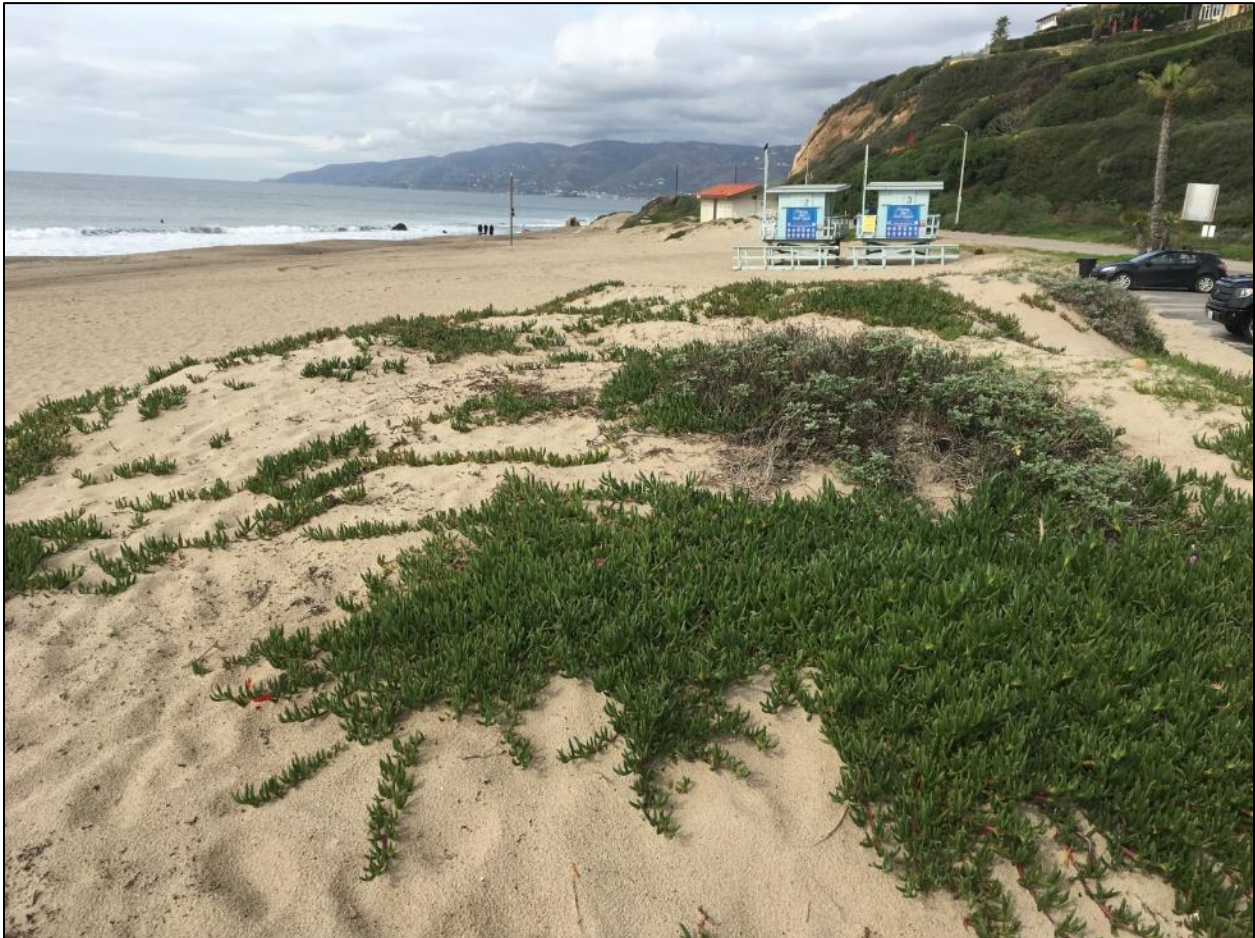
Figure 6a. Representative photograph of patchy dune system at Point Dume Beach adjacent to a parking lot with two lifeguard towers in the background.

The project area at Point Dume is comprised of small, sporadic and patchy dunes lining the edge of the beach and buffering the parking lot (Figures 6a-d). The site historically supported foredune, dune, and back dune habitats in front of the bluffs. Almost no native coastal strand or foredune vegetation species can be found here, with several exceptions of small intermixed native plant patches, and those areas that are vegetated are covered with non-native, invasive species such as iceplant and sea rocket (Cal-IPC 2020). The condition of this dune habitat is poor and restoration activities would increase ecosystem values, critical habitat, and the ability of these areas to build healthy and stable dune ecosystems to protect against sea level rise. Additionally, the dunes would serve to protect existing beach infrastructure such as parking lots, restrooms, and lifeguard facilities. There is sufficient sand supply and natural wind and wave conditions to restore natural processes that support dunes (Rios and CRC 2019). Both sites border the 16-square mile Point Dume State Marine Protected Area, and US Fish and Wildlife Service has also designated this area as critical habitat for the federally threatened western snowy plover.

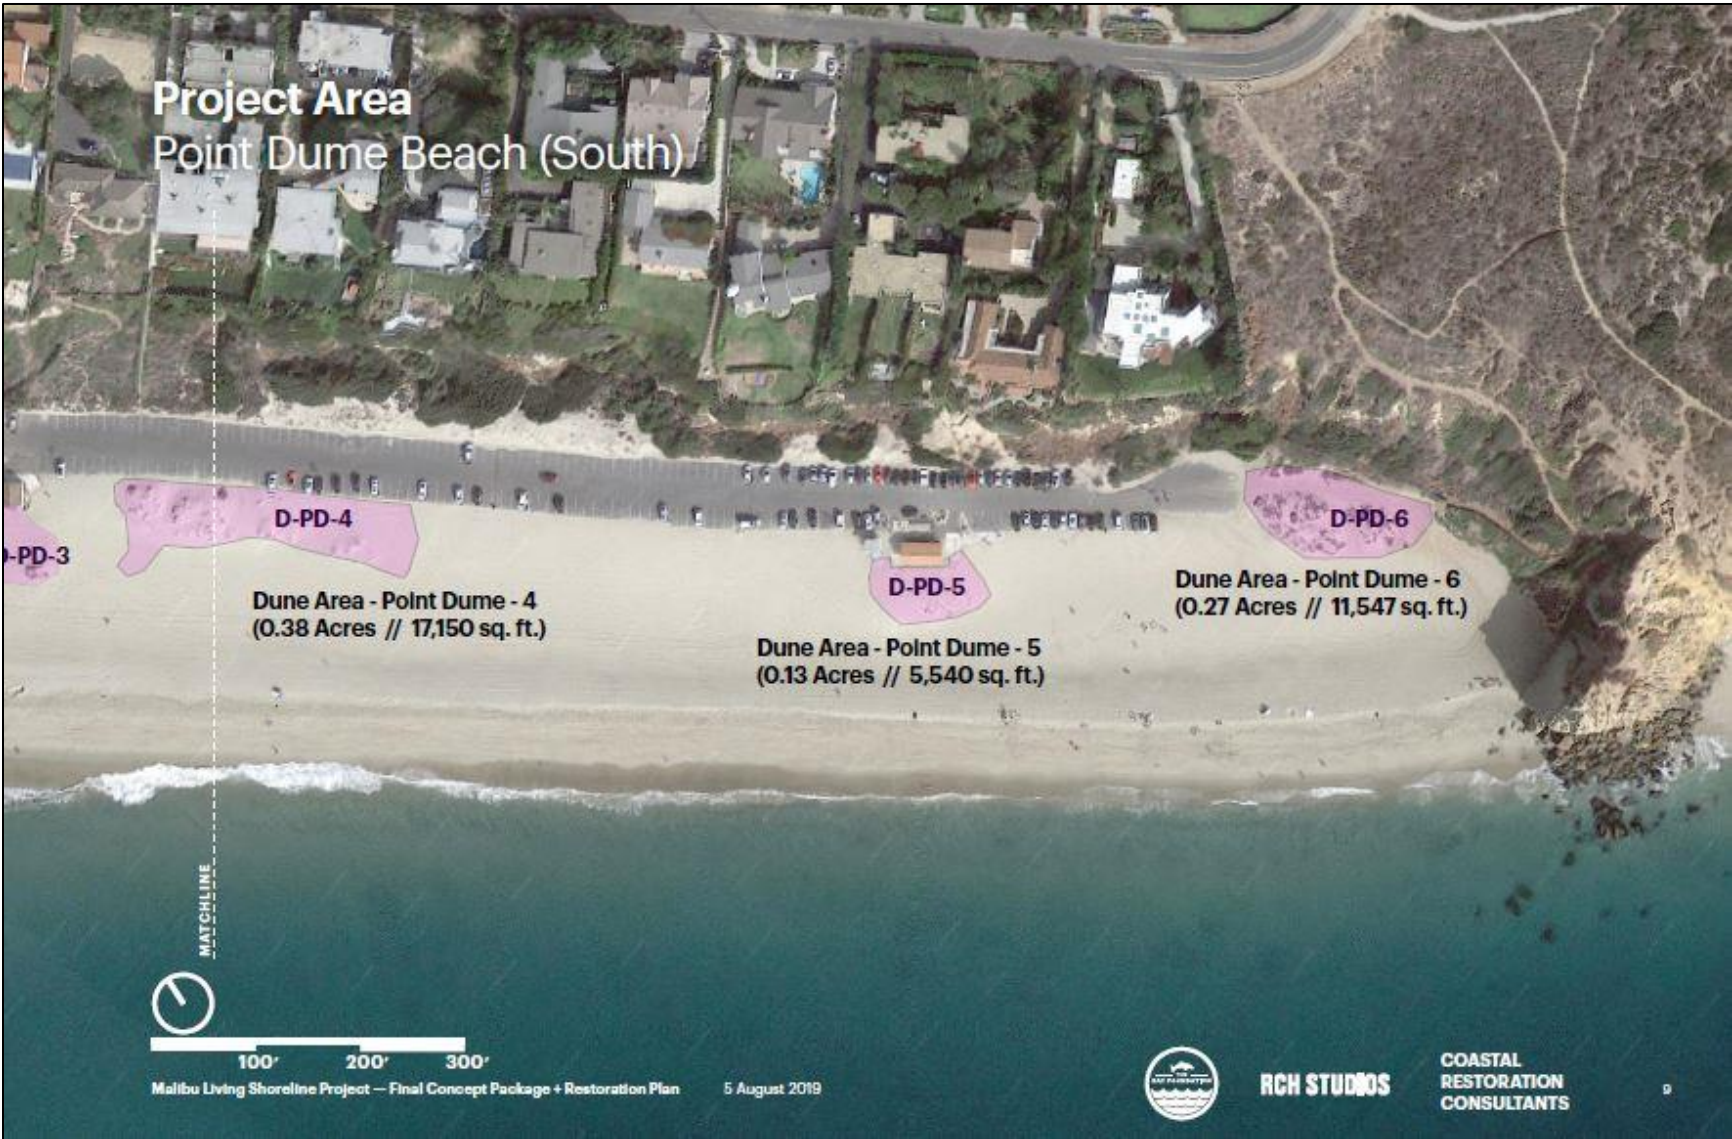
Figure 6c. Map of existing dune patches at within the project area at Point Dume Beach in Malibu, CA (southern half).

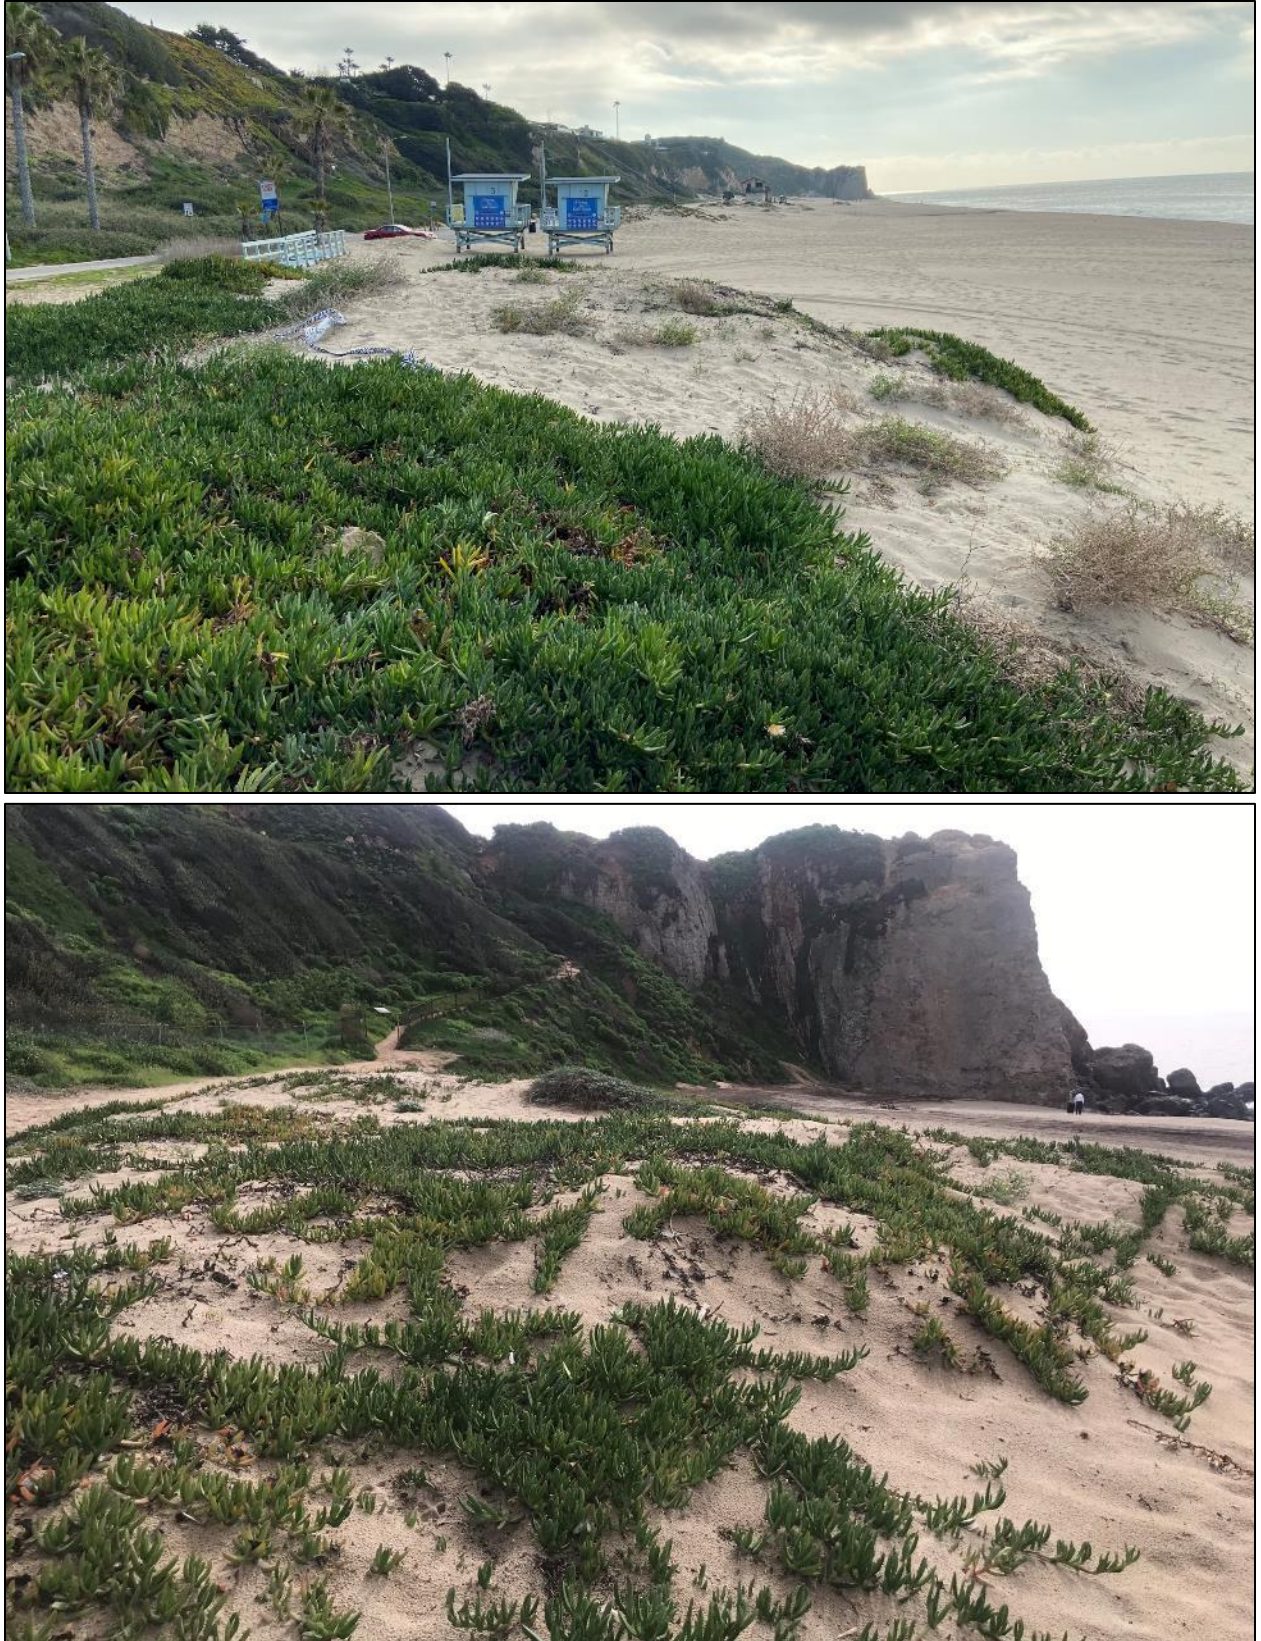
Figure 6d. Representative photographs from Point Dume Beach (north, top; south, bottom).

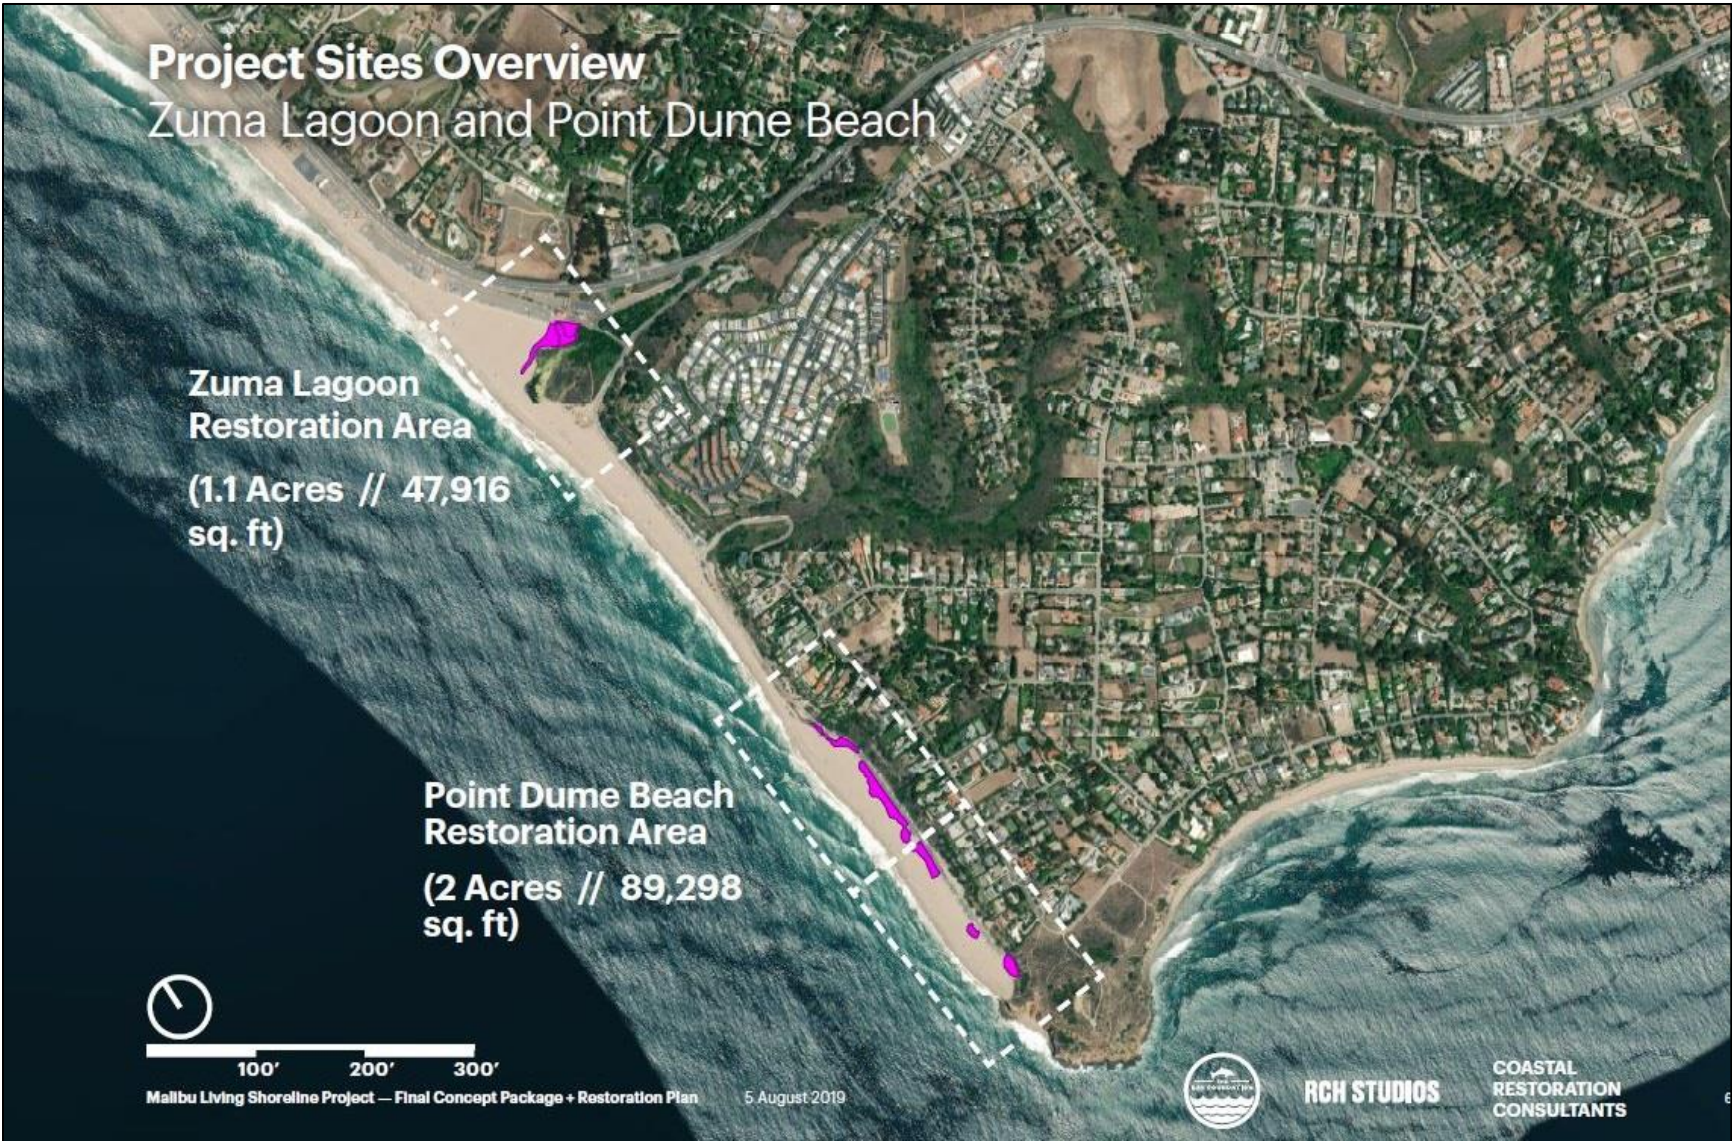
Figure 7. Overview map of the project sites adjacent to Zuma Lagoon and at Point Dume Beach in Malibu, CA.

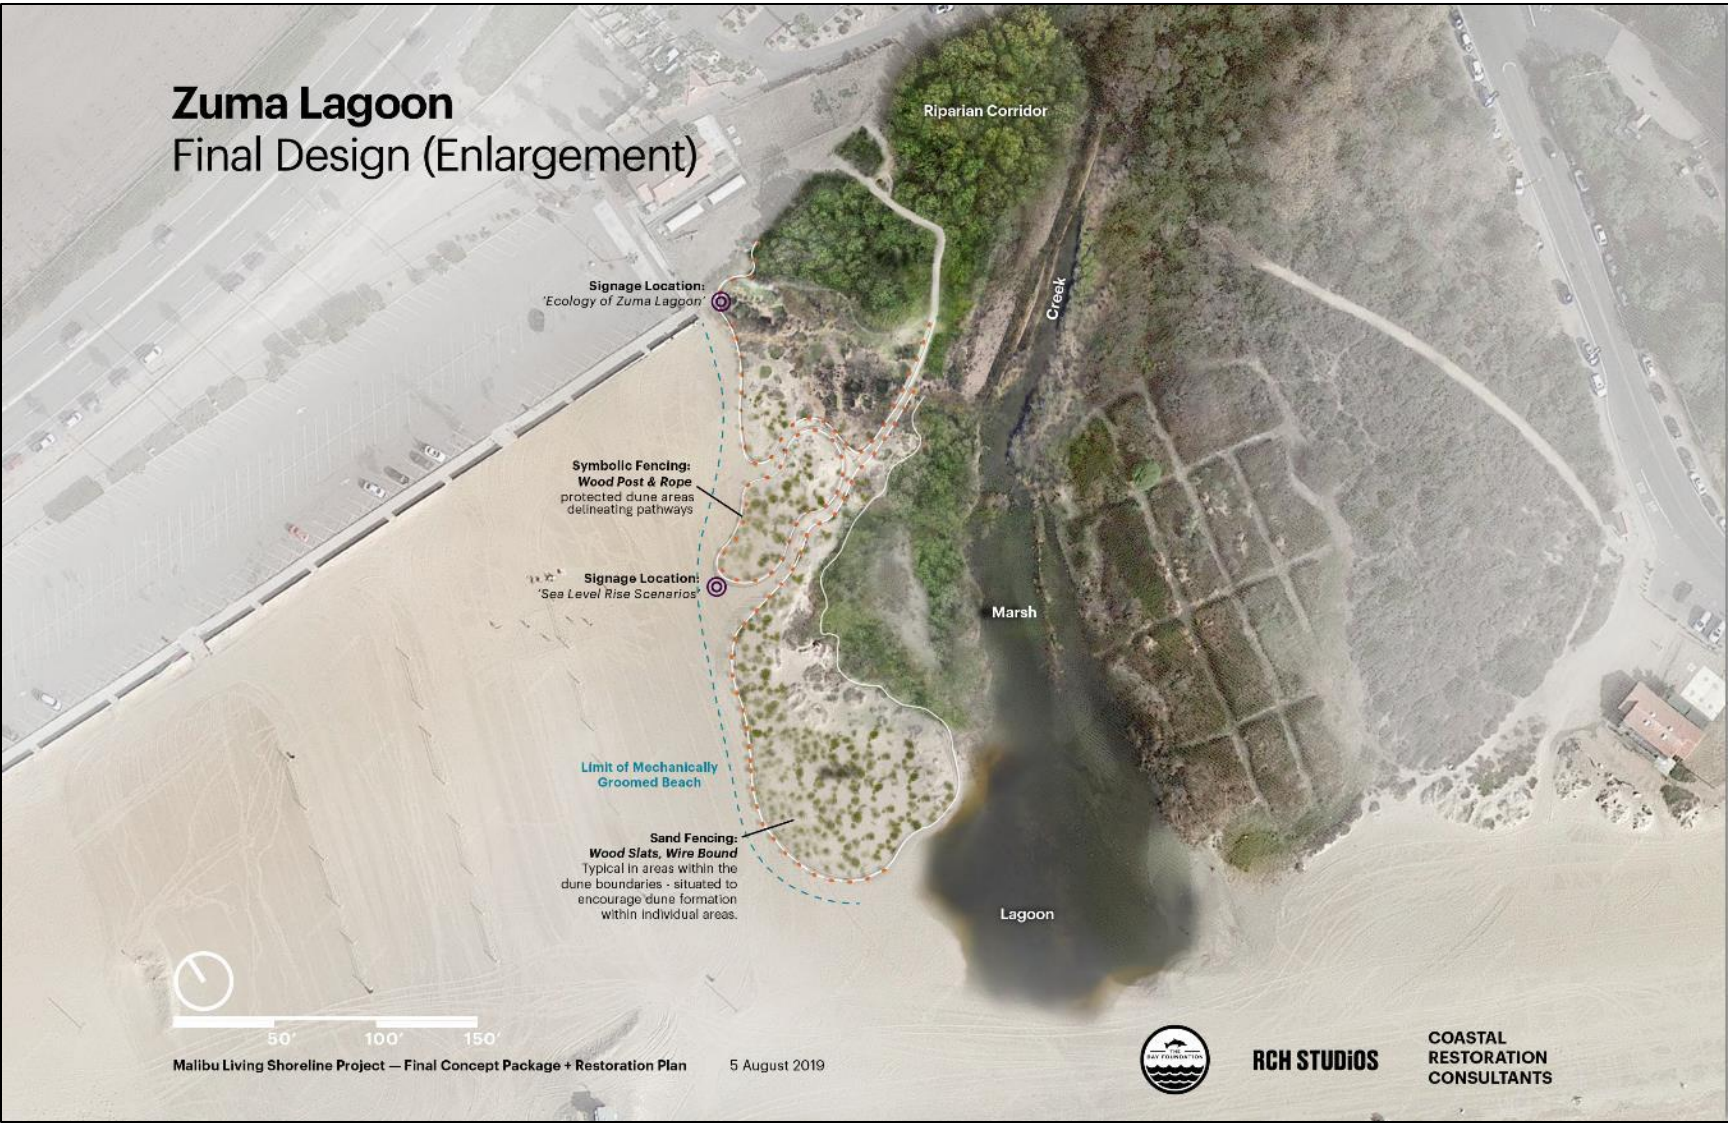
Figure 8. Map of the final site design for the one-acre footprint adjacent to Zuma Lagoon.

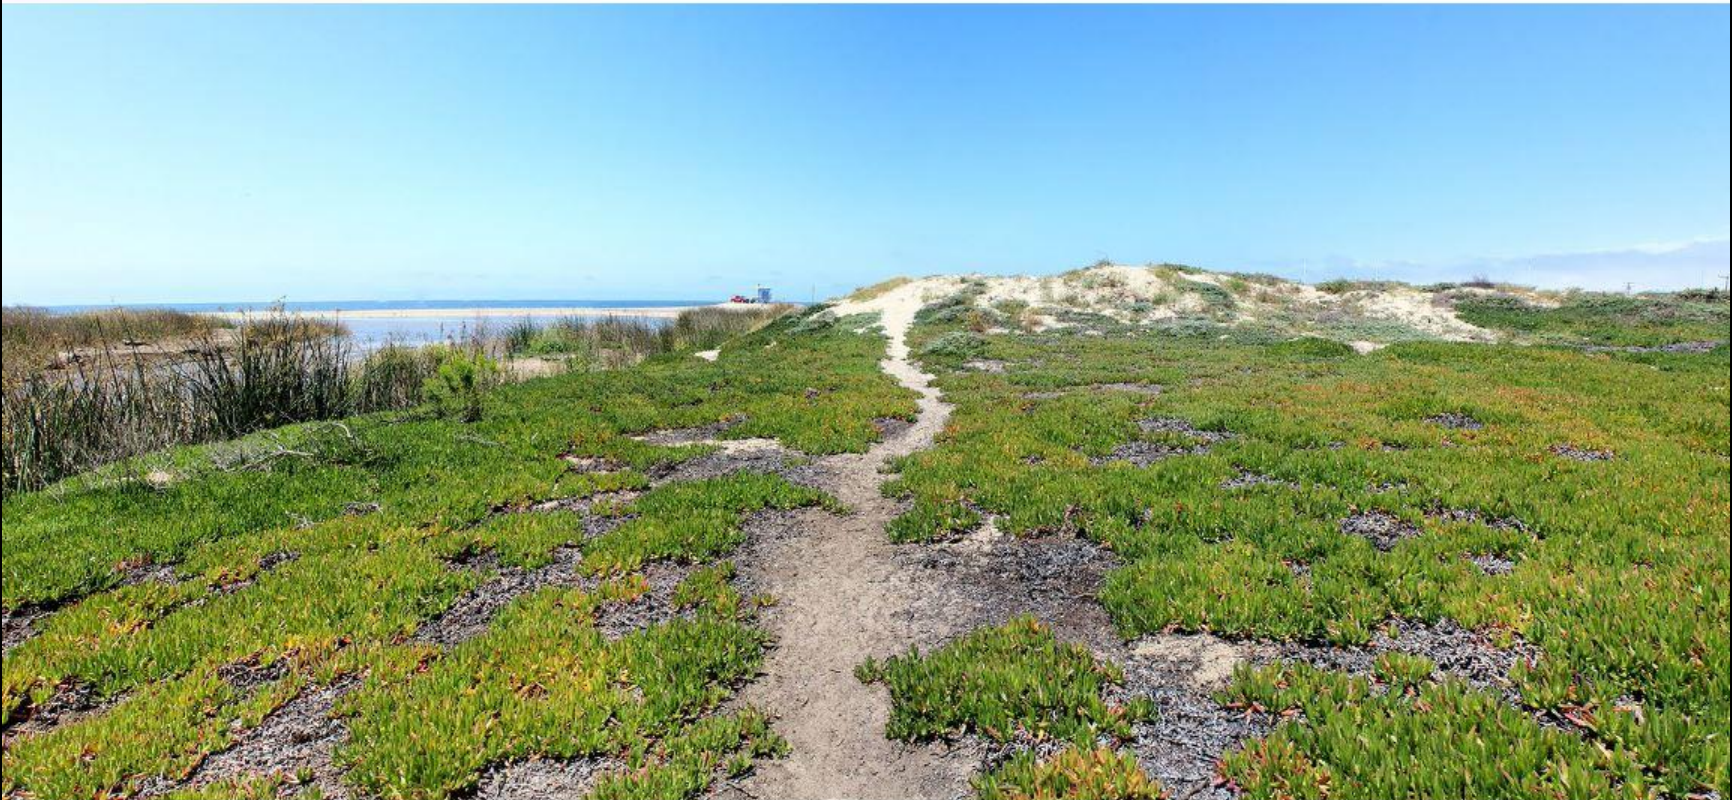
Zuma Lagoon Existing View

Figure 9a. Photograph of existing view of Zuma Lagoon taken in ecotone E-Z-1 (see map above) and dominated by iceplant.

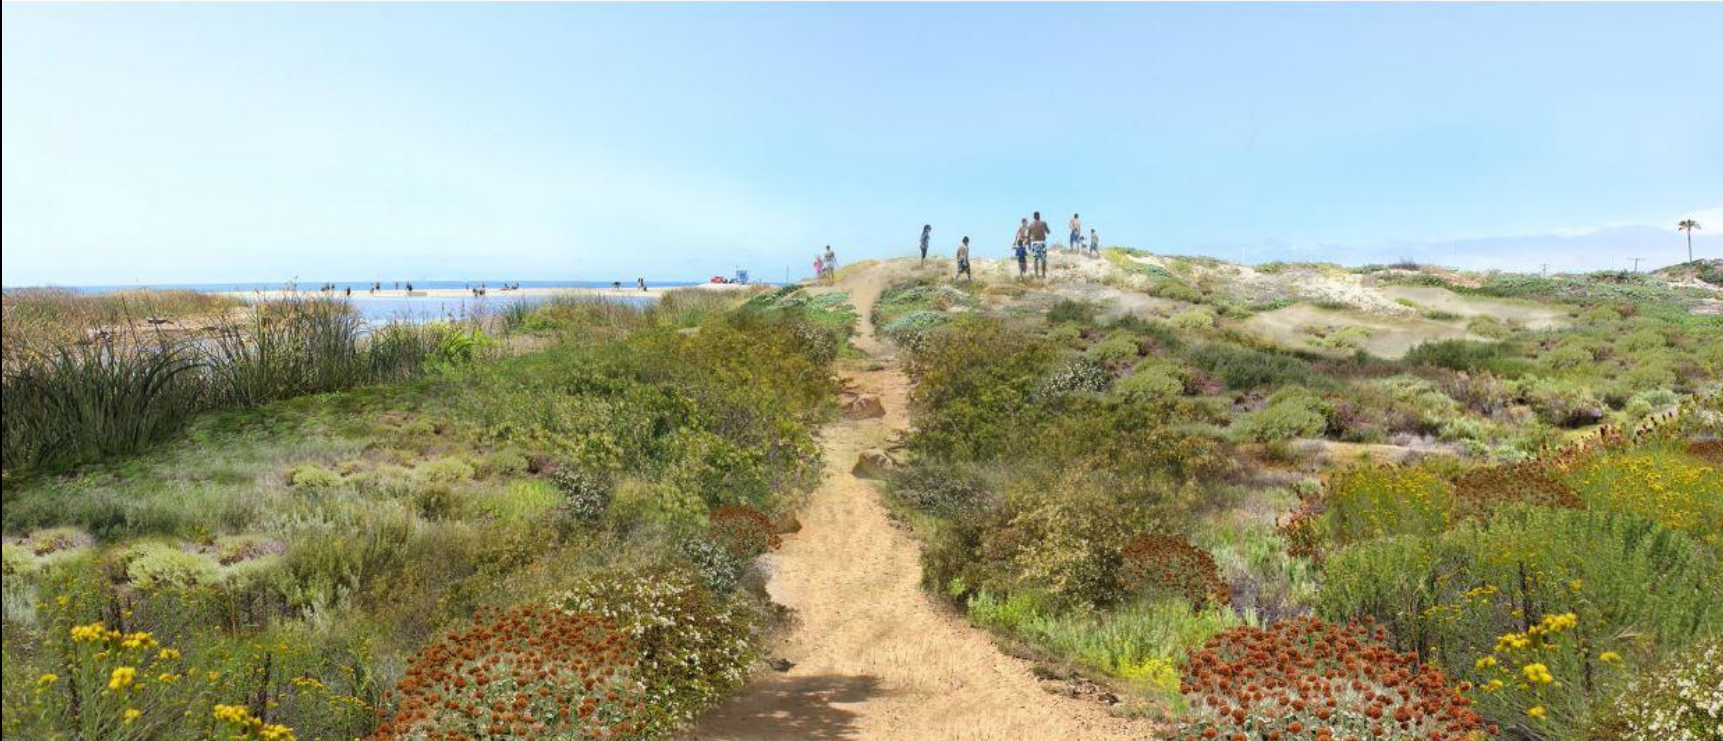
Zuma Lagoon Proposed View

Figure 9b. Artistic rendering of ecotone E-Z-1 in post-restoration conditions adjacent to Zuma Lagoon approximately five years after restoration.

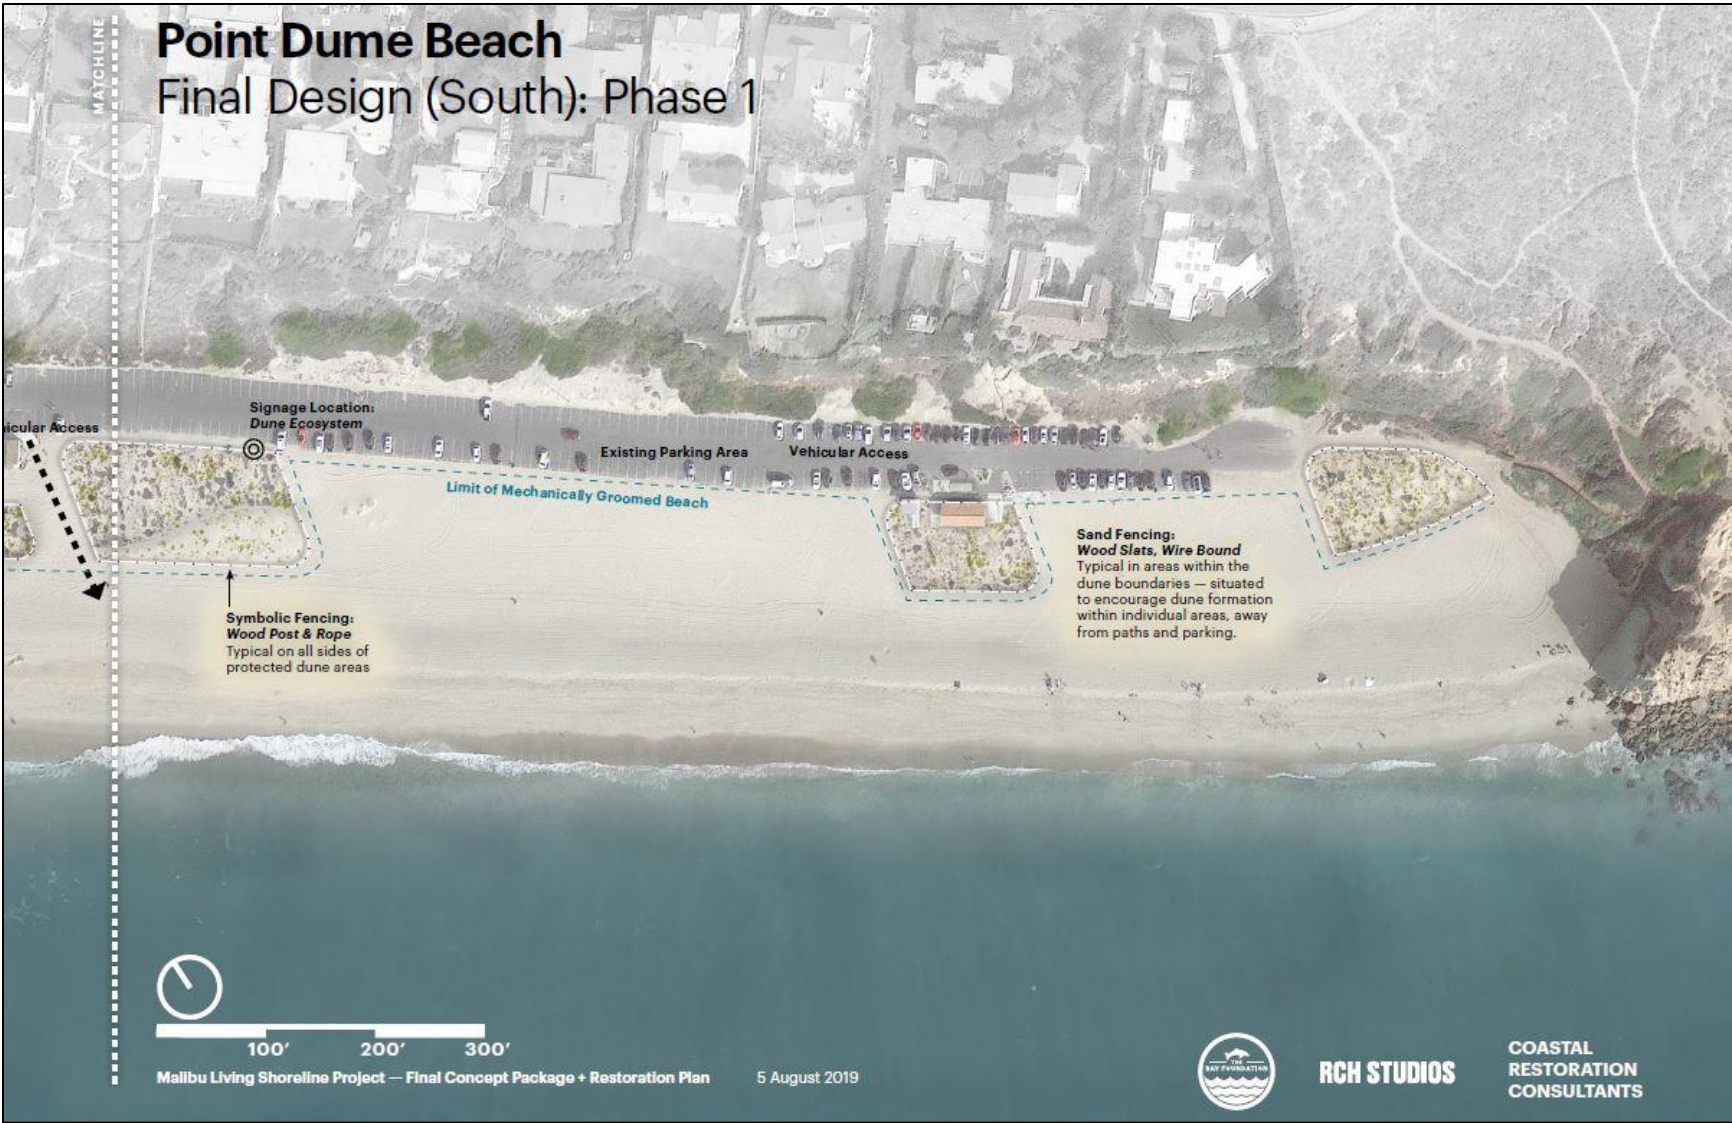
Figure 10b. Map of the final site design for the Point Dume Beach restoration area (south half, Phase 1).

Proposed restoration activities at Point Dume County Beach will restore approximately two acres of sandy beach and foredune habitat and will include non-native invasive species removal, seeding with native coastal dune species, several strategically placed segments of slatted sand fencing and “biomimicry wooden stakes” to optimize sand capture, and strategic placement of short symbolic pathways leading from the parking lot to the front beach area (Figures 10a and 10b). Interpretive signage will be a component of restoration activities and included at both the Zuma and Point Dume project sites. Figure 11a is a photograph of the existing view of Point Dume Beach from the bluff, and Figure 11b is an artistic rendering of the potential future of the site post-restoration. Figure 12 is a graphic representation of an existing and proposed dune section at Point Dume Beach. Note the target dune crest shifting oceanward of the parking lot over time to facilitate sand retention. Appendix A contains graphics for the four proposed interpretive signs (two for each site).
