Malibu Living Shoreline Project

Implementation and Monitoring Plan

May 2020

Malibu Living Shoreline Project Implementation and Monitoring Plan

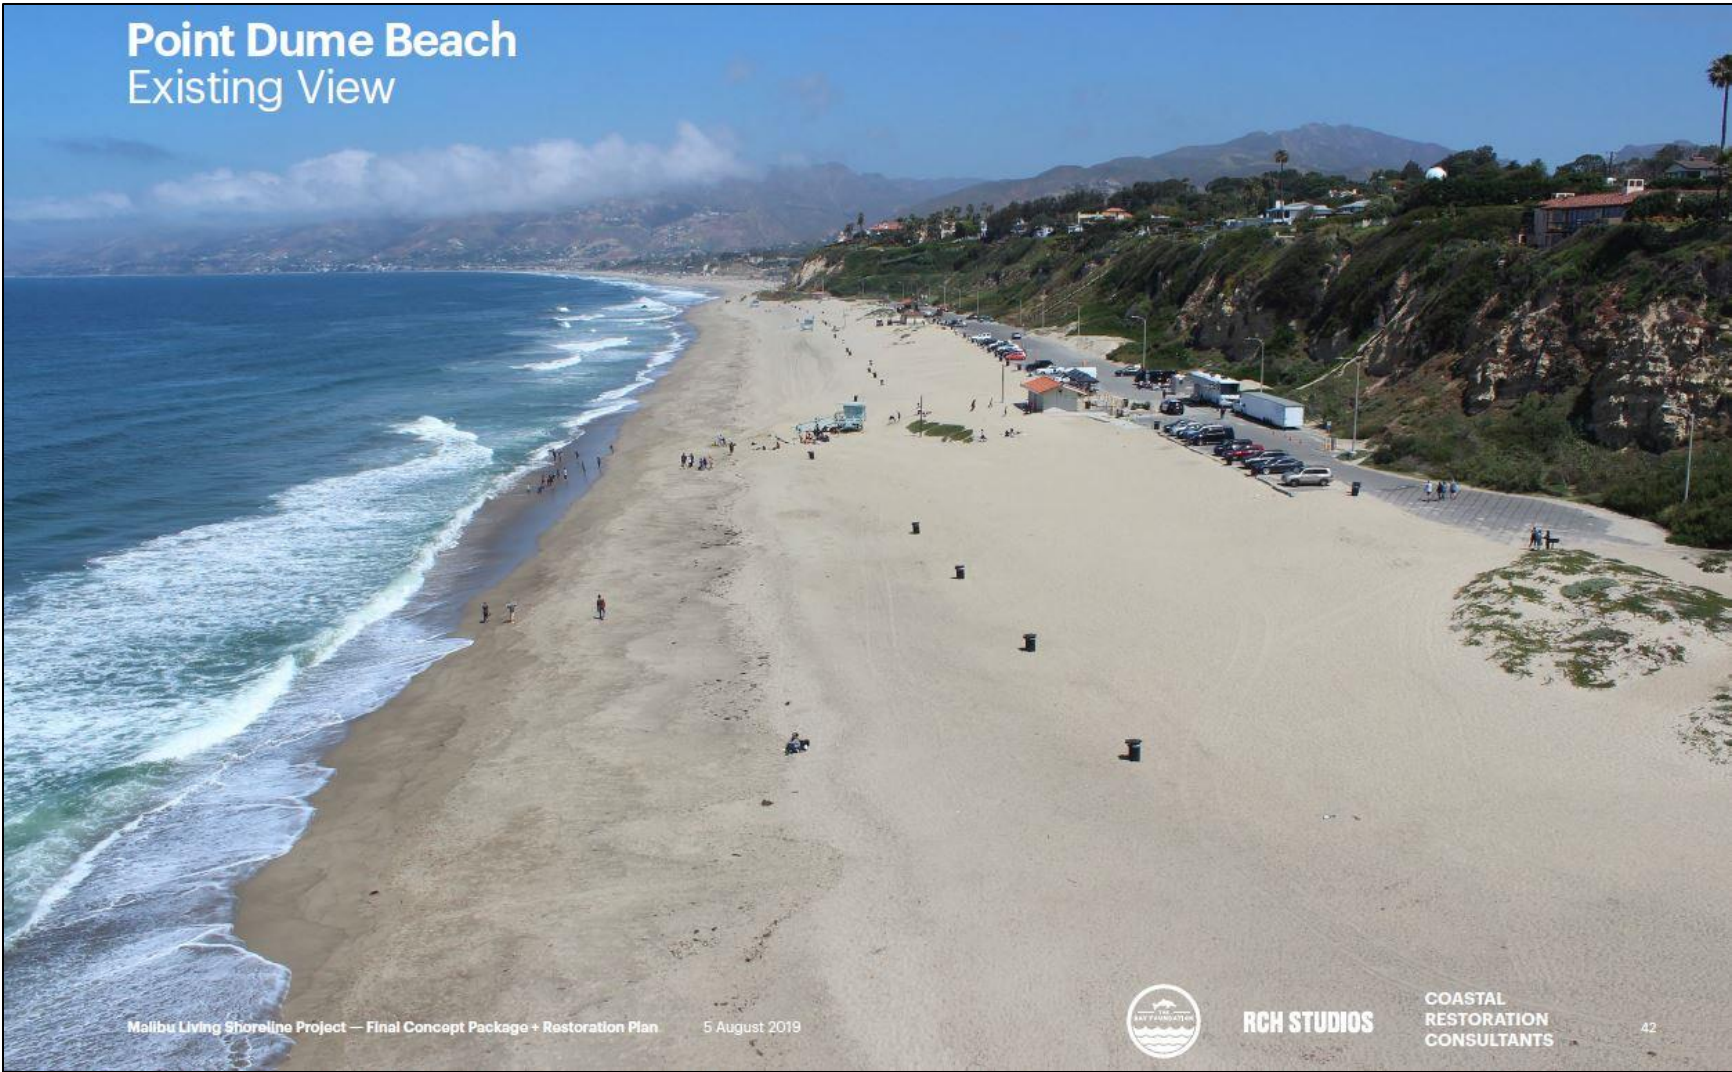
Figure 11a. Photograph of existing view of Point Dume Beach with some foredune dunes dominated by iceplant.

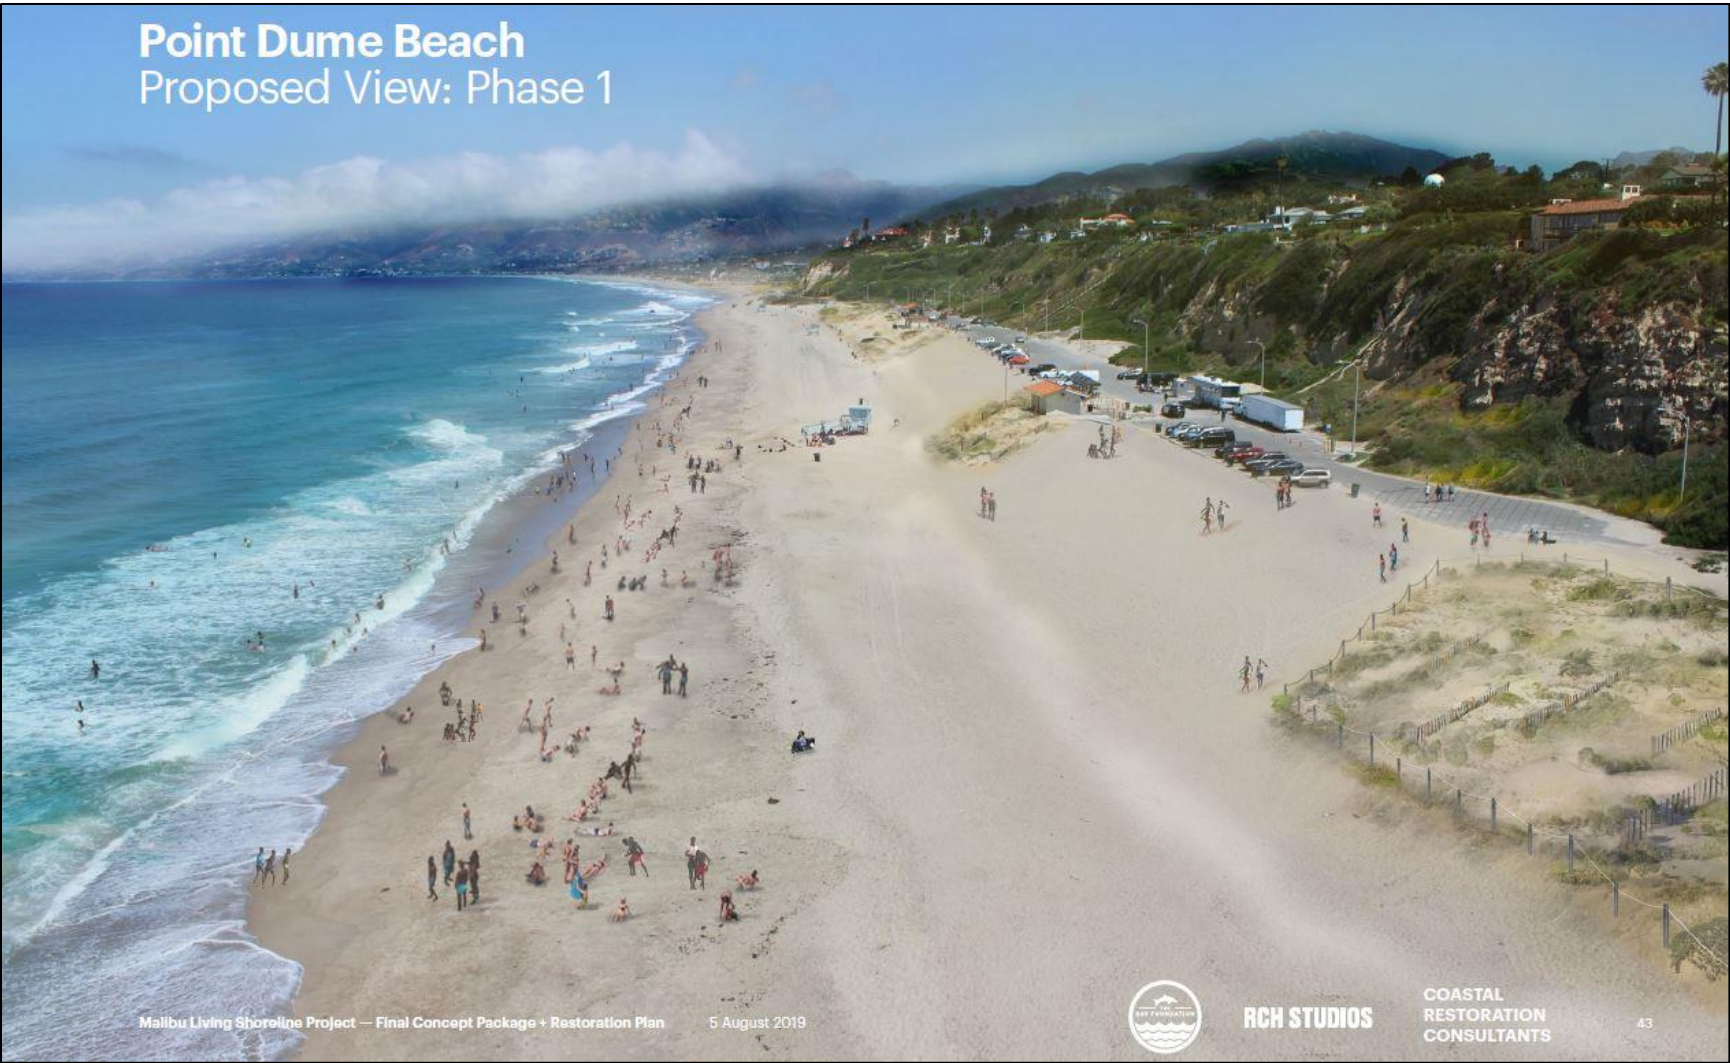
Figure 11b. Artistic rendering of Point Dume Beach (phase 1) post-restoration conditions approximately five years after restoration.
