# Santa Monica Beach Restoration Pilot Project

Year 4 Annual Report

September 2020

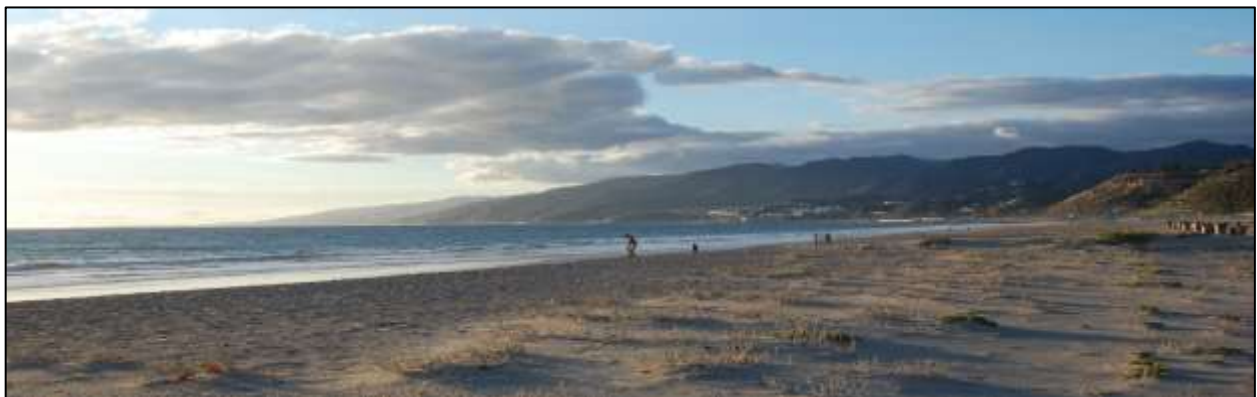
Figure 1. Photograph of the oceanward portion of the restoration area on 21 January 2020.

This pilot project restored approximately three acres of sandy coastal strand habitat located on the beaches of Santa Monica by utilizing existing sediments to transform a portion of the current beach into a sustainable coastal strand and foredune habitat complex resilient to sea level rise. As an alternative to traditional hardscaping options, this project will continue to evaluate a living, restored shoreline with a diverse wildlife community as an alternate approach to combat climate change (Figure 1).

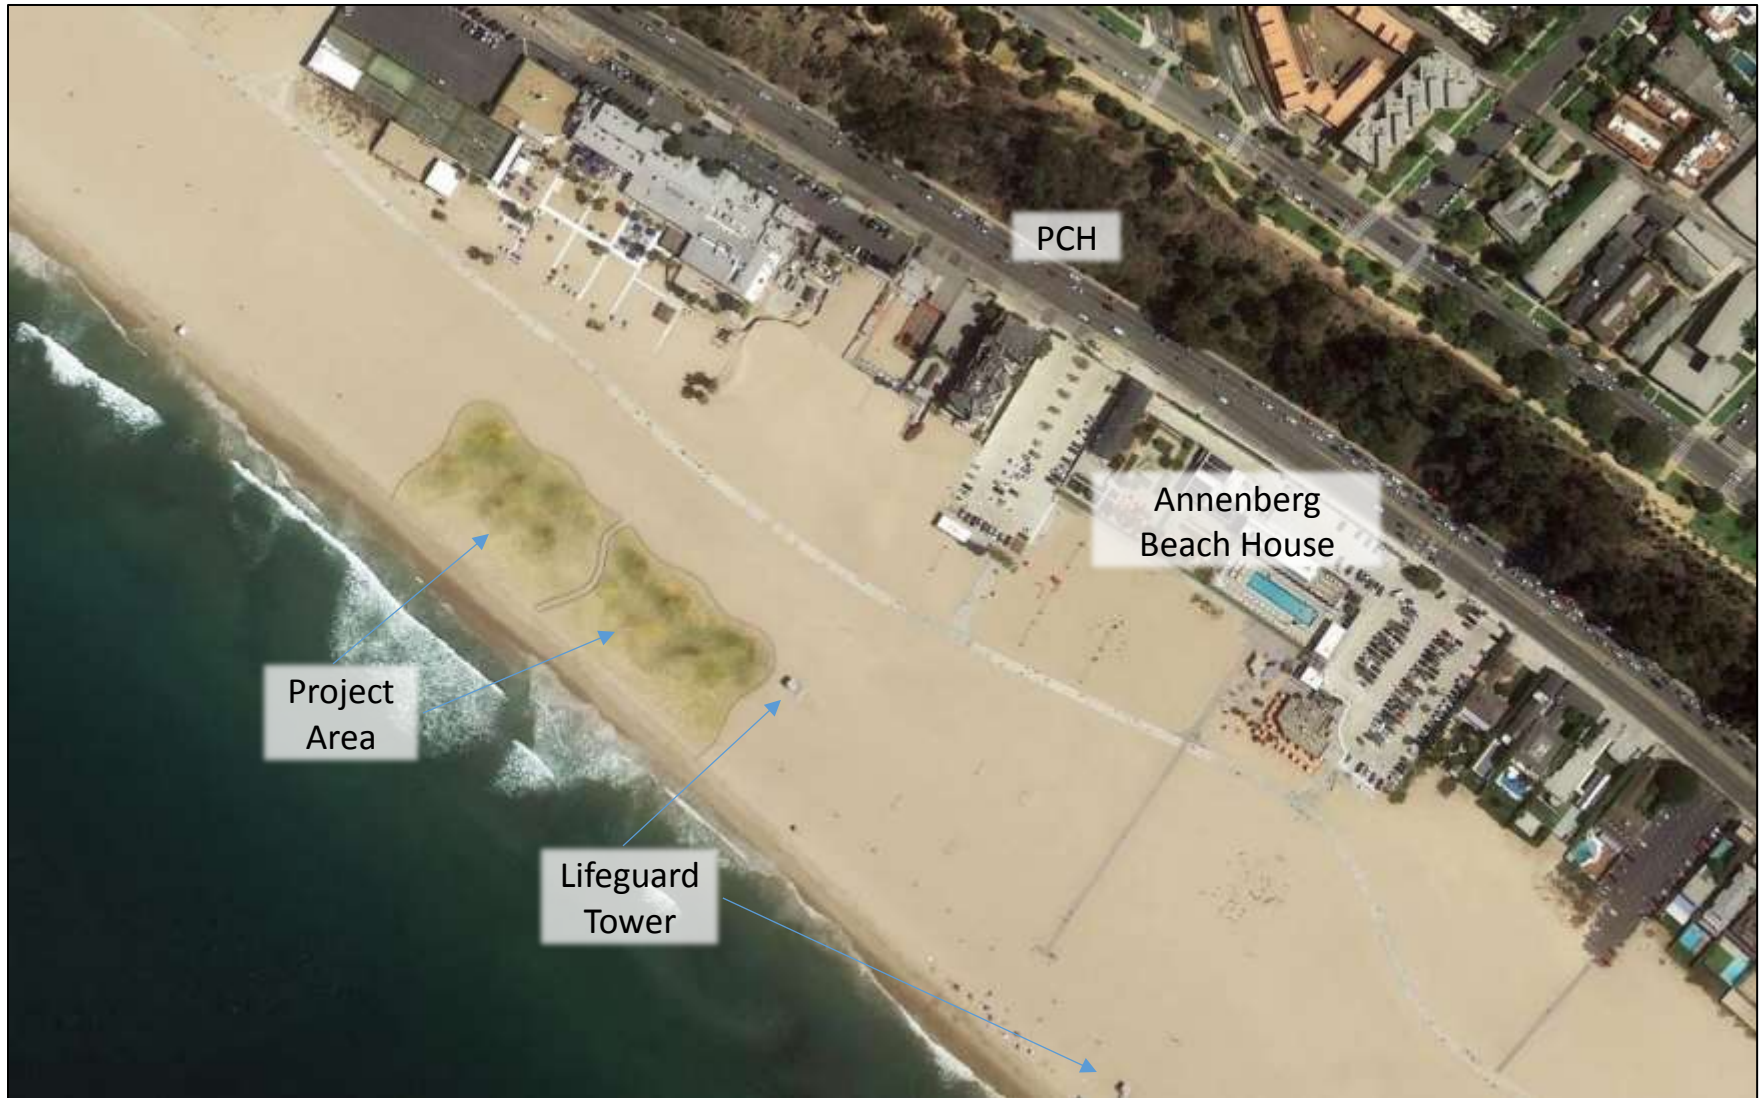
Figure 4. Artistic rendering overview of project area, post-establishment of vegetation (rendering credit: Studio-MLA).

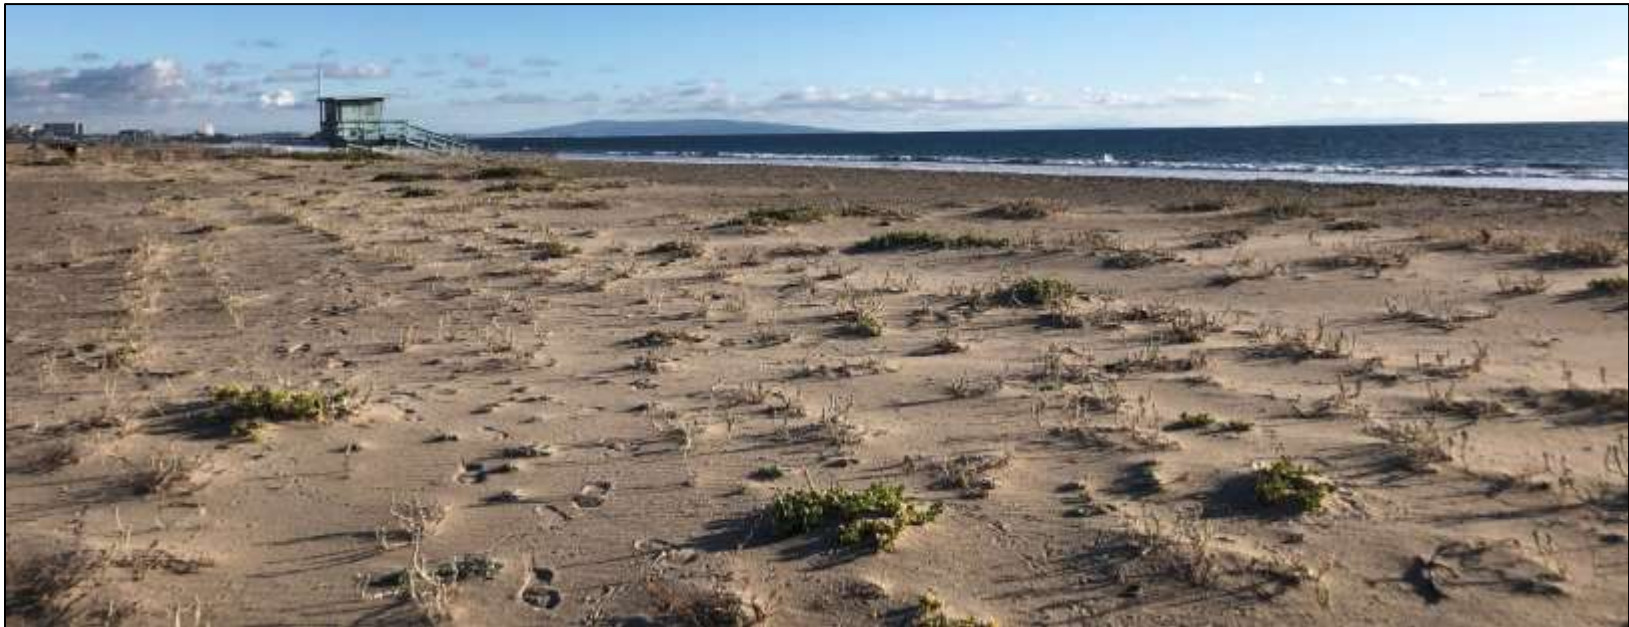
Figure 6. Photograph of post-restoration project site in Year 4 (21 January 2020).

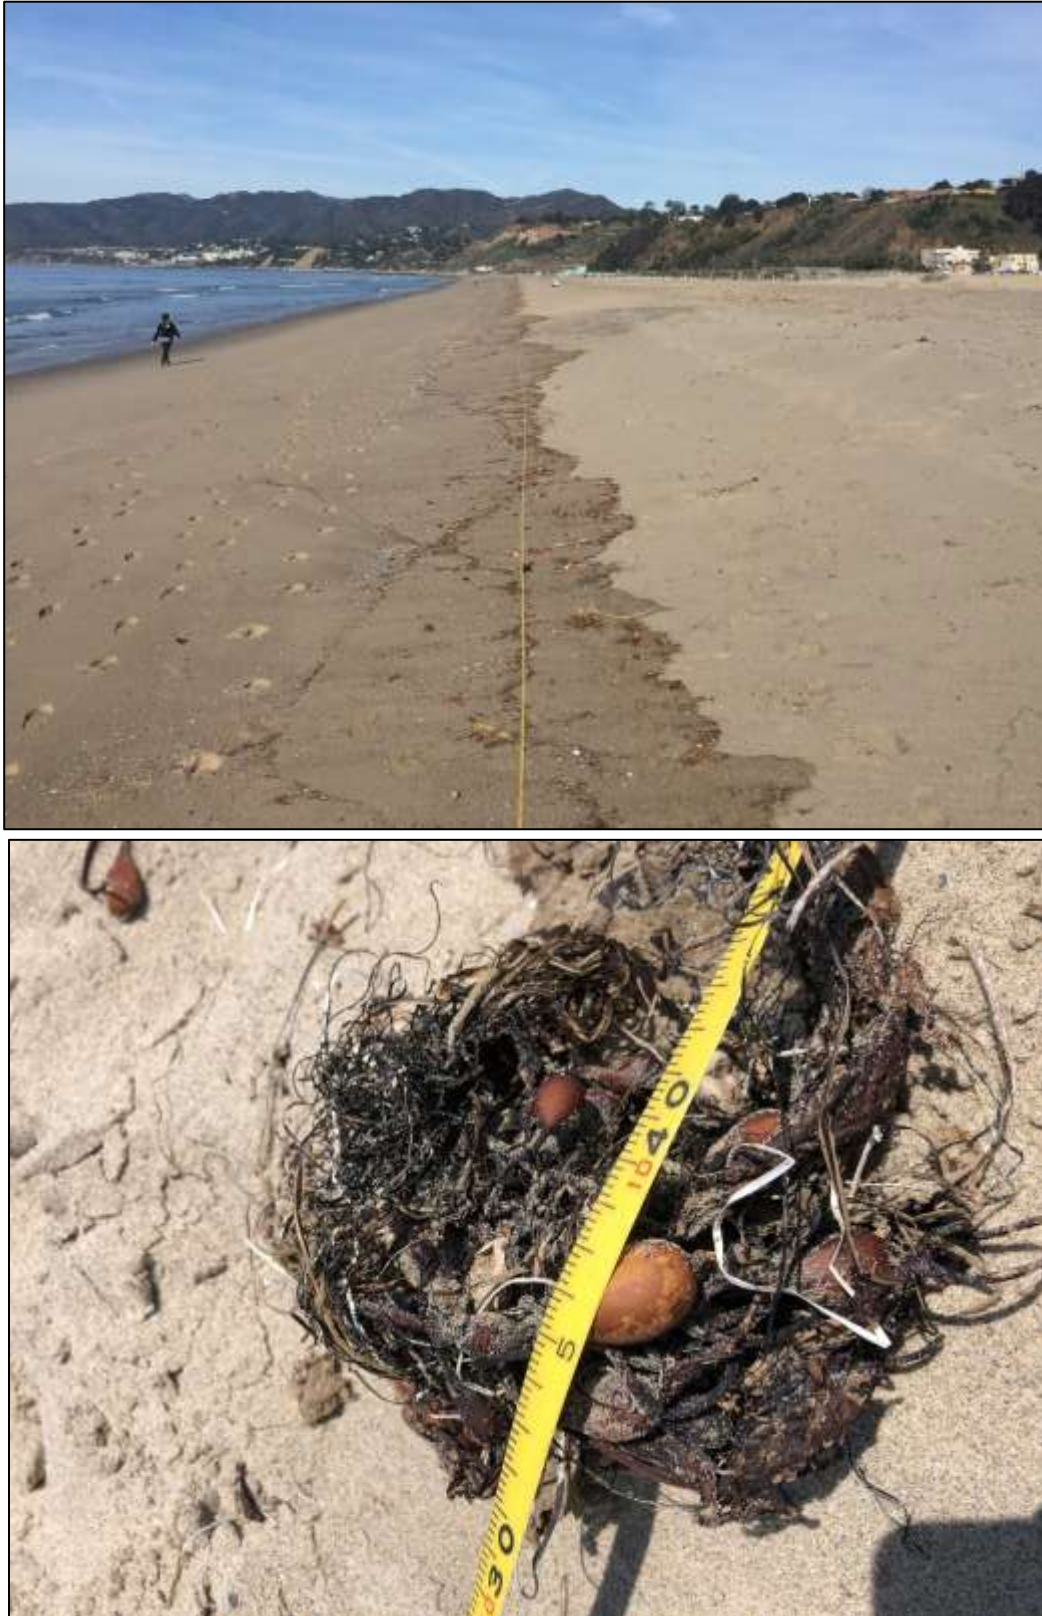
Figure 9. Photograph of wrack line in control site (top) on 5 February 2020 and photo of clump of mixed wrack found on 24 July 2020 (bottom).

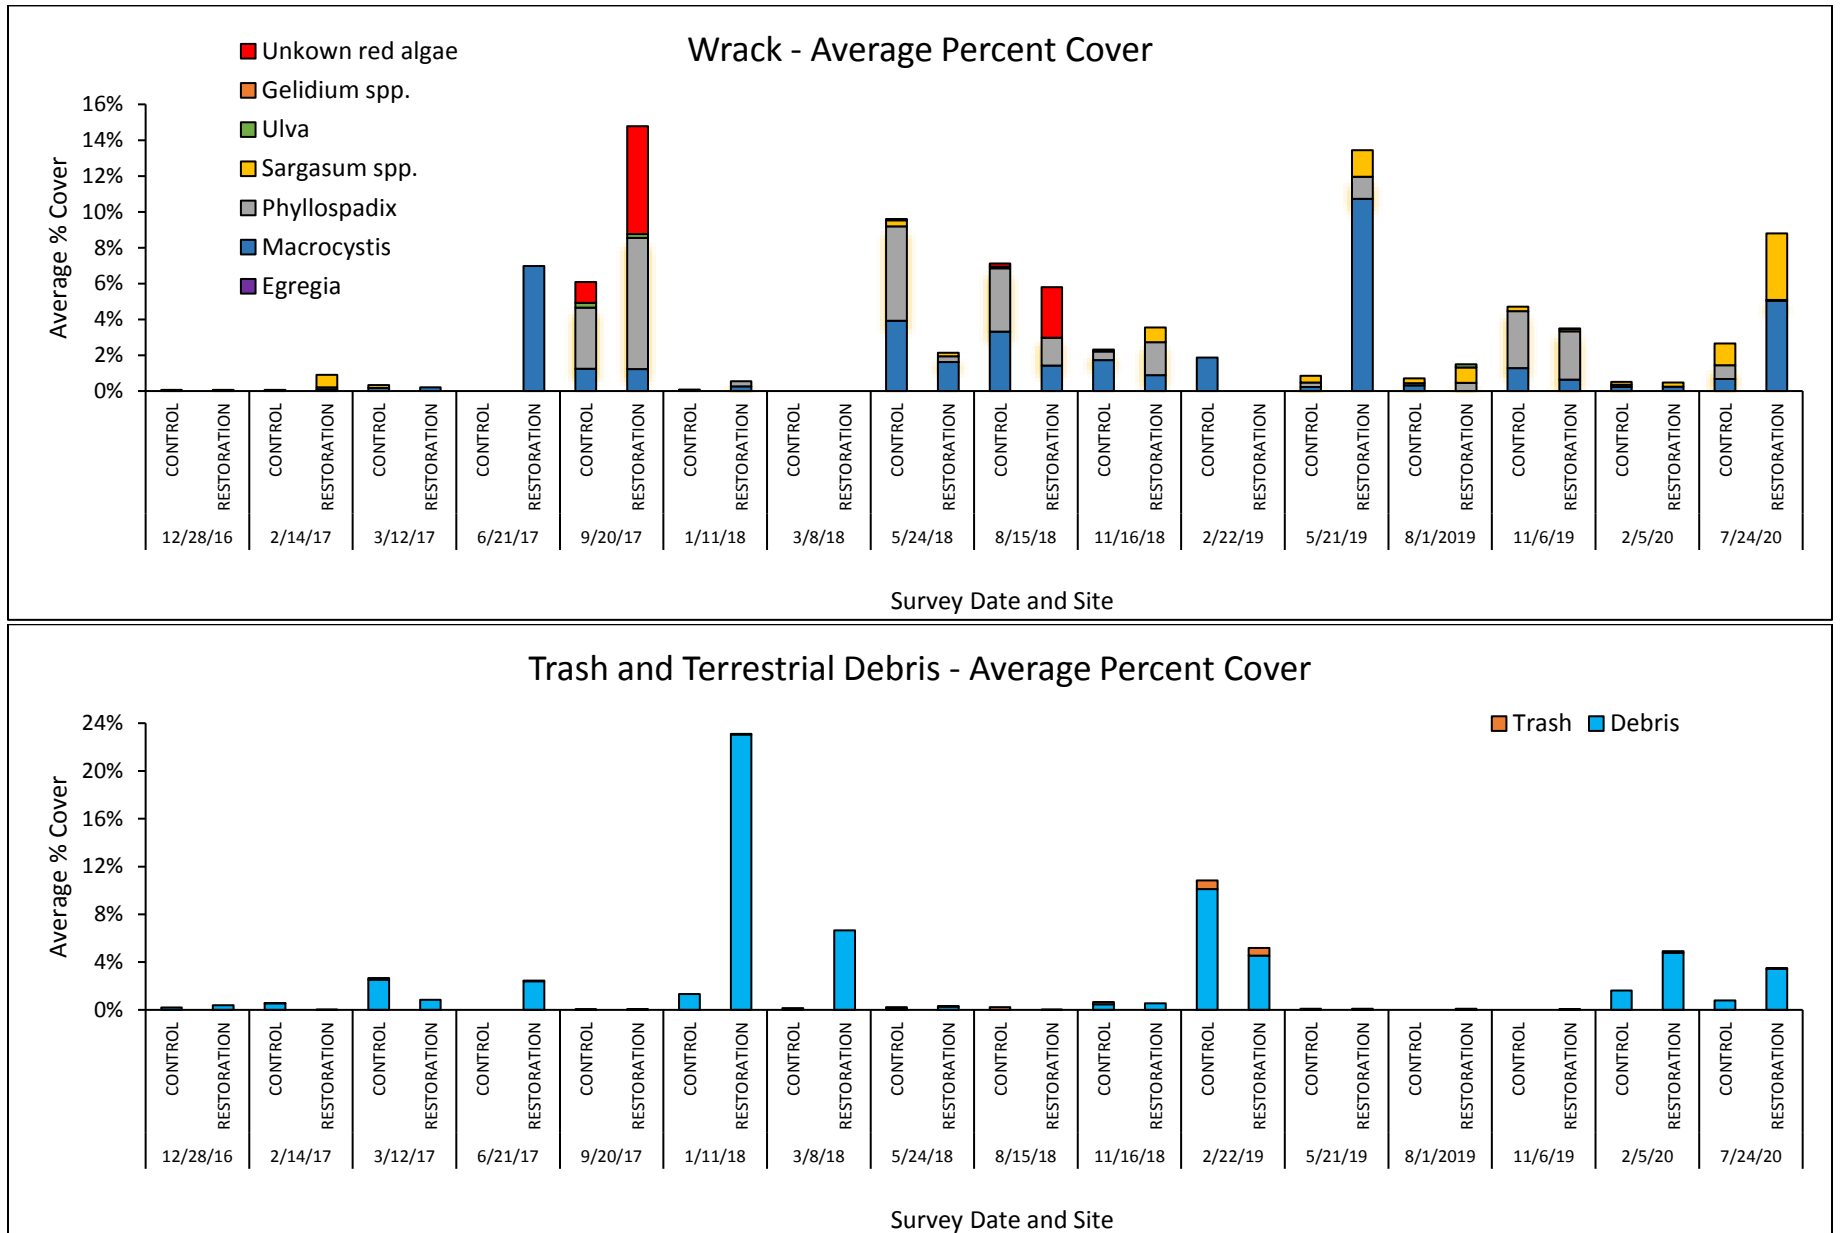
Figure 10. Average percent cover of wrack by species (top) and trash and terrestrial debris (bottom) in the restoration area and control site across all surveys. Note variable y-axis for each graph.

Terrestrial debris and trash were variable throughout the surveys (Figure 10, bottom). Terrestrial debris (e.g., twigs, leaves, feathers, other natural debris, etc.) in Year 4 remained relatively low across all surveys, with a maximum average cover of approximately 3% in the restoration site (February 2020). Trash also remained low across all surveys, at less than 1% cover in both the control and restoration sites. This indicates either a lack of trash in the survey areas, or beneficial adaptive management measures such as hand-removal of trash that are shown to be effective at maintaining the restoration and control areas with very low overall trash cover.

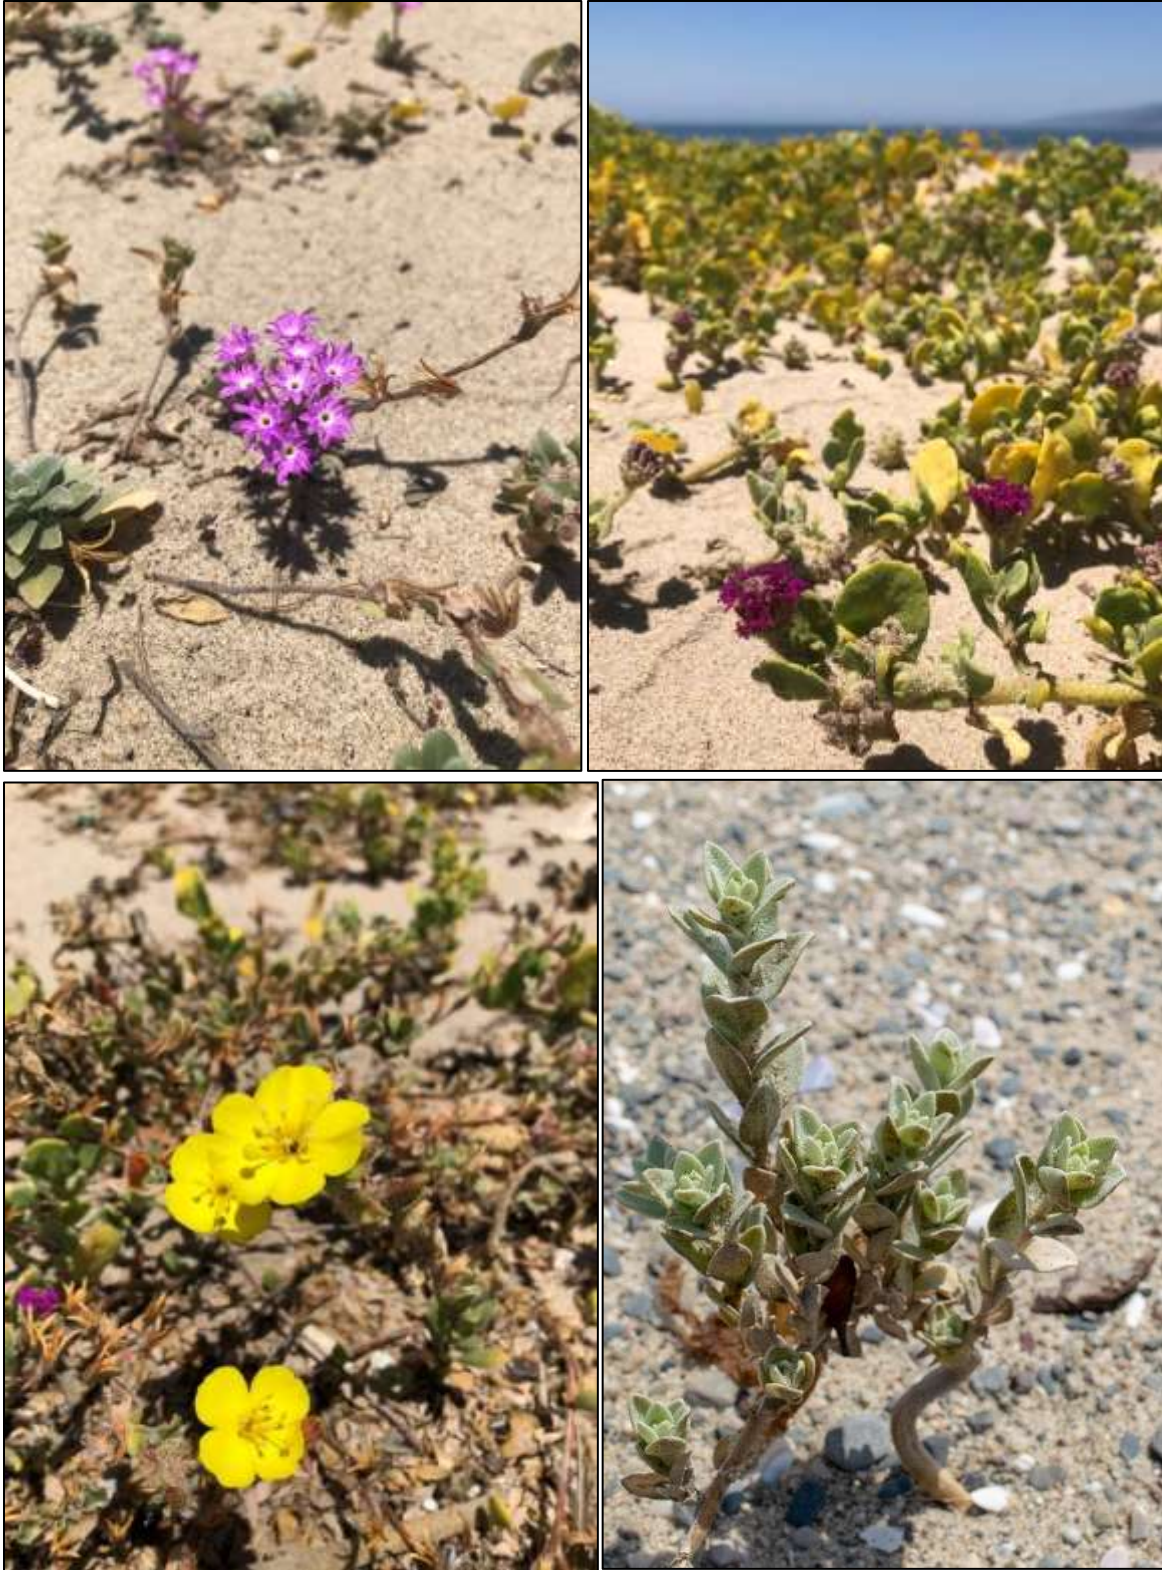
Figure 11a. Photograph of various vegetation in restoration site. Top left: pink sand verbena (*Abronia umbellata*); top right: red sand verbena (*Abronia maritima*); bottom left: beach evening primrose (*Camissoniopsis cheiranthifolia*); bottom right: (*Atriplex leucophylla*).

All four of the seeded vegetation species germinated within and immediately adjacent to the restoration area [i.e., beach evening primrose (*Camissoniopsis cheiranthifolia*), red sand verbena (*Abronia maritima*), beach bur sage (*Ambrosia chamissonis*), and beach salt bush (*Atriplex leucophylla*) (Figures 11a and 11b). Additionally, three other vegetation species germinated within the project area, two native and one non-native. The two natives were woolly heads (*Nemacaulis denudata*) and pink sand verbena (*Abronia umbellata*), and the non-native species was European sea rocket (*Cakile maritima*) (Figures 11a and 11b). Neither woolly heads, a native and possibly rare species variant, nor pink sand were in the seed mix as confirmed by the seed provider; thus, it is probable that there was either an existing seed bank for these species already along Santa Monica Beach, or that they were transported by wind, waves, birds, or humans. Combining all transects surveyed in Year 4, the highest proportions of cover were found to be beach evening primrose and beach saltbush (Figure 12). In all years, sea rocket exhibited the lowest cover of any of the present species and was periodically removed by hand from within the restoration area as an adaptive management maintenance activity. As Figure 12 displays, the vegetation has become more diverse over time (rather than dominated by one or two species), with a more even cover distribution of the native vegetation (see the most recent survey, 24 July 2020).

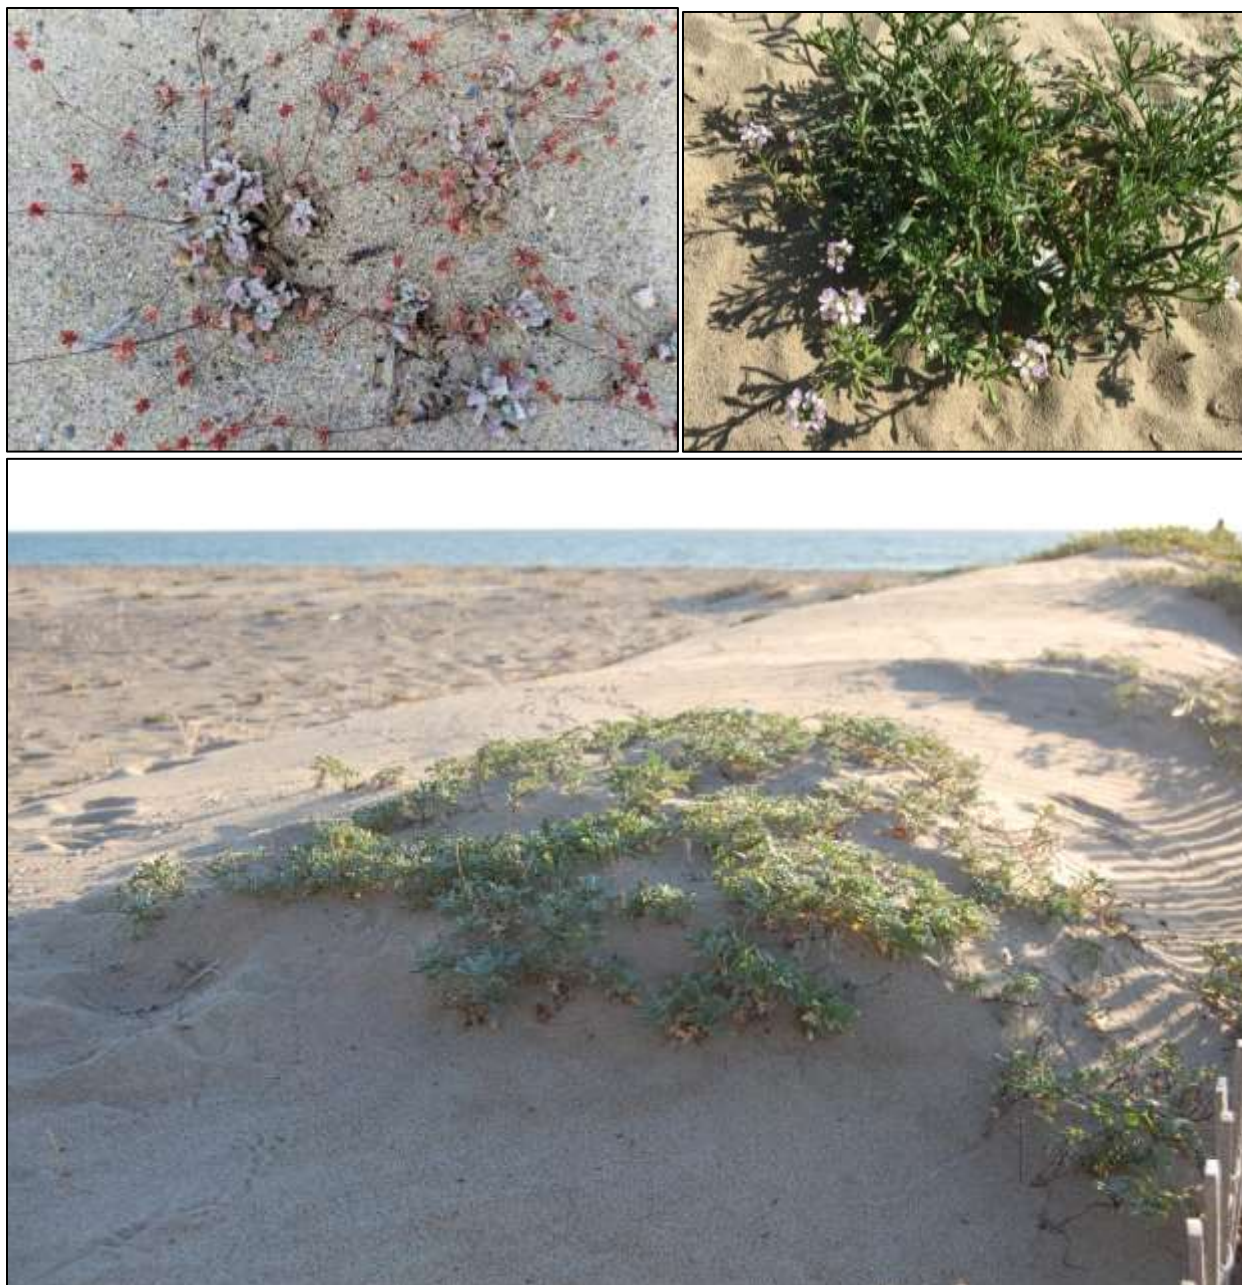
Figure 11b. (continued). Photograph of various vegetation in restoration site. Top left: woolly heads (*Nemacaulis denudata*); top right: non-native sea rocket (*Cakile maritima*); bottom: beach bur sage (*Ambrosia chamissonis*).

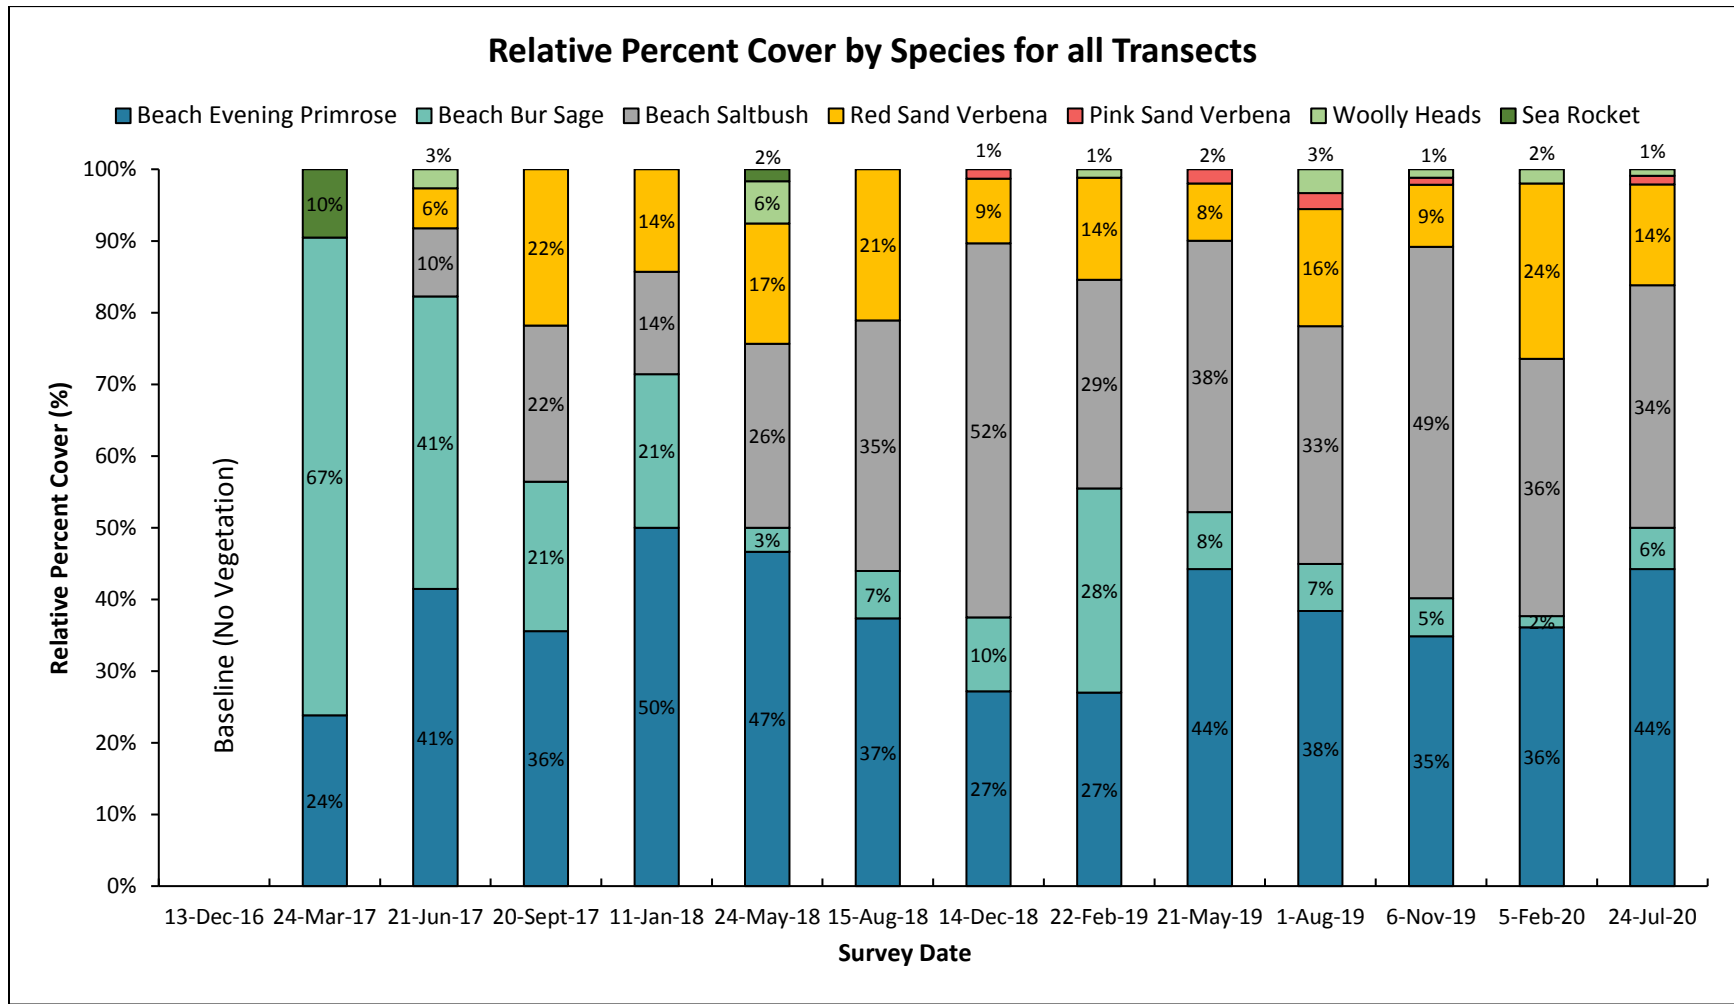
Figure 12. Relative percent cover by species for all transects (live vegetation only, 13-Dec-16 was baseline survey with no vegetation identified).

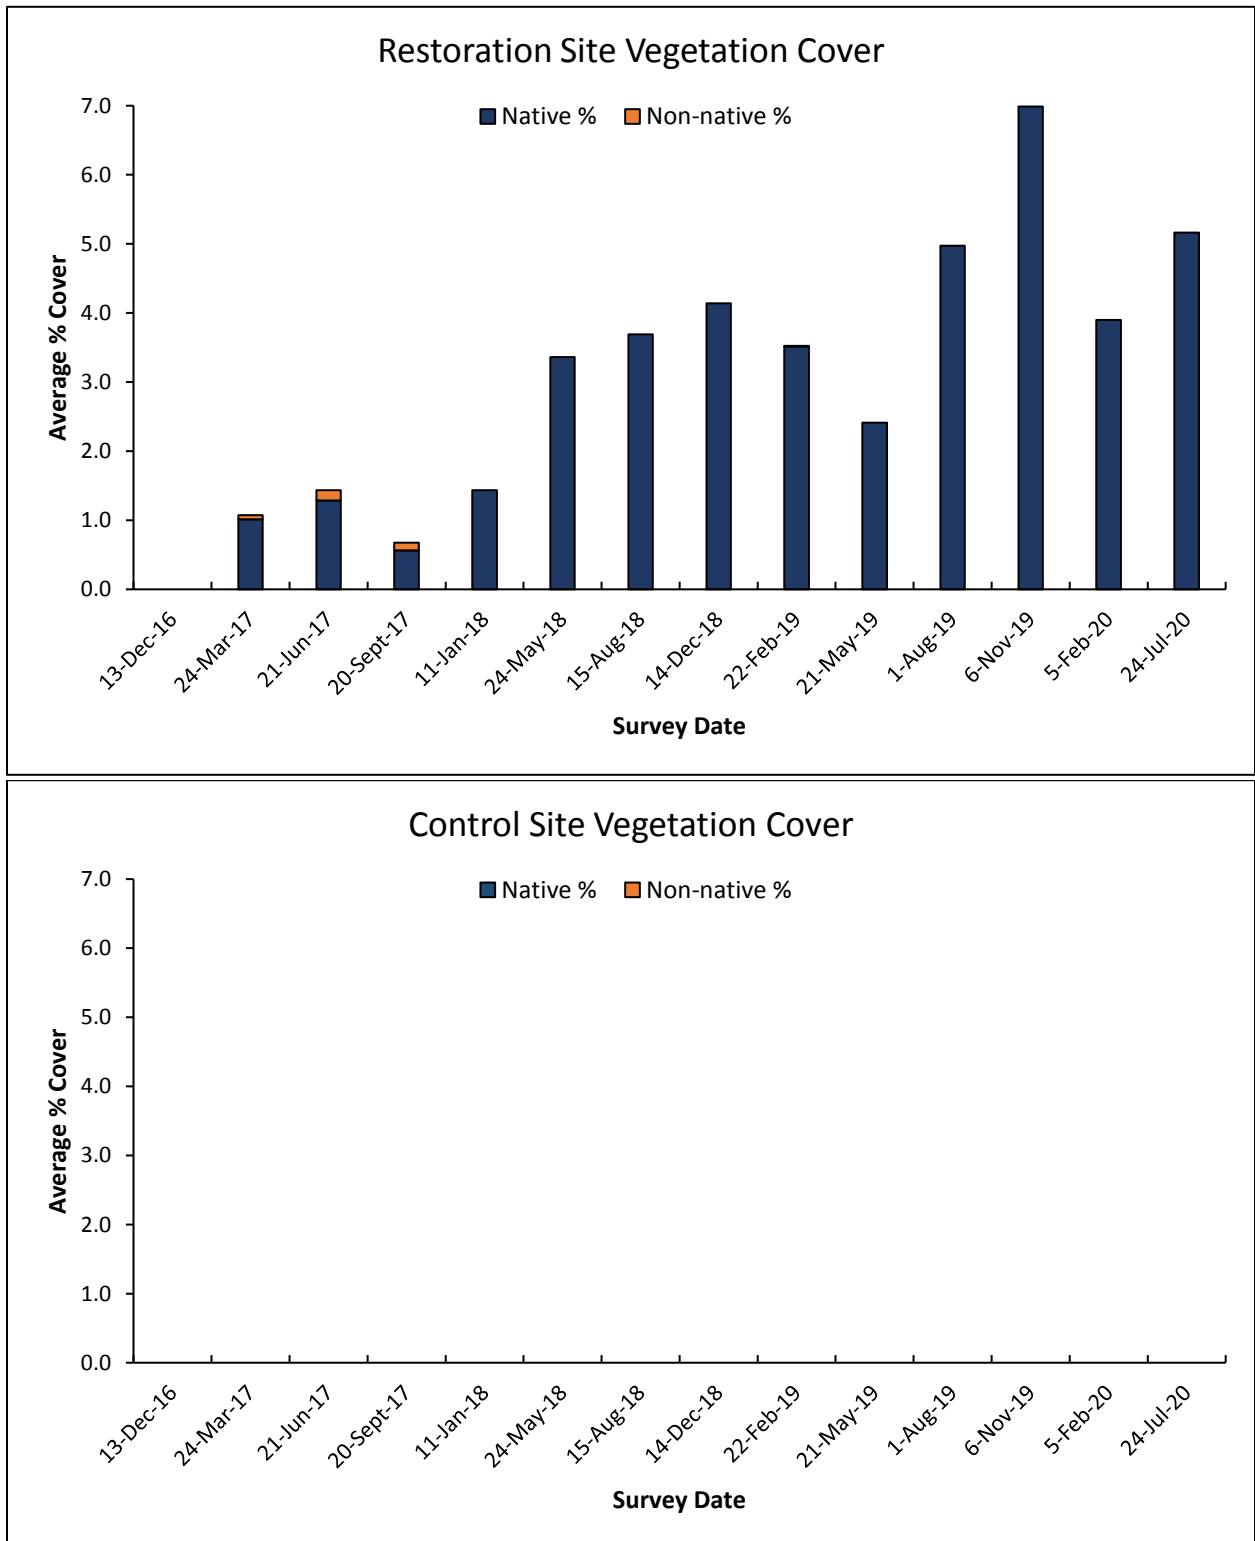
Figure 13. Average native and non-native vegetation cover during all surveys within the restoration area (top) and at the control site (bottom).

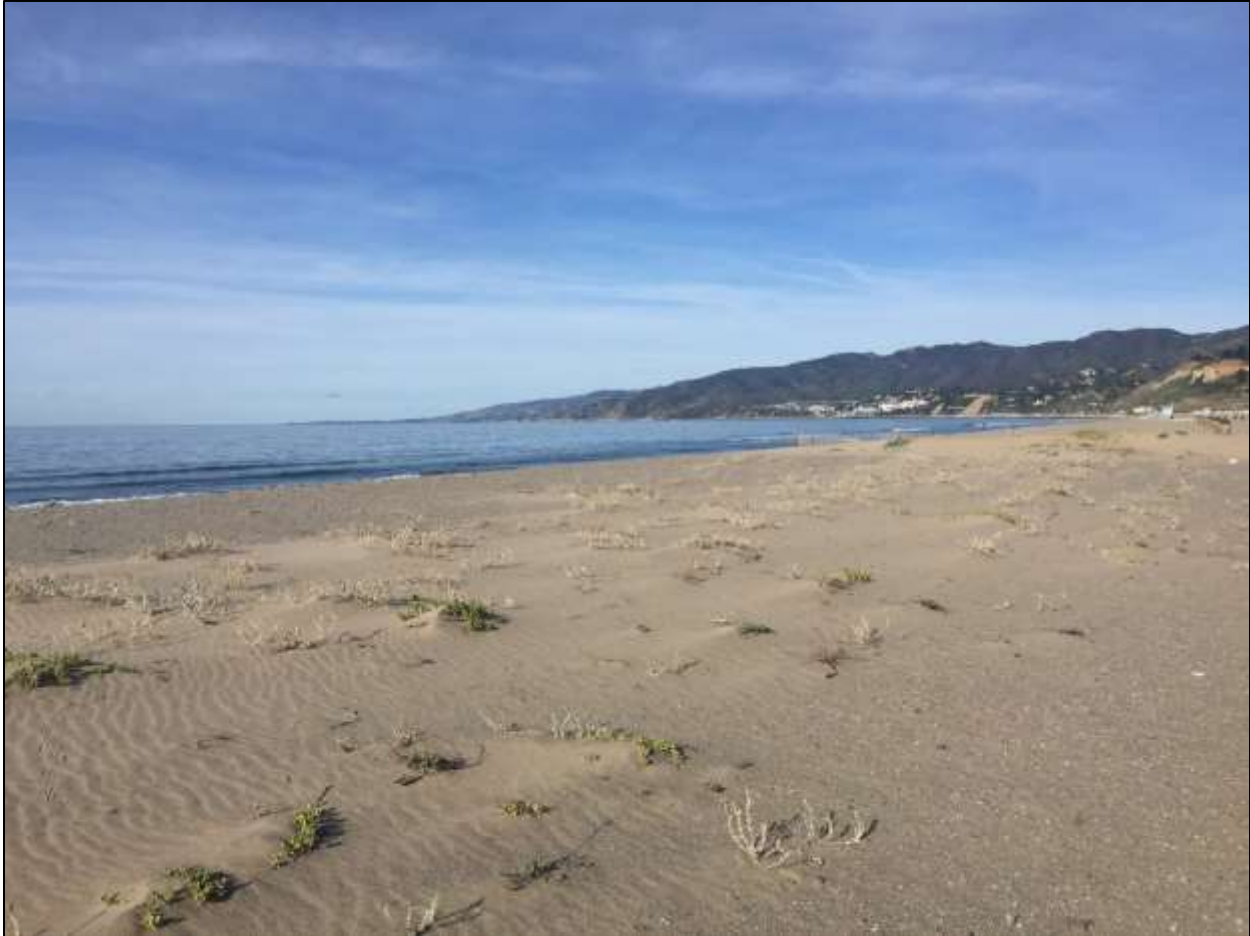
Figure 14. Photograph of various interspersed native vegetation scattered throughout the project site with areas of sandy bare ground (5 February 2020).

Vegetation cover assessed during the baseline (December 2016) surveys within both the restoration area and control site was zero and remained zero at the control site throughout all surveys (Figure 13). Native vegetation cover was much higher than non-native cover (sea rocket) during all surveys, with zero non-native vegetation in all Year 3 and 4 surveys. Native cover has increased over time, with some seasonal variation. Native cover increased to a maximum cover of approximately 7% in the November 2019 survey and decreased slightly in the February 2020 survey. However, the most recent survey (July 2020) shows vegetation again increasing to over 5%. Vegetation is likely to continue to increase and become more complex over time, though naturally occurring coastal strand habitats also usually have a significant portion of bare sand, even after becoming mature vegetation communities (Figure 14).

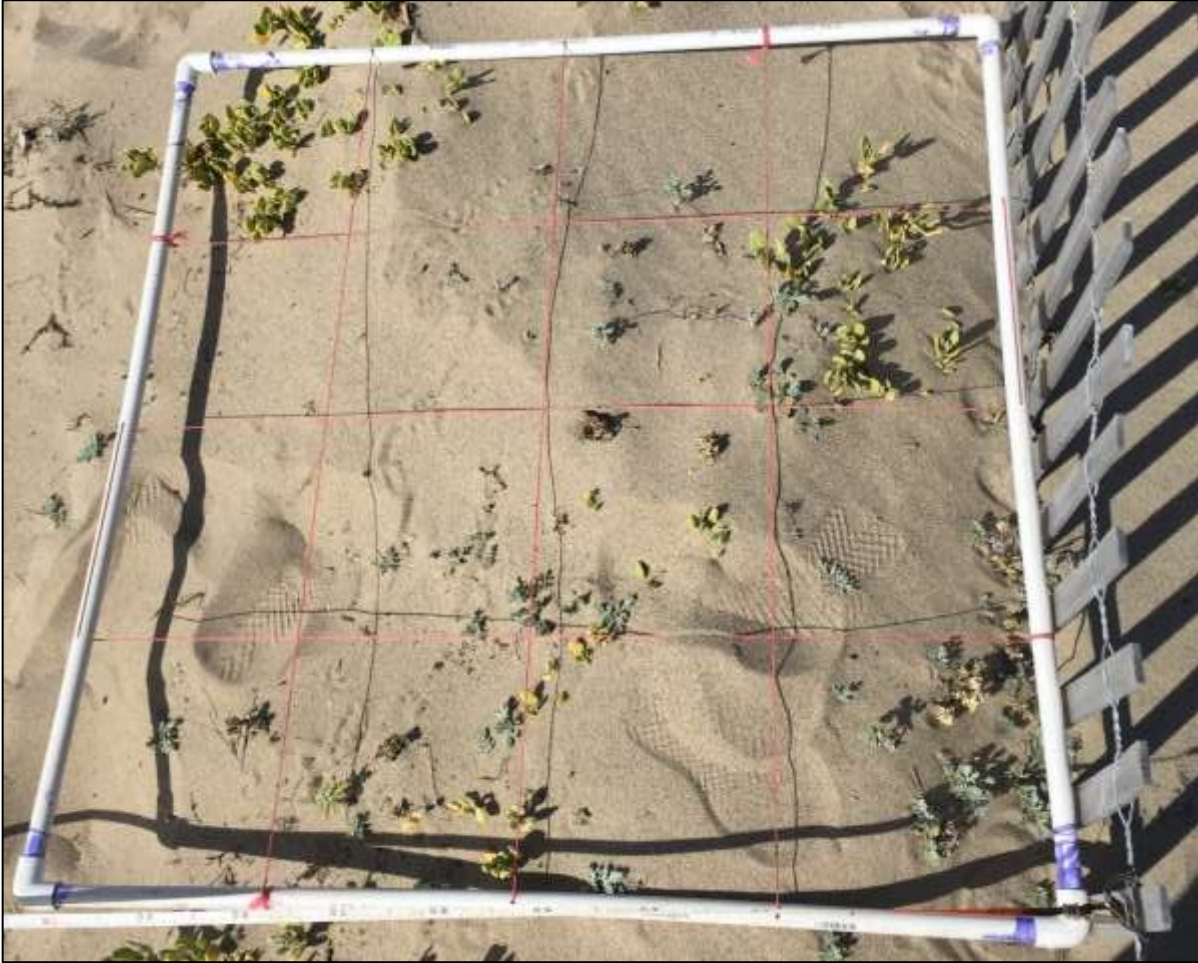
Figure 15. Seedlings intermixed with other juvenile native vegetation (5 February 2020).

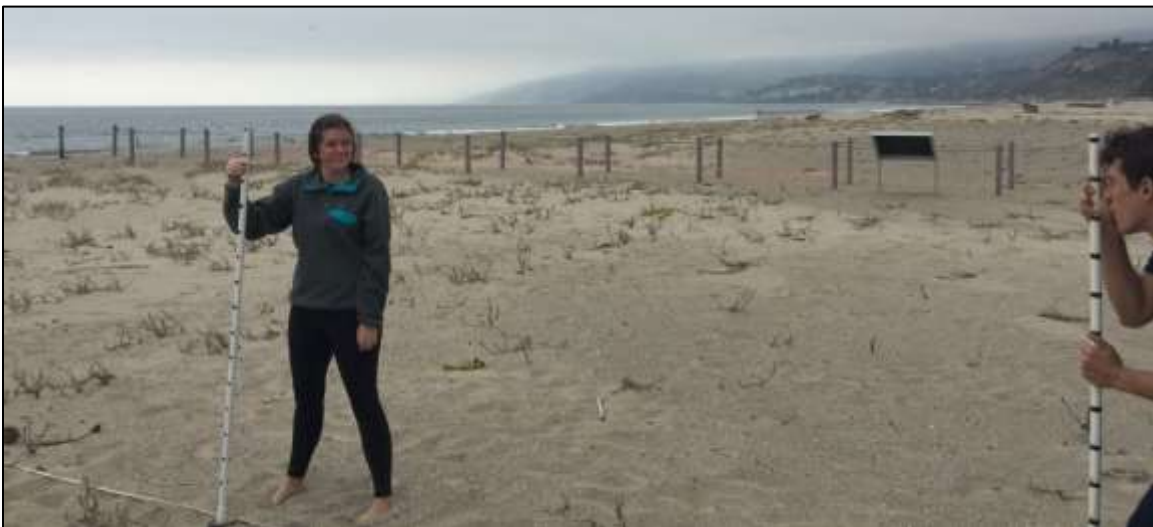
Figure 25. TBF staff and CRI interns conducting an elevation profile survey on 6 November 2019.

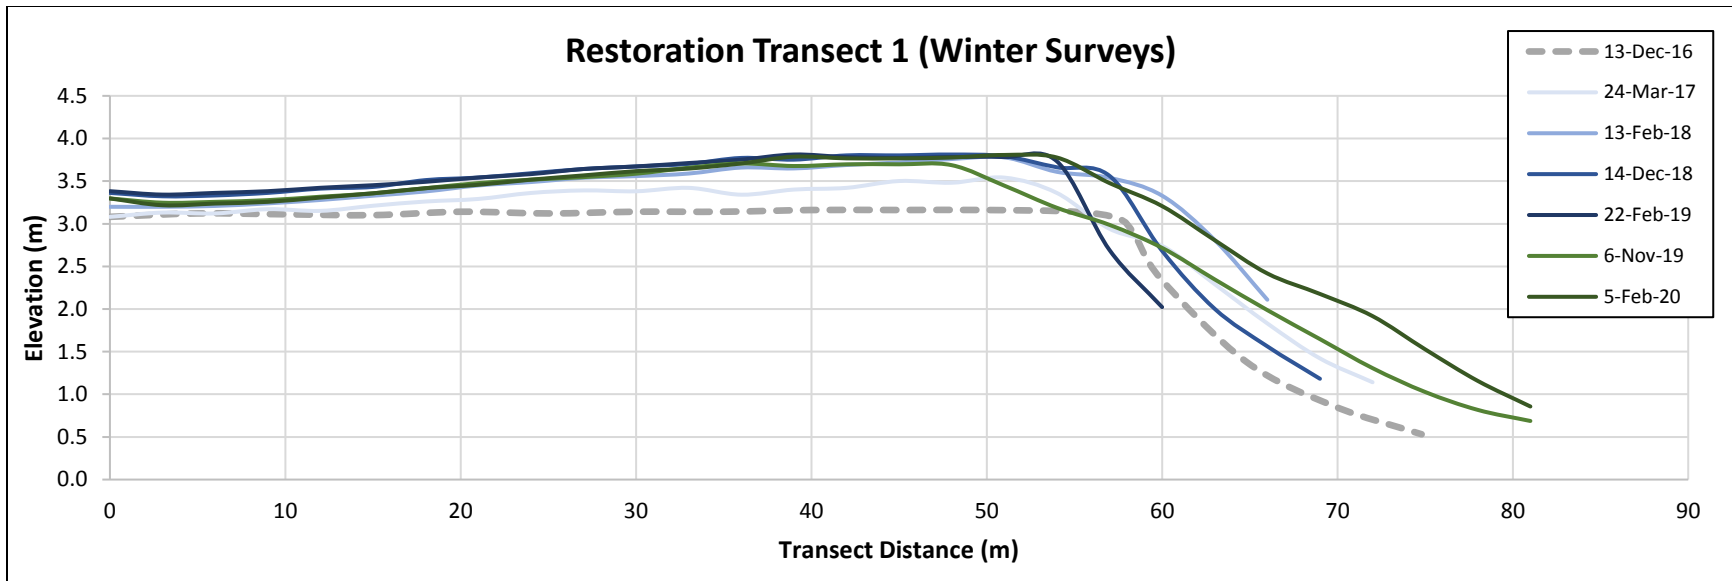
Figure 26a. Restoration Transect 1 elevation profiles during Winter Beach surveys (Elevation in NAVD88).

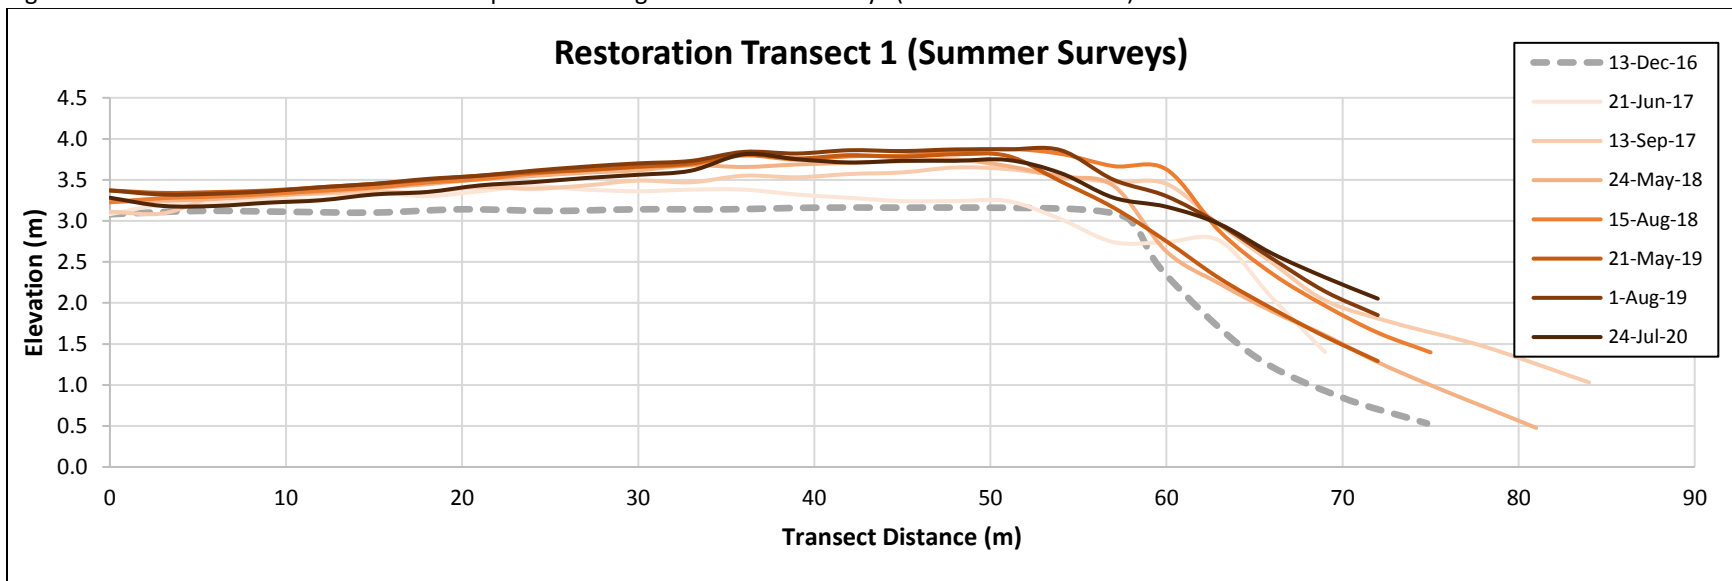
Figure 26b. Restoration Transect 1 elevation profiles during Summer Beach surveys (Elevation in NAVD88).

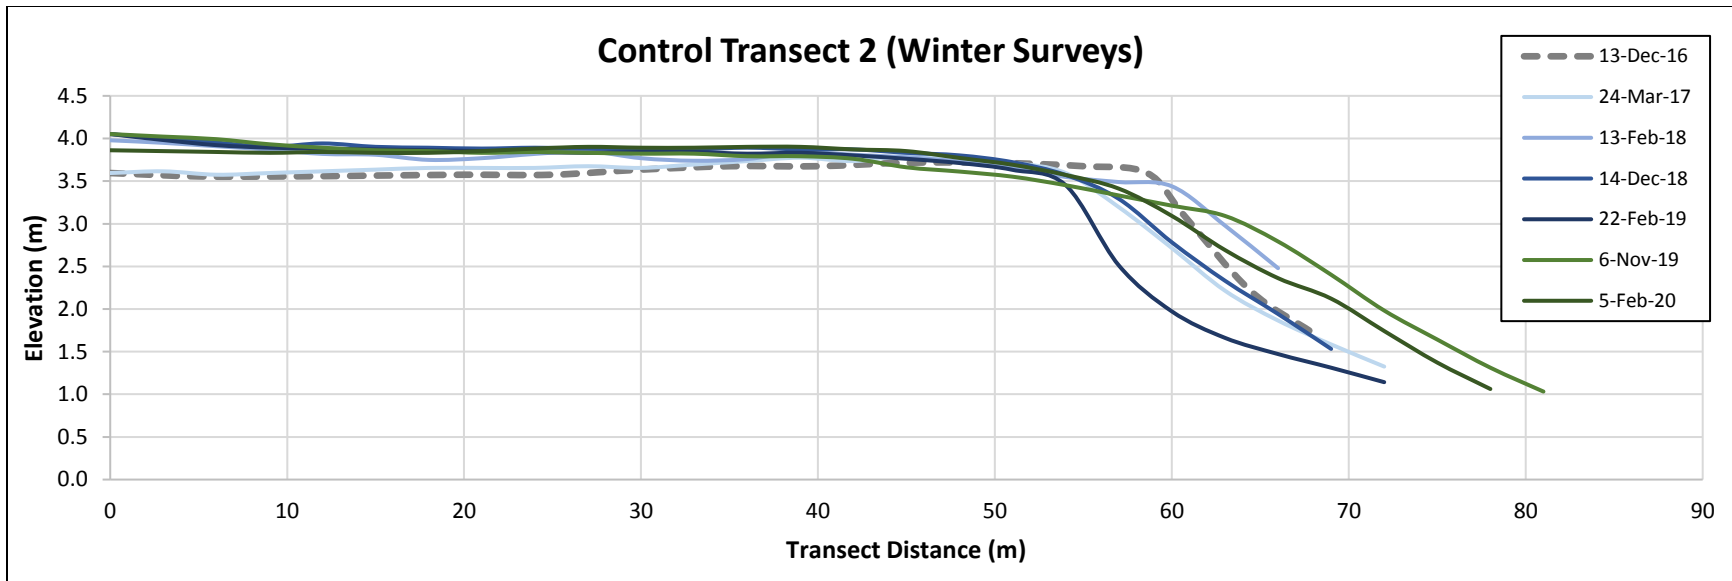
Figure 31a. Control transect 2 (non-restored area) elevation profiles during Winter Beach surveys (Elevation in NAVD88).

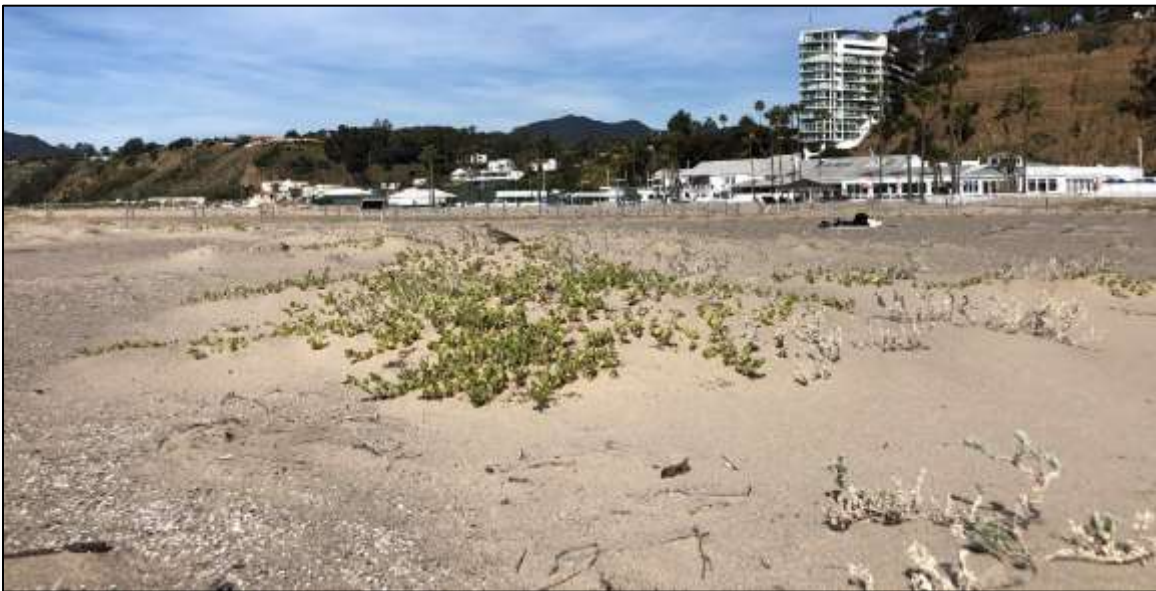
Figure 32. Photograph of vegetated dune hummock within the restoration area (5 February 2020).

High-resolution elevation surveys using a Trimble Geo7x GPS were conducted on 12 April 2017 (Year 1), from 24 to 27 June 2018 (Year 2), and on 21 August 2020 (Year 4). Elevation points were downloaded, quality control checked, and analyzed in a geographic information system (GIS) to create a topographic surface of the restoration site. Figure 33a displays the topographic map results from the GPS elevation survey in May 2017 (top) and May/June 2018 (bottom) and Figure 33b displays results for Year 4. Note that Figure 32b (Year 4 survey) includes two additional elevation interval color categories due to increased height. The topographic data supplement the elevation profile transects and indicate a buildup of sand along the berm and fence perimeter, with smaller plant hummocks throughout the site. The Year 4 survey shows a noticeable increase in elevation throughout most of the restoration area. This is most apparent in the southern portion of the project footprint. Additionally, the micro-topography of the restoration site appears to become increasingly more complex across each subsequent survey, which supports visual observations of the formation of dune hummocks around vegetation and wrack within the restoration site (Figure 32). An additional topographic survey using GPS is planned for Year 5.
