# Santa Monica Beach Restoration Pilot Project

Year 4 Annual Report

September 2020

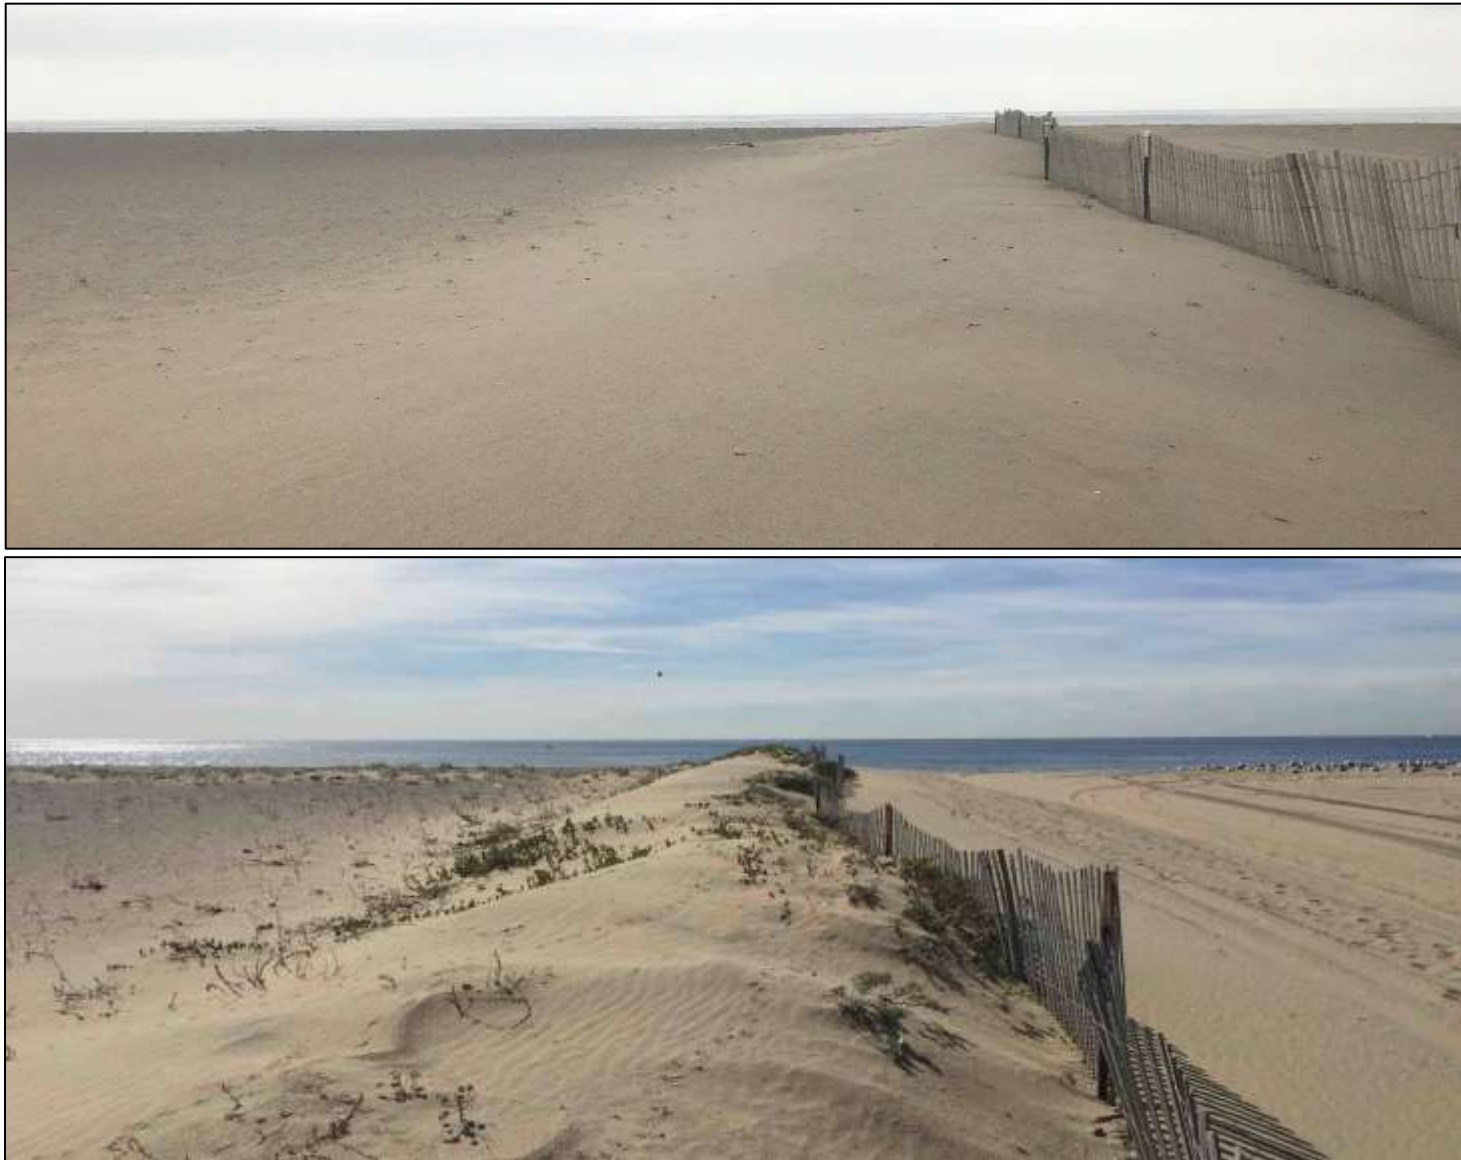
Figure 34. Photograph of sand build-up along the northern fence line in the restoration area (top: 9 May 2017, approximately five months after implementation; and bottom: 5 February 2020).

Figure 34 shows buildup of sand along the northern fence perimeter in May 2017 and again in February 2020, where an increase of vegetation, especially red sand verbena and beach bur are present. Berm changes parallel to the ocean have also been observed in photographic documentation and monitoring data with seasonal variations present. The beach berm ridge is higher in elevation and more prominent in the restoration site. Figure 35 shows a time-series of the berm changes observed post-restoration. Additional surveys will continue to track the berm fluctuations over time. The continued rise in elevation of the berm in multiple elevation profiles and supporting topographical surveys indicate promising results that the site is potentially becoming more resilient to coastal flooding than other sections of the beach that retain a low, flat profile. Future surveys will continue to inform changes in the restoration site and berm morphology over time. Additional data may also provide the opportunity to begin modelling sea level rise scenarios under new restoration conditions compared to control sites.

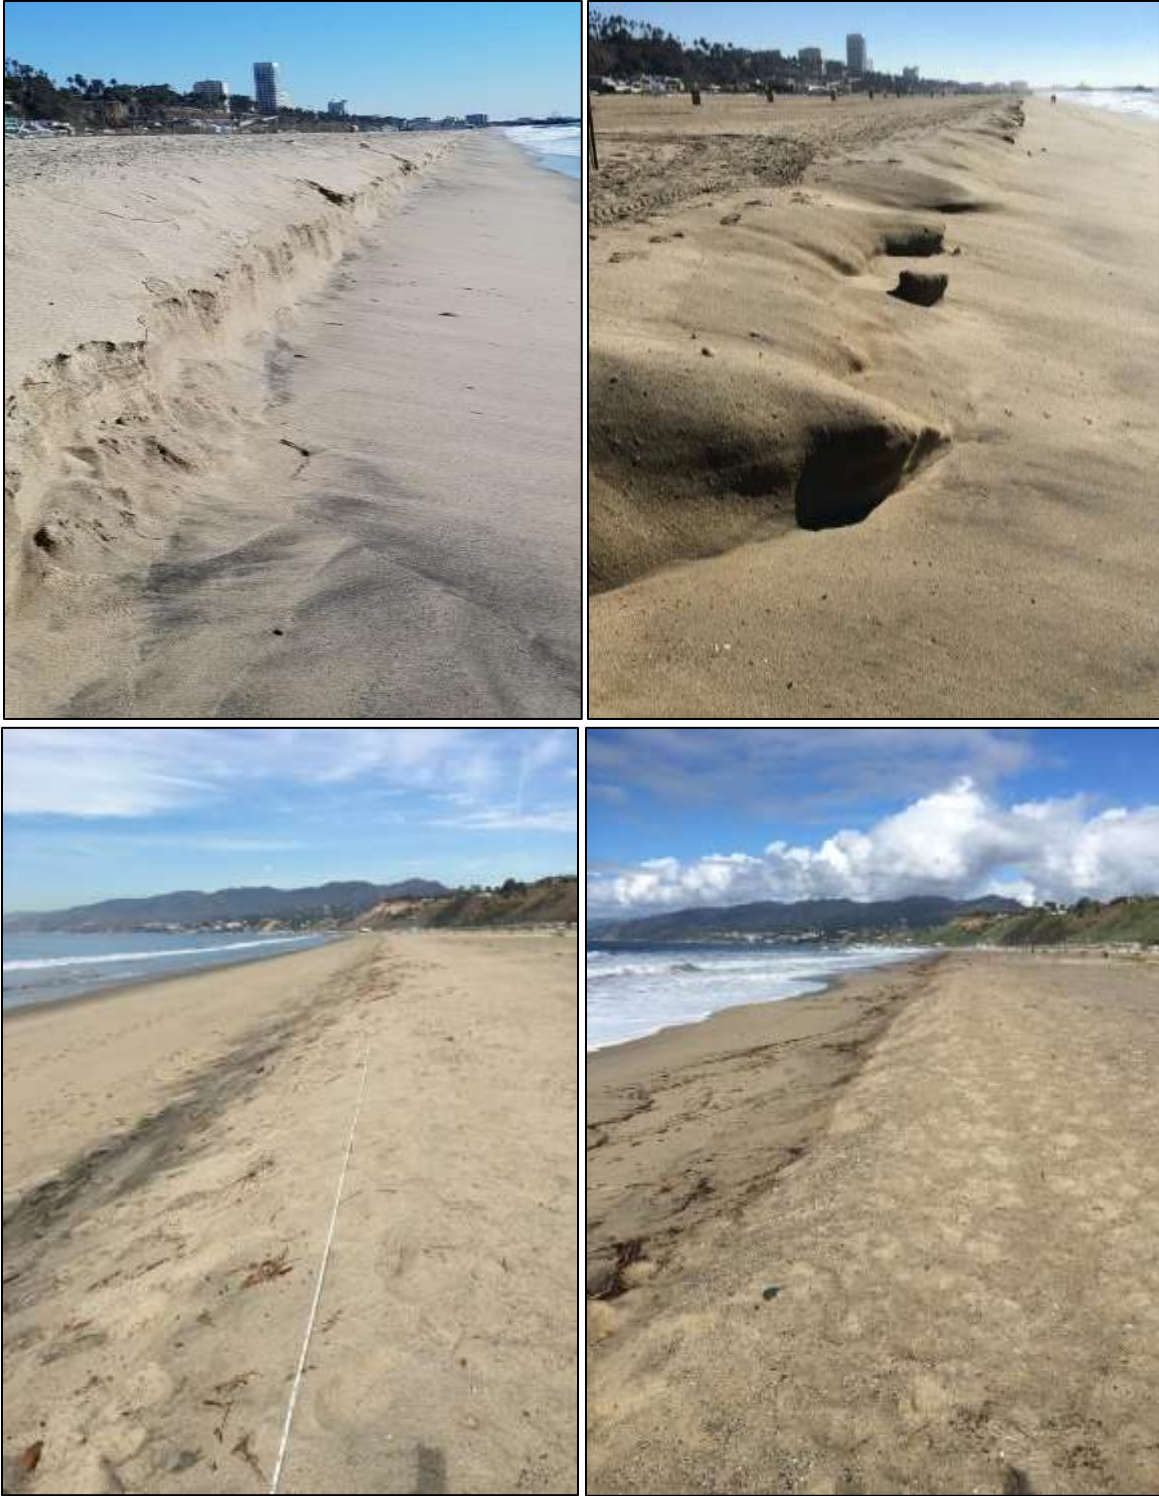
Figure 35. Berm topography (top left: 17 December 2016, top right: 25 January 2017, bottom left: 8 March 2018, and bottom right: 3 March 2019).

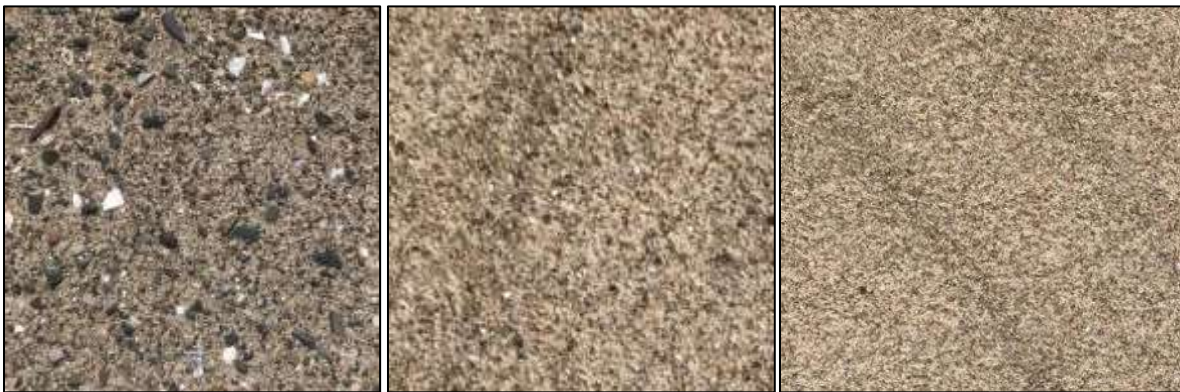
Figure 36. Sand grain in restoration site (left: pebbles; middle: coarse sand; right: medium to very fine sand).

Sand within the restoration site varied from pebbles (very fine) to very fine sand (Figure 36). Small dunes and plant hummocks were observed to form with larger sized sediment at the base of the hummocks and finer grain sizes on top due to wind driven transport (Figure 37). Dry sand samples collected (averaged for 15 and 30 m) saw variable trends between surveys, with a small increase in very coarse sand and pebble percent composition within the restoration area (Figure 38). The latest survey in November 2019 shows that coarse sand continues to be one of the most dominate grain size types. Additionally, medium sand was found to be a co-dominant grain size in the Year 4 survey. This continues the trend from Year 3 of increasing medium sand grain size type.

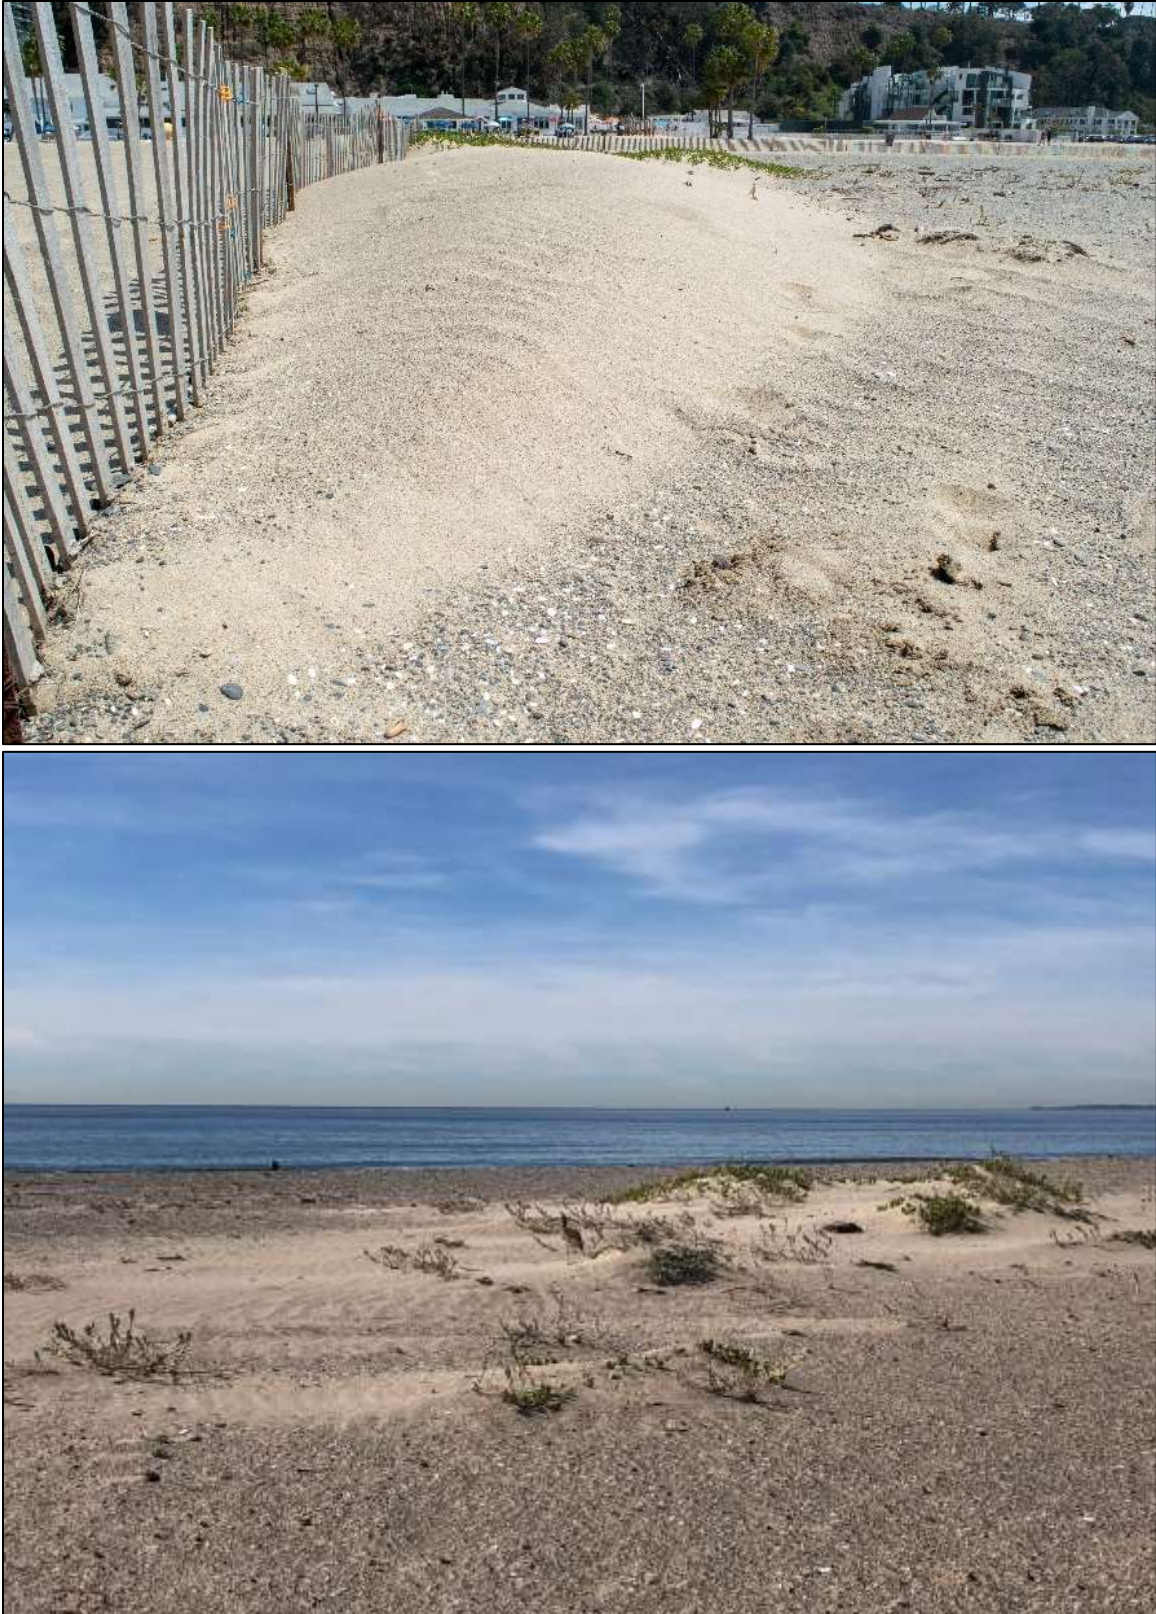
Figure 37. Photographs showing larger grains at the base of the dune and finer grains on top due to aeolian processes (top: 29 April 2019; bottom: 5 February 2020).

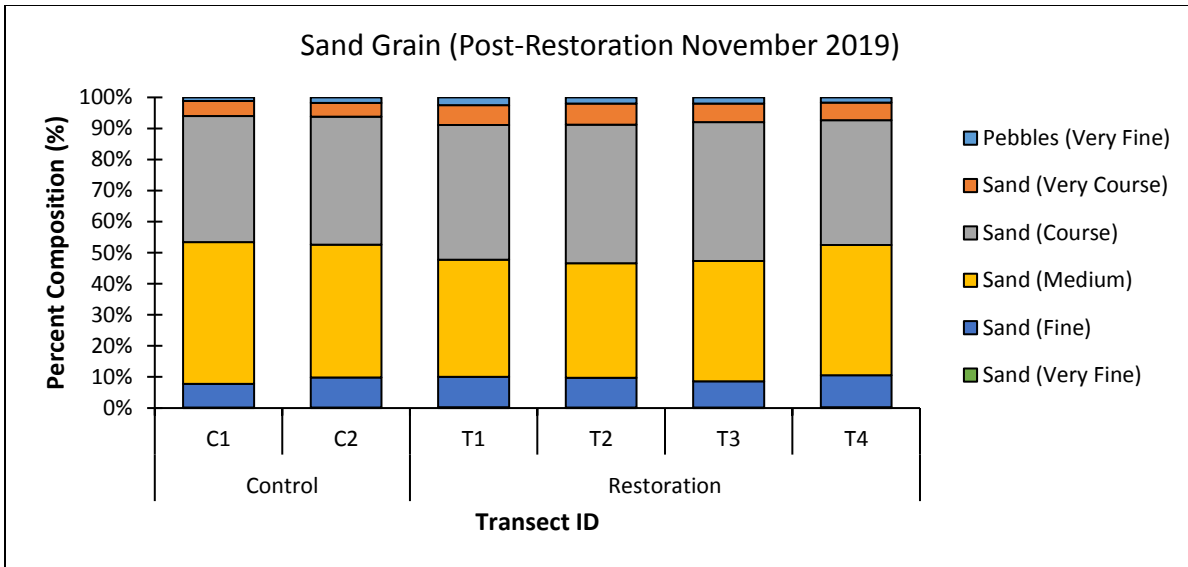
Figure 38. Baseline (top) followed by post-restoration sand grain results for all transects (dry sample averages).

Figure 38 (cont'd). Post-restoration sand grain results for all transects (dry sample averages).

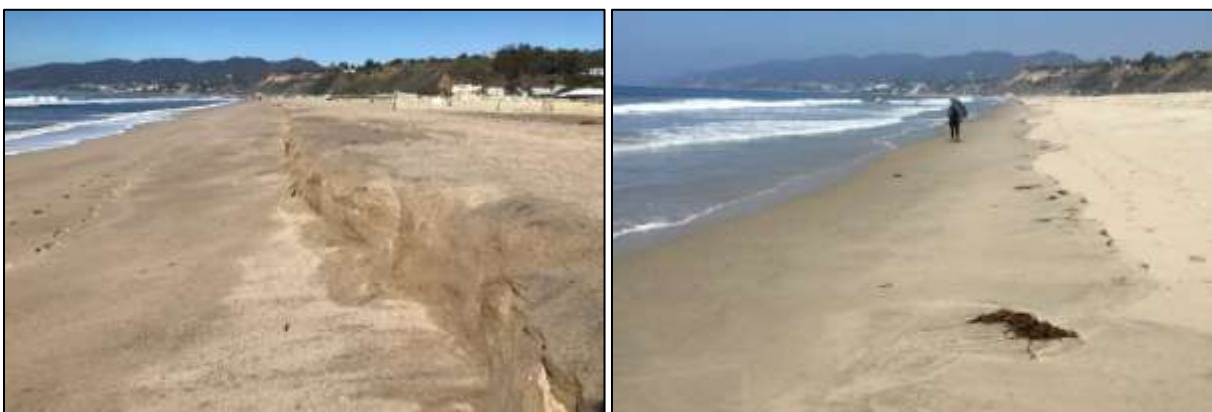
Figure 39. Photographs of eroded beach face following a winter king tide on 25 January 2017 (left) and a gentler sloping beach face on 15 August 2018 during summer season (right).

Wet sand results were reported separately (Table 8). Results from the wet sand samples were variable between the baseline survey and the post-restoration survey but displayed relatively similar results at both the control transects and the restoration transects. As the wet sand is outside of the area actively maintained for the restoration, the similarity between the control and restoration results for the wet sand was expected. The variability between the baseline and post-restoration surveys is likely due in part to the collection of the samples in two different wet sand locations based on the seasonal movement of the berm and wave erosion. Baseline sand composition, taken December 2016, was dominated by coarse and medium sand grains, and the data indicate an oscillation between medium grains during summer to coarse sand grains in winter season (Table 8). This shift in grain sizes is likely consistent with winter storms eroding the beach face followed by the deposition of sand in the calmer spring and summer months (Figures 39).

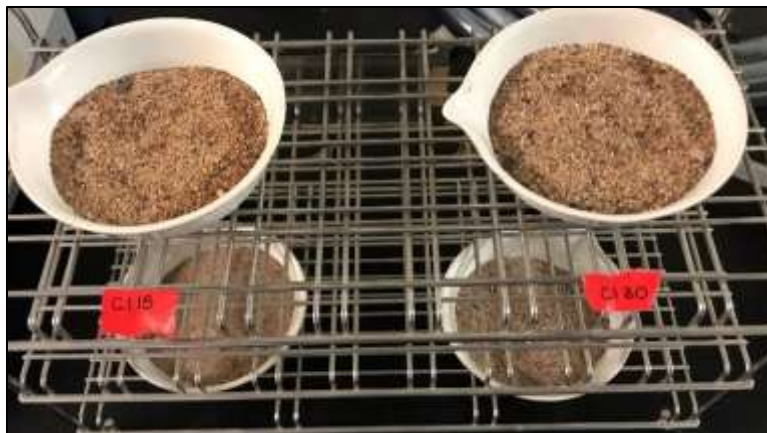
Figure 40. Organics (loss on ignition) analysis on sand samples (18 July 2018).

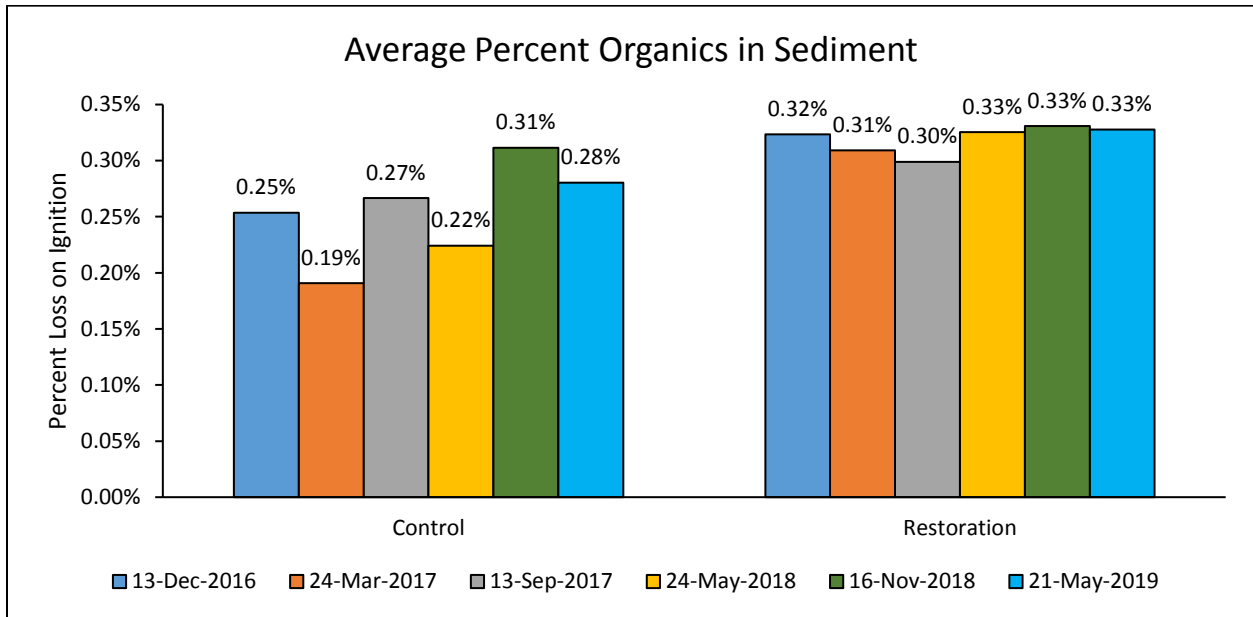
Figure 41. Average percent organics in sediment samples by survey date (dry samples only).

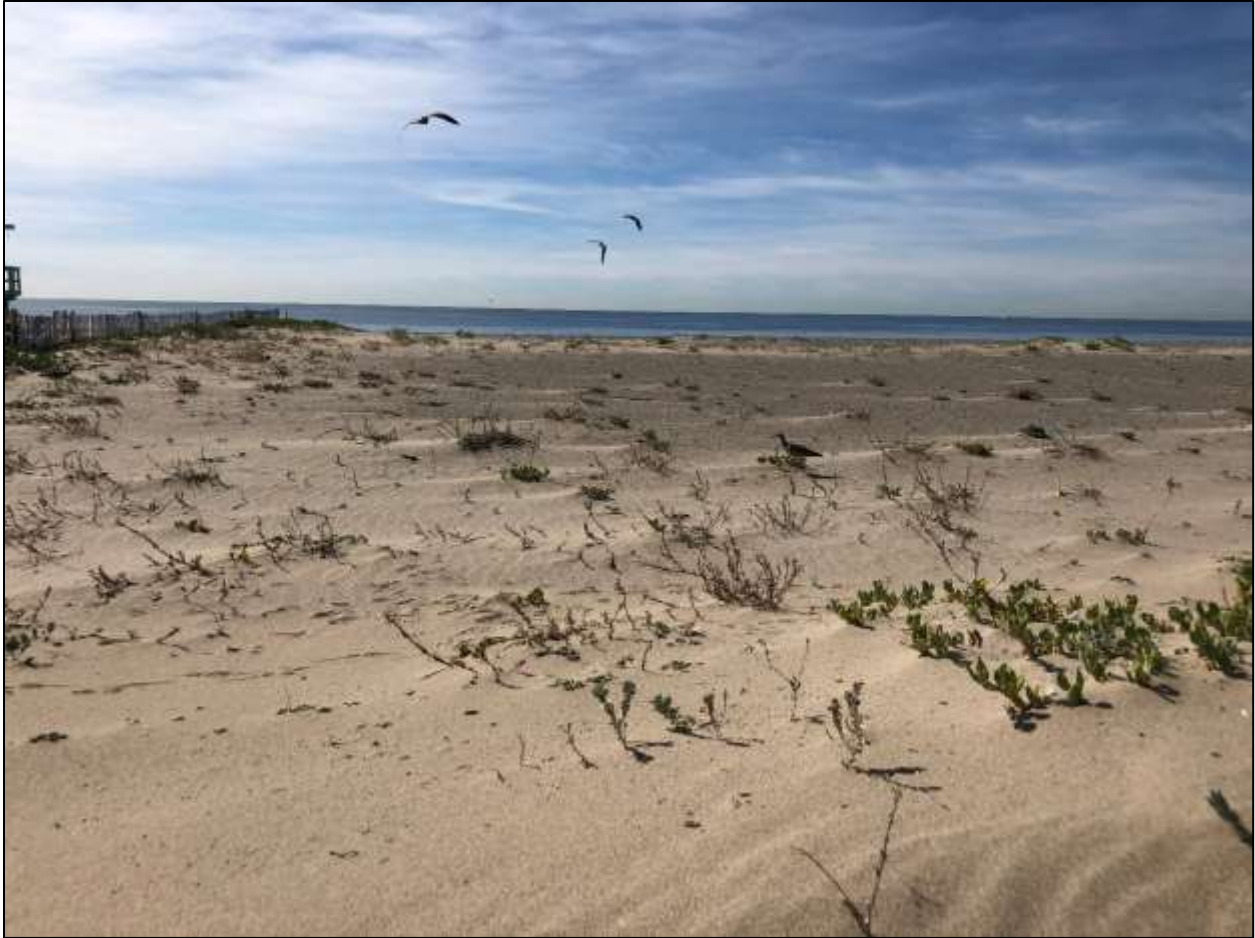
Figure 42. Representative site photograph from 5 February 2020 looking out oceanward from inside the back beach southern fence perimeter.

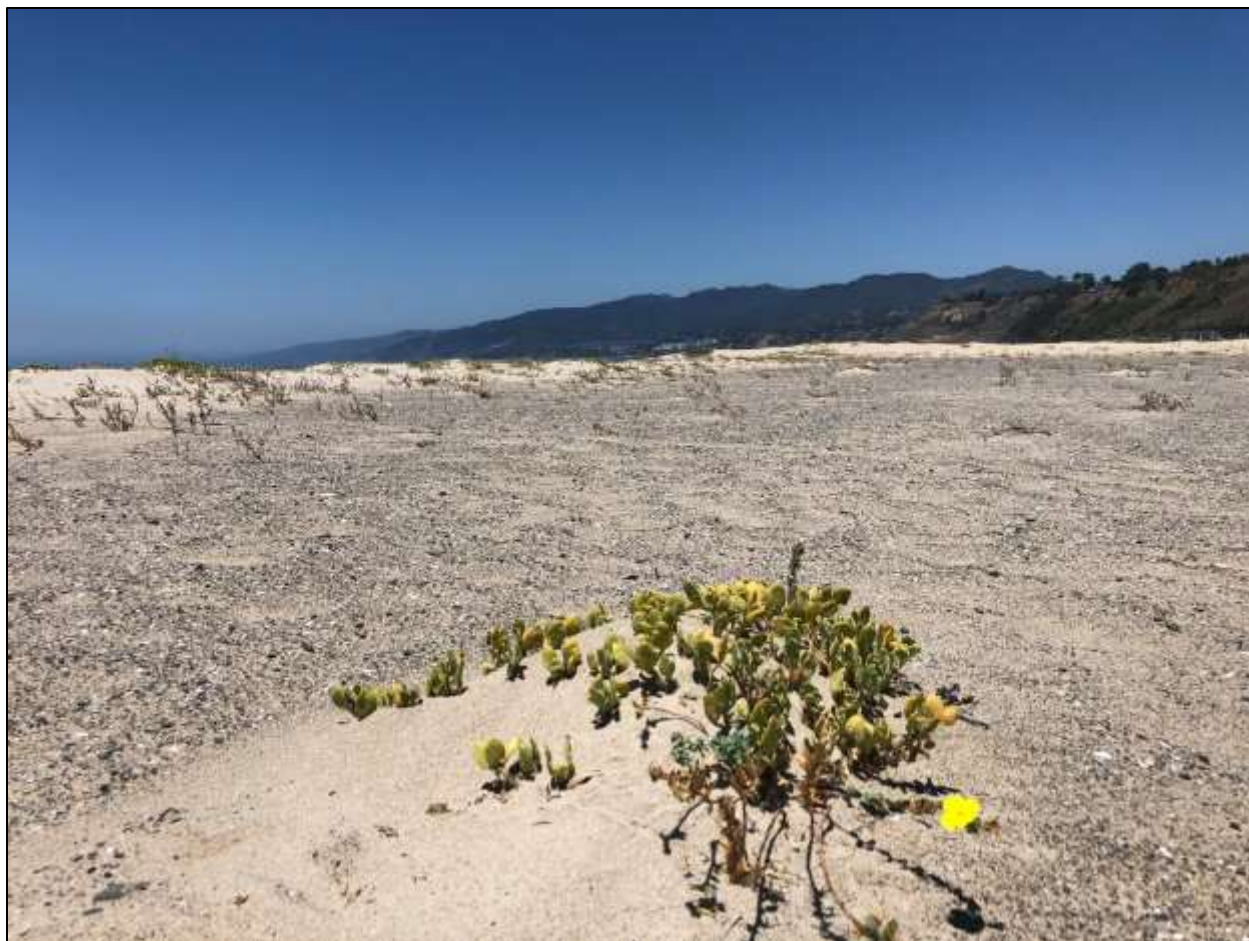
Figure 44. Beach evening primrose growing atop a small dune hummock within the restoration area on 11 June 2020.
